Subject: CONNECTED VEHICLE SYMPTOM TROUBLESHOOTING	Service Alert No.: SA-013/21
	Last Issued : 05/11/2021

DESCRIPTION

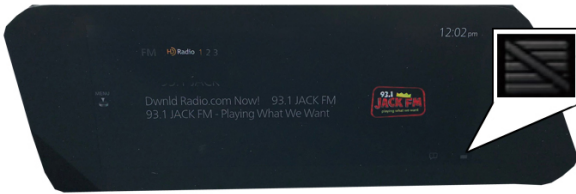
CX-5, CX-9

MAZDA CONNECT connected vehicle reception strength icon shows "X" or "\".
Mazda3, CX-30

- **Yes:** Go to MGSS for normal DTC diagnosis.
- **No:** Go to next step.

3. Disconnect battery terminal for 30 seconds, then move the vehicle. **Is the reception strength signal normal?**

4. Perform TCU activation. Go to [SA-004/21](#). **Is the reception strength signal normal?**

5. Compare Tel antenna No. 1 signal strength with good known vehicle near by.

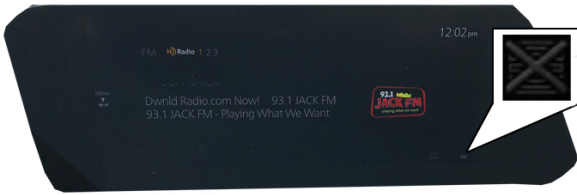
2019 Mazda3 only:

- The customer is not able to activate Connected Services via the MyMazda app after CSP06 completion.
- MAZDA CONNECT connected vehicle reception strength icon is missing or shows unsubscribed after CSP06 completion.

Go to [CSP07 Repair instructions](#).

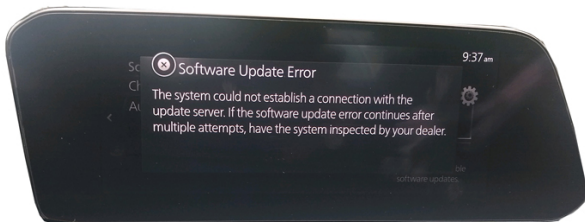
2020 Mazda3 only:

- Infotainment center display does not provide Authorization Code during the MyMazda App Connected Vehicle enrollment and infotainment Software Update Error message.

Go to [SSPC1](#).
