Location: Powertrain Systems - Cooling System

Topic: Hybrid System Fault warning message on the instrument cluster

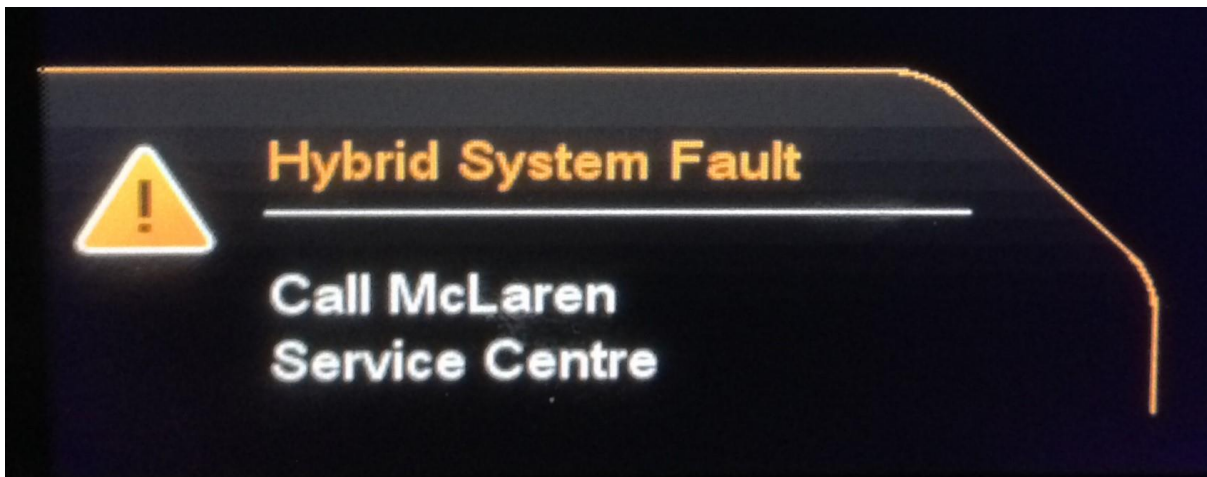
The warning message "Hybrid System Fault" (screenshot below) is **not** related to the vehicle's Hybrid System when is not followed by "12V Battery Discharging" and Engine MIL light.

This warning message relates to the coolant system of the vehicle and does not generate a DTC.

- Check the engine coolant level.

- With the use of the coolant displacement tool kit, check the coolant displacement. Refer to SIS instructions BA-RM-04L001-00-001 - Drain/fill fluid - cooling system - Step 23.
If the displacement is outside the limit, proceed with the full vacuum bleed of the coolant system as per the SIS instructions.
- Once the coolant displacement is within the limits, test drive the vehicle to confirm the warning message is not returned.
