**Symptom in Brakes – Creaking Noise from Front End Area When a Brake Pedal is Actuated:
No Action Required (SY 56/21)**

Model Line: **Taycan (Y1A)**

Model Year: **As of 2020**

Concerns: **Brake booster**

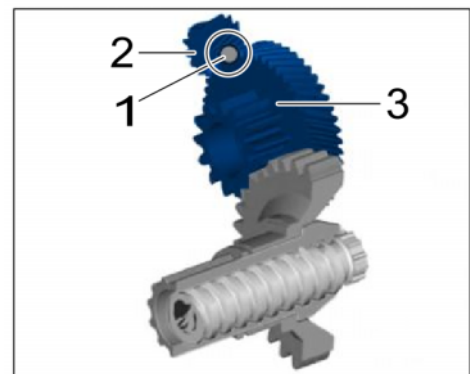
Brake booster mechanism

Cause: The reason for this may be a gear engagement of the pinion teeth ⇒ *Brake booster mechanism -1-* between the engine pinion ⇒ *Brake booster mechanism -2-* and the gear of the brake booster ⇒ *Brake booster mechanism -3-*.

The cause of the noise is perceived to be a mechanical operating noise inside the brake booster and is **not** a technical fault.

No action is required. Replacing the brake booster will not work.
