PSB E265 EPA2017 PACCAR MX-13 Engines High Oil Flow Kit (HOFK) and Camshaft Inspection

E265

Selected engines have been identified to receive a camshaft inspection and an update for improved camshaft lubrication.

690 chassis (674 U.S. and 16 Canada) T680, T800, T880, W900, and W990 chassis built from 02/28/17 through 04/25/19, equipped with PACCAR MX-13 EPA2017 engines. See the attached chassis list for specific chassis.

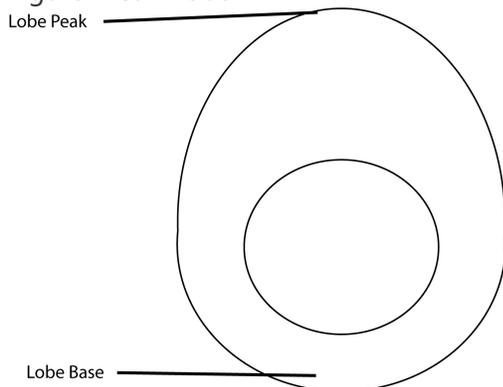
Figure 1 Cam lobe

- d. Use cable ties to hold the harness away from the pan.
 - e. Remove the oil pan bolts and remove the oil pan.
 - f. Refer to the Camshaft Inspection Photo Guide to take clean, clear, and in focus photos of the **PEAK** of the **EXHAUST** camshaft lobes. The exhaust cam lobe is the wider lobe.

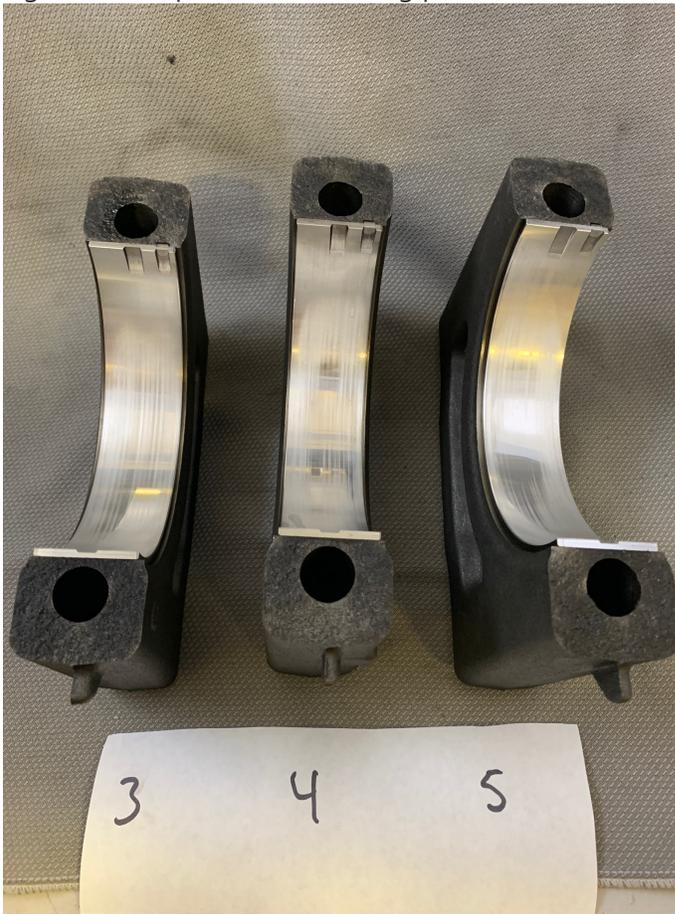
Figure 2 Example of main bearing photos

- h. Take clear and in focus photos of the bearings.
8. Inspect the condition of the bearings and attach the bearing photos to the TCS365 case and update the Diagnostic Details of the case with "inspected and attached #3, 4, & 5 main bearing photos". VSC will provide final direction of repair.
- If you are directed to replace the camshaft, if the chassis has E263 Open in SIR, also replace the valve guide seals per PSB E263.
 - Use caution when opening the camshaft box. The box must be reused to return the camshaft.
 - If you are directed to install a short block, see the Flush the oil module procedure below.

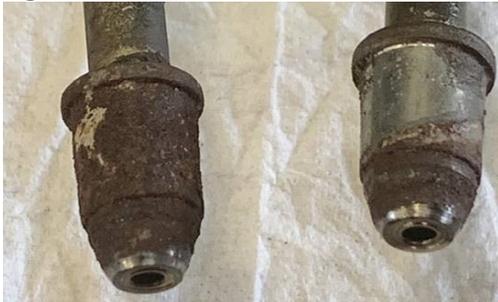
Figure 3 Corroded Fuel Lines

- The high pressure fuel rail lines should only be disconnected during a camshaft or engine replacement.
- If the ends of the fuel lines are corroded as shown below, replace the fuel lines.
- Attach photos of the corroded fuel lines and the connections at the unit pumps to the TCS365 case.

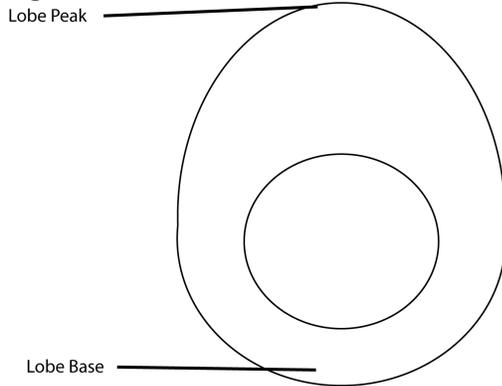
Figure 1 Cam lobe

- No further repair required-the HOFK and other open campaigns can be performed.
 - Camshaft replacement required.
 - Long block or complete engine replacement required.
1. Remove the oil pan and inspect the camshaft exhaust lobes.
 - a. Disconnect the batteries.
 - b. Drain the oil.
 - c. Remove the electrical harness bracket from the driver's side front of the engine block and oil pan.
 - d. Use cable ties to hold the harness away from the pan.
 - e. Remove the oil pan bolts and remove the oil pan.
 - f. Refer to the Camshaft Inspection Photo Guide to take clean, clear, and in focus photos of the **PEAK** of the **EXHAUST** camshaft lobes. The exhaust cam lobe is the wider lobe.
 2. Open the Camshaft Inspection Photo Guide document in the Attachments section of this bulletin and save it as a new file. Use the naming convention of "*last 8 digit of VIN* Cam Inspection".

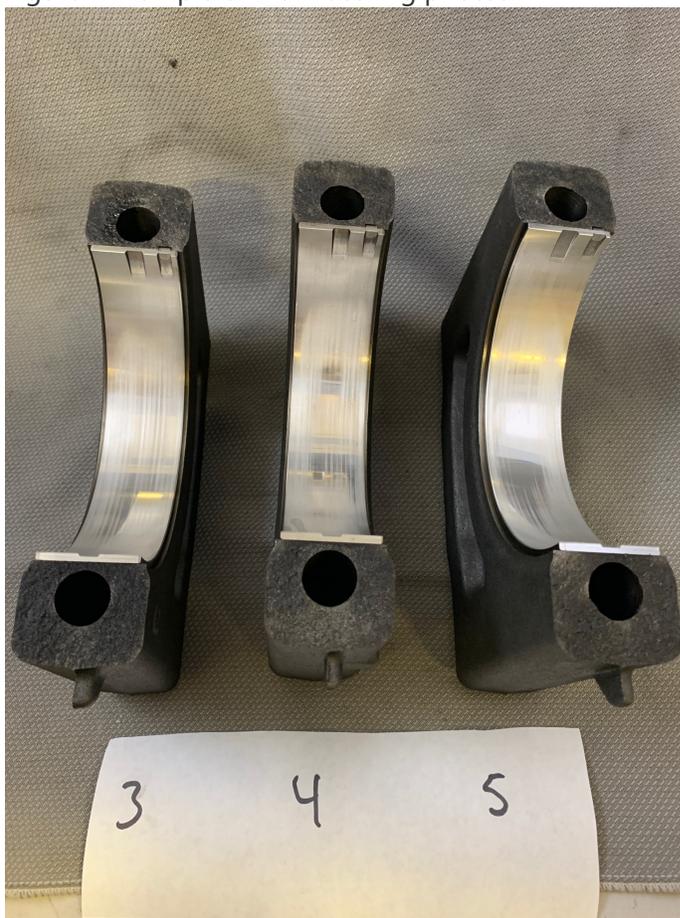
Figure 2 Example of main bearing photos

- g. Place the bearing caps on a clean piece of paper or cardboard and label the bearing locations.
 - h. Take clear and in focus photos of the bearings.
8. Inspect the condition of the bearings and attach the bearing photos to the TCS365 case and update the Diagnostic Details of the case with "inspected and attached #3, 4, & 5 main bearing photos". VSC will provide final direction of repair.
 - If you are directed to replace the camshaft, if the chassis has E263 Open in SIR, also replace the valve guide seals per PSB E263.
 - Use caution when opening the camshaft box. The box must be reused to return the camshaft.
 - If you are directed to install a short block, see the Flush the oil module procedure below.

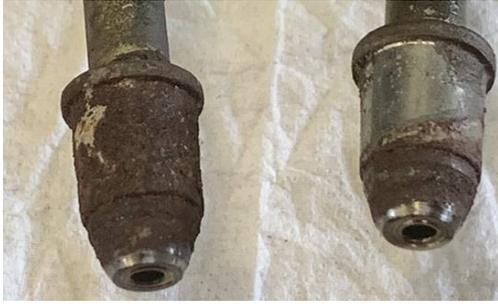
Figure 3 Corroded Fuel Lines

- The high pressure fuel rail lines should only be disconnected during a camshaft or engine replacement.
- If the ends of the fuel lines are corroded as shown below, replace the fuel lines.
- Attach photos of the corroded fuel lines and the connections at the unit pumps to the TCS365 case.
