<b>Subject:</b>  <b>WATER LEAK FROM ROOF CAUSING ELECTRICAL AND MECHANICAL CONCERNS</b>	<b>Service Alert No.: SA-035/21</b>
	<b>Last Issued : 05/19/2021</b>

2020-2021 CX-30

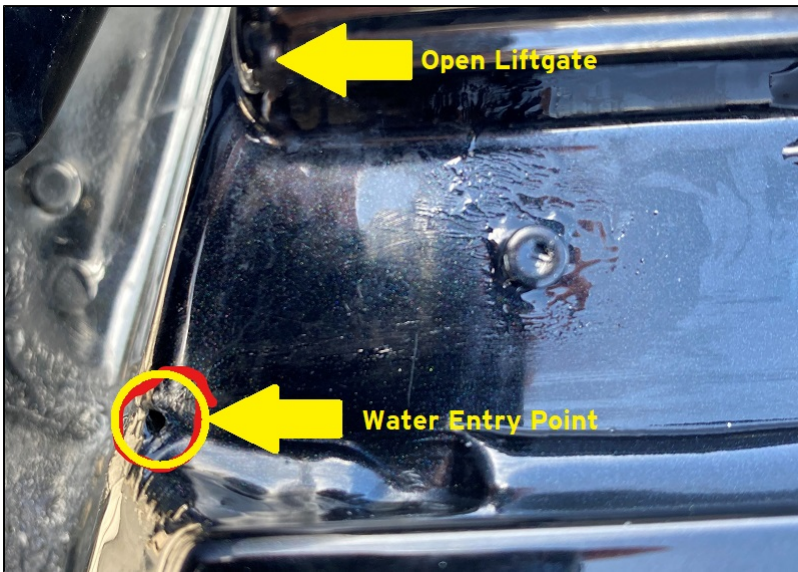
A customer may experience symptoms caused by a roof water leak. Some will be obvious, like water in the spare tire well, others might be electrical in nature or water in the rear differential. The source of the leak may be pinhole anywhere along the roof seams under the 2 trim strips (where the roof rails attach). Depending on the location of the leak, the headliner may or may not be visibly affected.

1. Document the following information on the RO:
  - Document all concerns caused by the leak (e.g. radio not working because it got wet).
  - Check for and document any stored DTCs.
  - Take photos of the area where the leak was found. These will be needed for the warranty claim or pre-authorization (if needed).
2. Check these locations on both sides of the vehicle for a small hole. If a leak is found at this location, sublet to a body shop for repairs.
