## 992 / 982 (4.0 liter variants) – Diagnosing DMTL Leakage Faults

### Condition

MIL (Check engine light) fault(s) for either an active or a passive tank leakage detection fault "P044200 (002EB3) – Fuel tank system leaking > 1 mm" or "P045600 (002EB2) – Leak (micro) in fuel tank system 0.5 to 1.0 mm." These faults also result yellow dash warning.

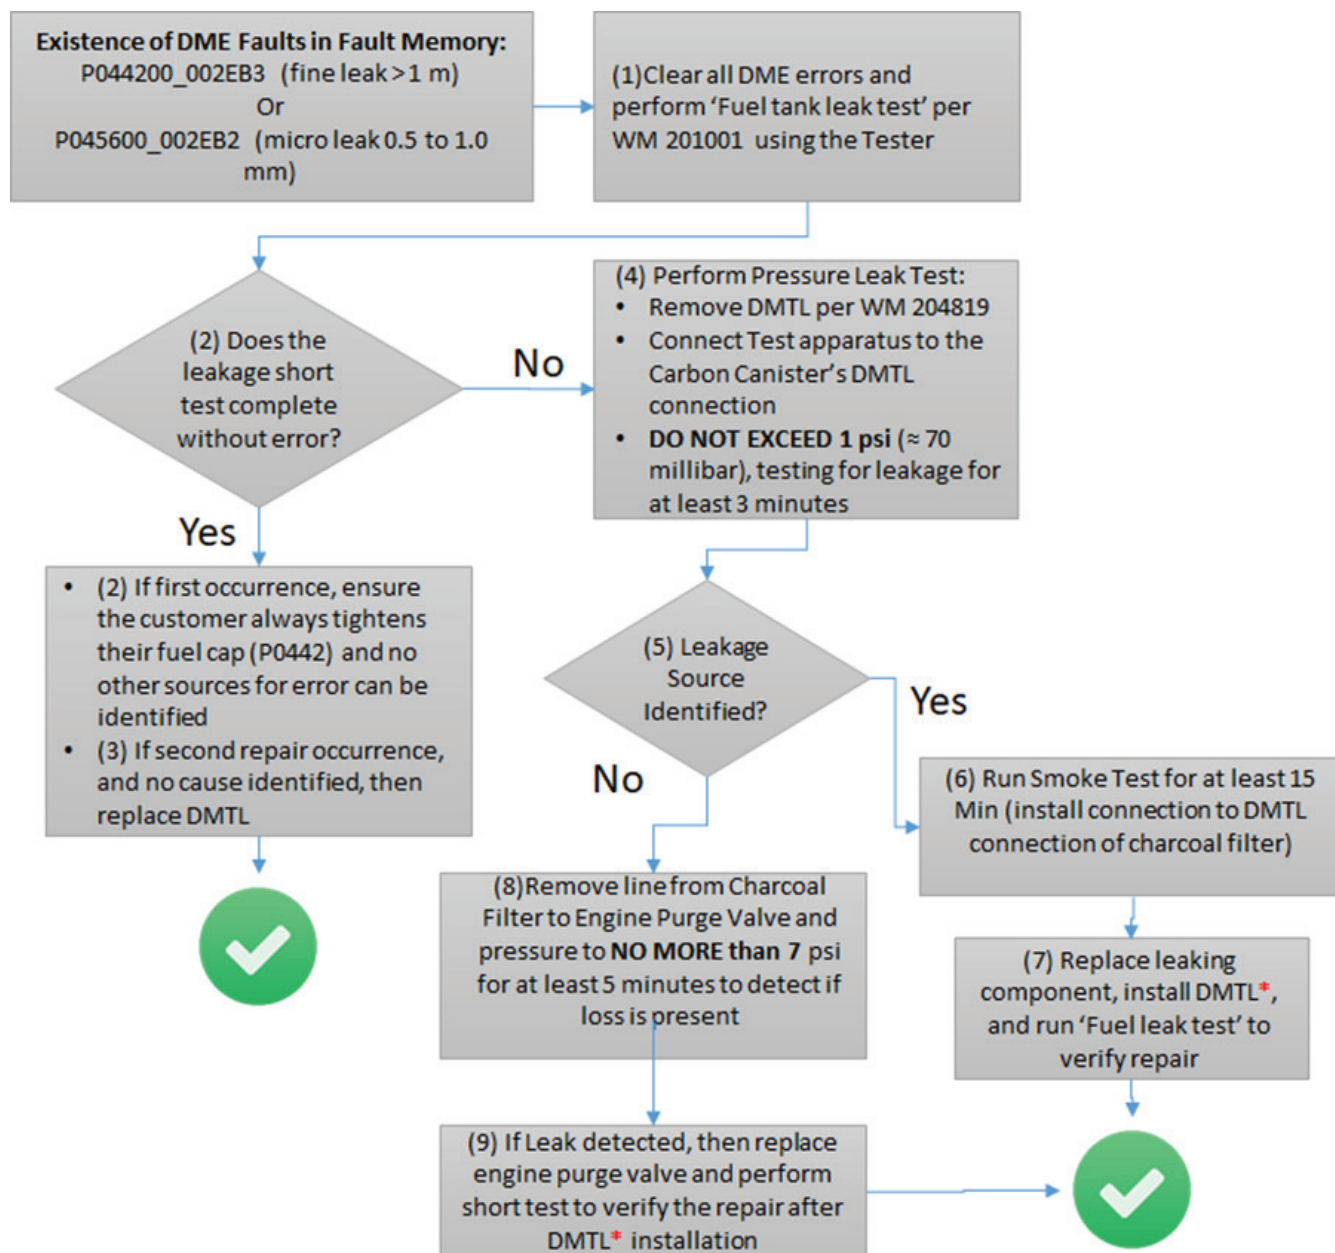
Figure 1 - Diagnostic Fault Tree for Leak Detection Faults

Please follow the fault tree presented in Figure 1 when diagnosing the aforementioned faults. Further background and reference for the Evaporative Emissions Leak Detection system in these vehicles is available in the attached film.

\*Regardless of whether or not an exchange of the DMTL is deemed necessary in accordance with Figure 1, the rubber grommet seals of the DMTL at the mating instances to the carbon canister and fresh air filter require replacement following testing.

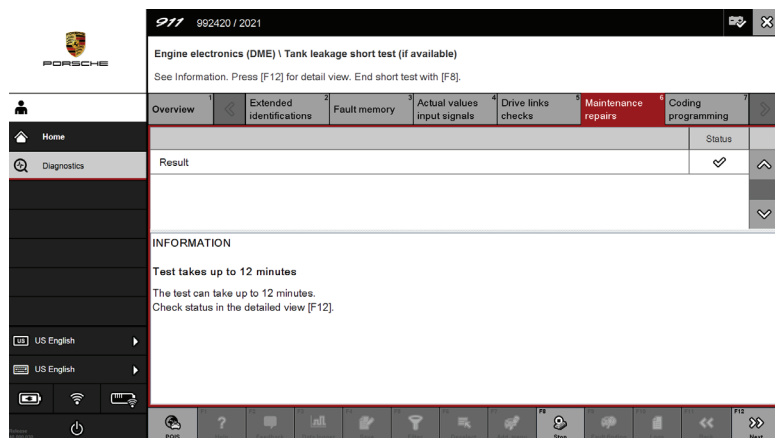
**Figure 2 - Successful Tank leakage short test in Tester**

A successful 'Tank leakage short test' results in no EVAP errors in the fault memory and a check sign in the result status. An unsuccessful short test results in an "X" and tank leakage errors.

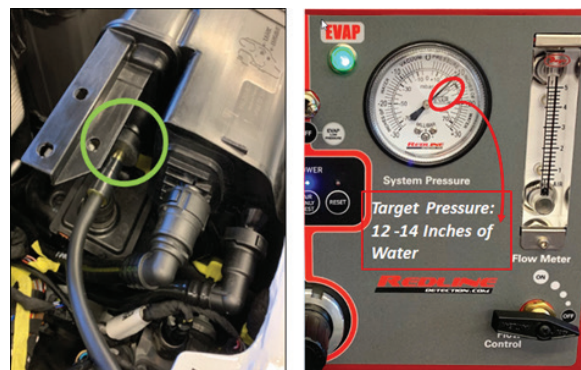
**Figure 3 - Air Introduction into System and 'Leak Down' Operation**

After removing the DMTL in accordance with WM 204819, introduce pressurized air into the system where the DMTL connects to the charcoal canister (green circle, Fig. 3). A No. 4 stopper works well in this application. Even if the testing apparatus includes a fuel cap adapter for testing, the best fail-safe for identifying potential leaks is removing the DMTL and beginning as shown here. This allows for identification of any potential leaks at the cap, which may otherwise be masked. When performing a 'leak down' test, ensure the pressure does not exceed 1 psi ( $\approx$  70 millibar).

Some detection apparatuses incorporate a flow meter indicating air mass is flowing, e.g. the *Dual Purpose Diagnostic Leak Locator™* from Redline targets 12 – 13 inches of water column, which is slightly less than 0.5 psi. When the detection system reaches its targeted pressure, depending on whether or not there is a leak, the airflow stops. When checking for smaller leaks, the airflow control knob can stop flow at or below target pressure via the flow control knob to watch for pressure drop as a function of time.

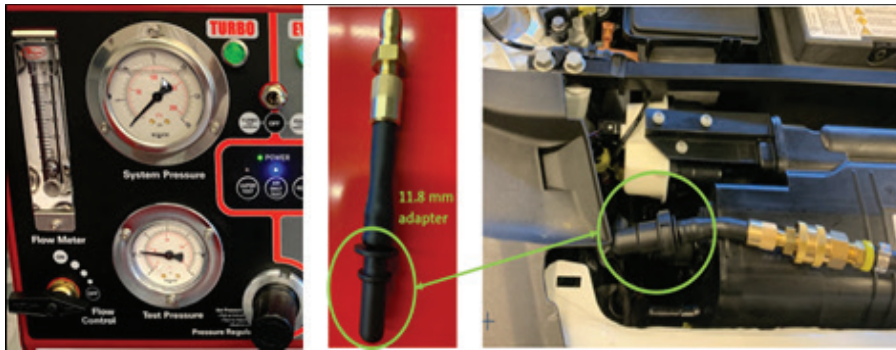
**Figure 4 - Pressure Test to Tank Vent Valve**

This step allows for leakage detection between the tank vent valve (purge valve) and the charcoal canister without removing the throttle or intake pipe. When following this step of the fault tree procedure of Figure 1, ensure the usage of an EVAP adapter of the proper size, 11.8 mm (Figure 4). When testing for a leak, do NOT exceed 7 psi and test for no less than 5 minutes. Similar to Step 4, if using *Redline's Dual Purpose Diagnostic Leak Locator™*, then the 'Turbo' side intended for testing exhaust/turbo leaks is helpful because it offers more pressure with a regulator. Again, there is a flow meter and a control valve to stop flow for 'leak down' testing.
