### 992 / 982 (4.0 liter variants) – Diagnosing DMTL Leakage Faults

#### Condition

MIL (Check engine light) fault(s) for either an active or a passive tank leakage detection fault "P044200 (002EB3) – Fuel tank system leaking > 1 mm" or "P045600 (002EB2) – Leak (micro) in fuel tank system 0.5 to 1.0 mm." These faults also result yellow dash warning.

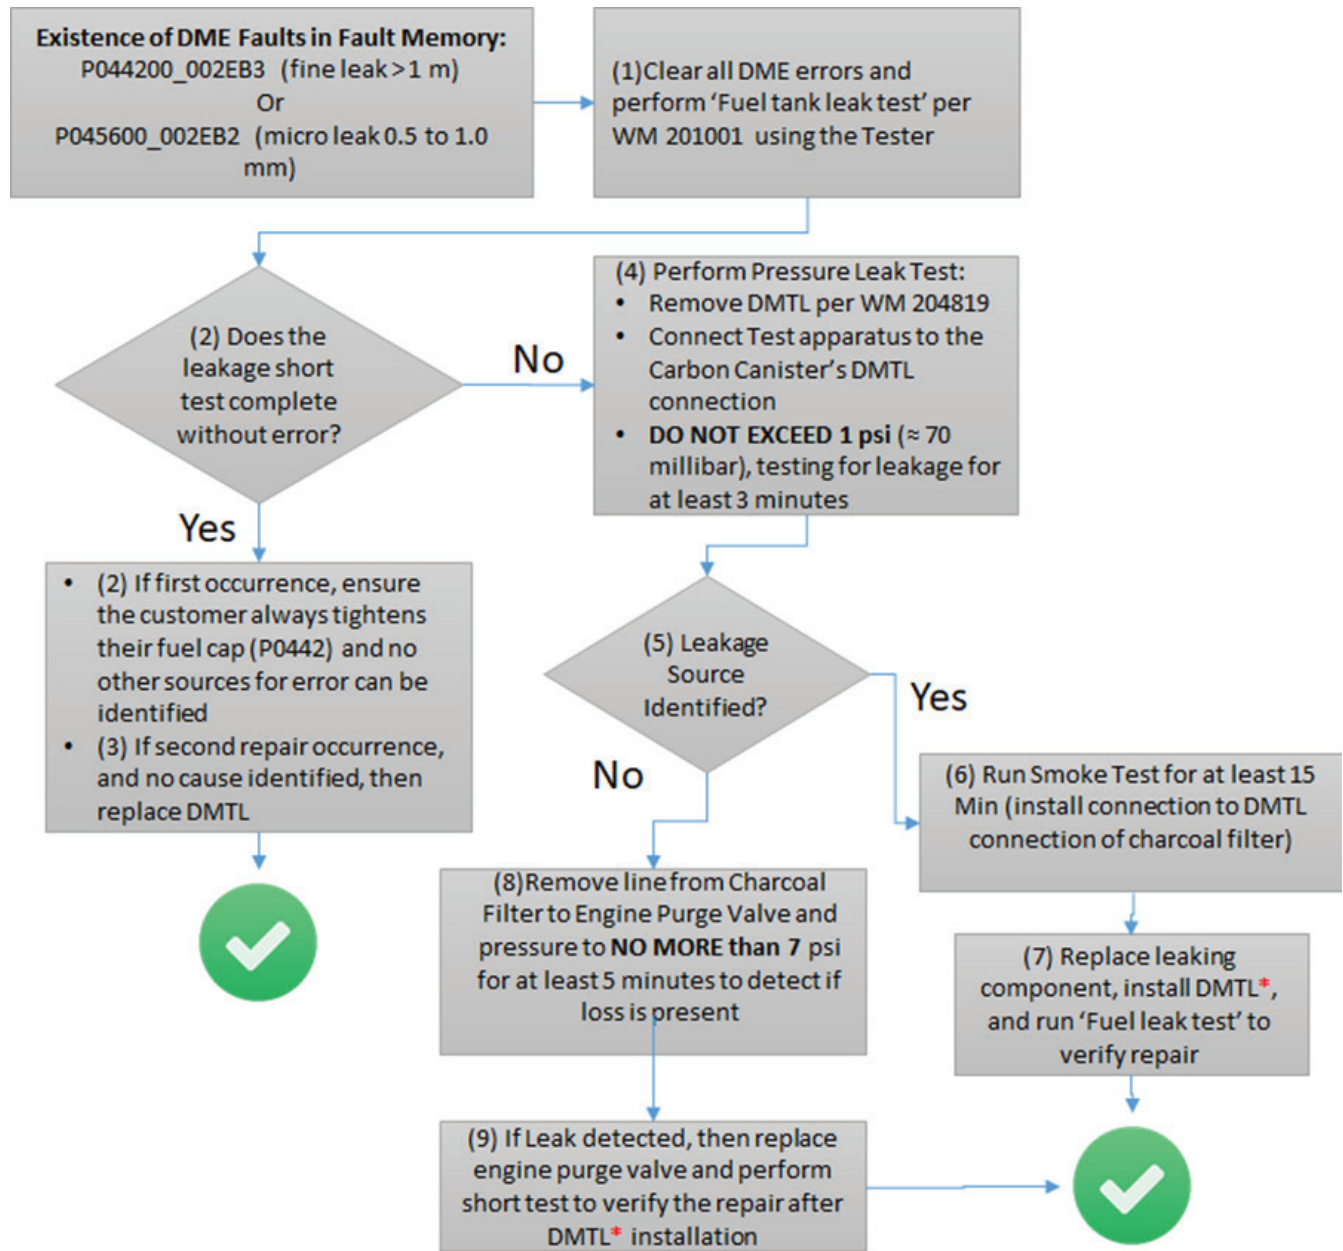
Figure 1 - Diagnostic Fault Tree for Leak Detection Faults

Please follow the fault tree presented in Figure 1 when diagnosing the aforementioned faults. Further background and reference for the Evaporative Emissions Leak Detection system in these vehicles is available in the attached film.

\*Regardless of whether or not an exchange of the DMTL is deemed necessary in accordance with Figure 1, the rubber grommet seals of the DMTL at the mating instances to the carbon canister and fresh air filter require replacement following testing.
