Service Alert

Subject: DTC U2050:55 STORED AFTER REPLACING OR REPROGRAMMING BCM	Service Alert No.: SA-038/21
	Last Issued : 05/24/2021

2019-2021 Mazda3

2020-2021 CX-30

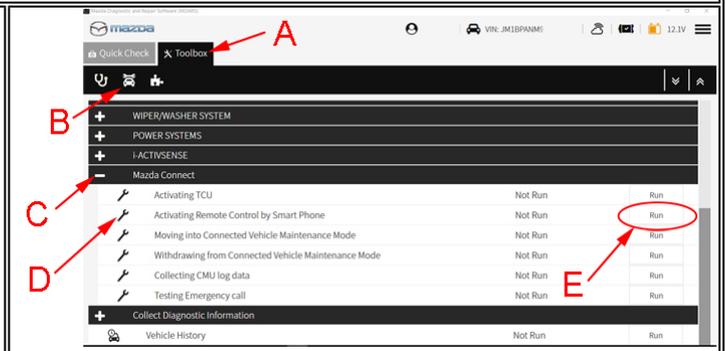
This is caused by a communication error between the telematics communication unit (TCU) and BCM when the control software in them are not of the version being ready for activation of the connected service.

4. Select the following:

- A. Toolbox
- B. Repair icon
- C. MAZDA CONNECT
- D. Activating Remote Control by Smart Phone (links TCU to BCM)
- E. RUN.

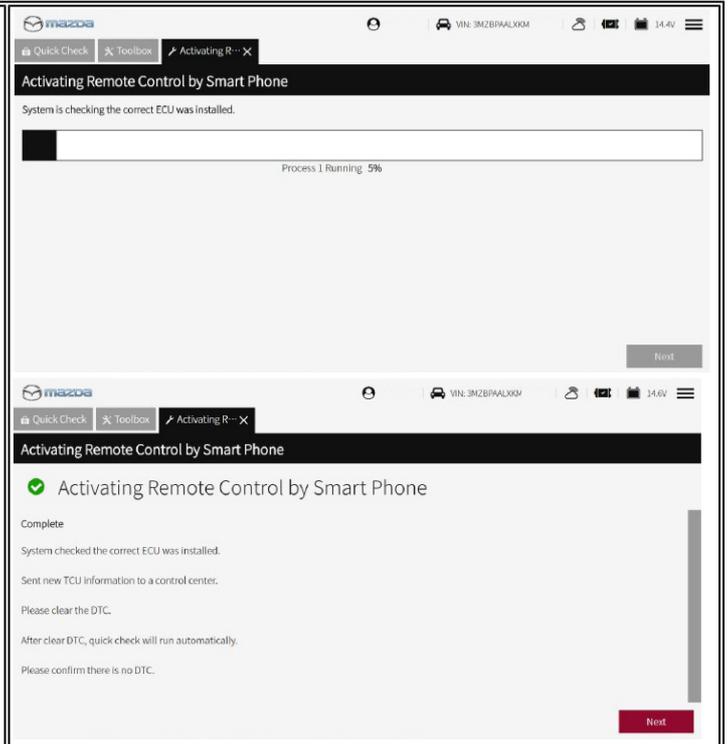
NOTE: If the Activating Remote Control by Smart Phone shows "Incomplete", the possible causes are:

- The advanced key is not in the vehicle.
- The Connected Vehicle Maintenance Mode is enabled.
- The key transmitter power saving function is enabled.
- The pacemaker radio wave interference prevention function is enabled.

5. Follow the on-screen instructions and wait for process to complete.

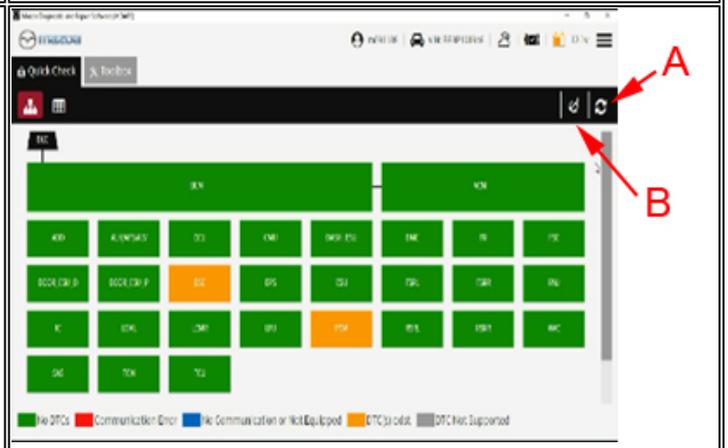
CAUTION: If the engine is not started, DTC P2610 is stored and cannot be erased.

6. Select Quick Check (A), then start the engine and select the DTC Clear icon (B).
