Service Alert

Subject: CRACKED REAR DIFFERENTIAL	Service Alert No.: SA-033/21
	Last Issued : 05/11/2021

2017-2021 CX-3 AWD
2017-2021 CX-5 AWD
2017-2021 CX-9 AWD
2020-2021 CX-30 AWD
2021 Mazda3 AWD

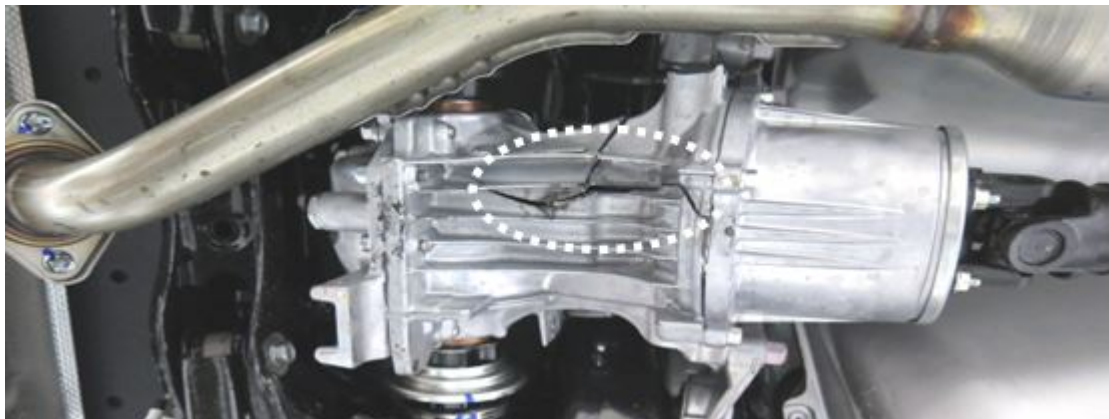
The rear differential case could develop a crack in the case, as shown below.

1. If the vehicle belongs to a customer, request the customer to fill out the questionnaire attached below. If the vehicle is a rental (AVIS, Enterprise, etc.) or a used car without a known history, note this on the repair order and let the MASH agent know, no questionnaire is needed.
2. Take photos of rear differential damage.
3. Contact MASH for differential approval. Have photos and questionnaires available for quick approval.
4. Replace rear differential according to MGSS.

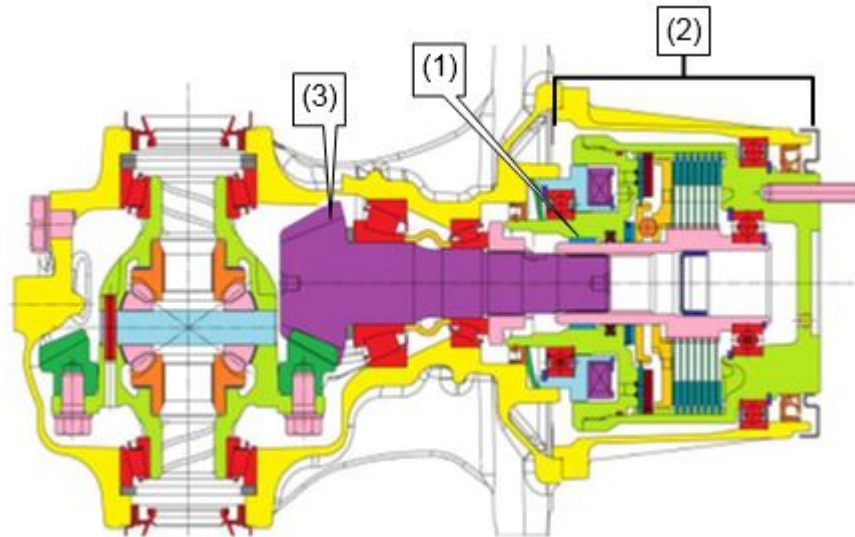
This concern is caused when the sliding bearing (1) in the coupling (2) is seized and causes the coupling component to fit loosely. The pinion shaft head (3) then contacts the differential case and causes a crack.
