Articles Contained in this Issue

01 Vibration After Transmission or Engine Removal

03 Ascent or Legacy/Outback 2.4L Binding When Turning Basic Diagnosis Overview

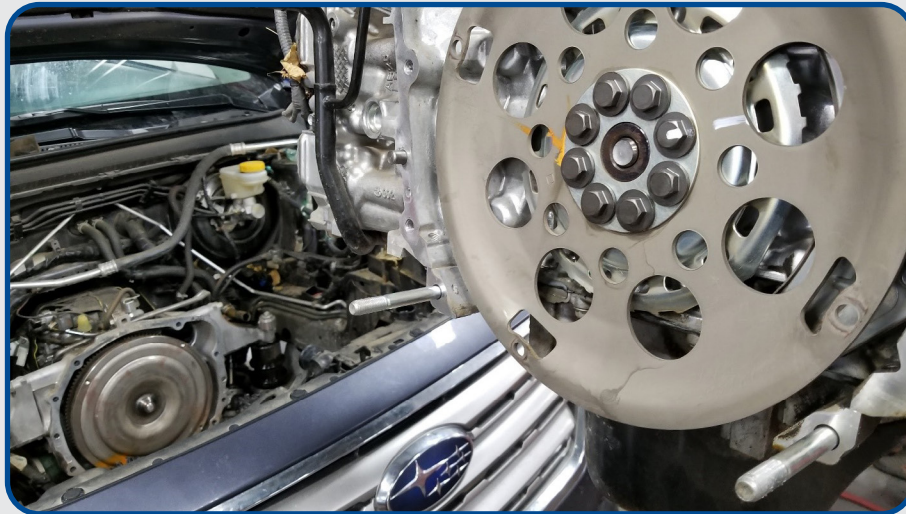
Techline has received increasing concerns of vibration after transmission or engine removal. Multiple cases have been identified where the vibration has been traced back to the snout of the torque converter being broken. This can happen if the torque converter holder tool is not used. When removing an engine or transmission the component needs to be released as straight as possible without any rocking or pitching.

The photo above shows the nose of the torque converter is broken off and remaining in the crankshaft. Also note, there is no torque converter holder tool installed to the transmission.

During component removal it is imperative to follow all steps of the procedure as outlined in the Service Manual. In addition, always confirm both dowel pins are installed in the engine block before engine reinstallation to insure proper engine to transmission alignment.

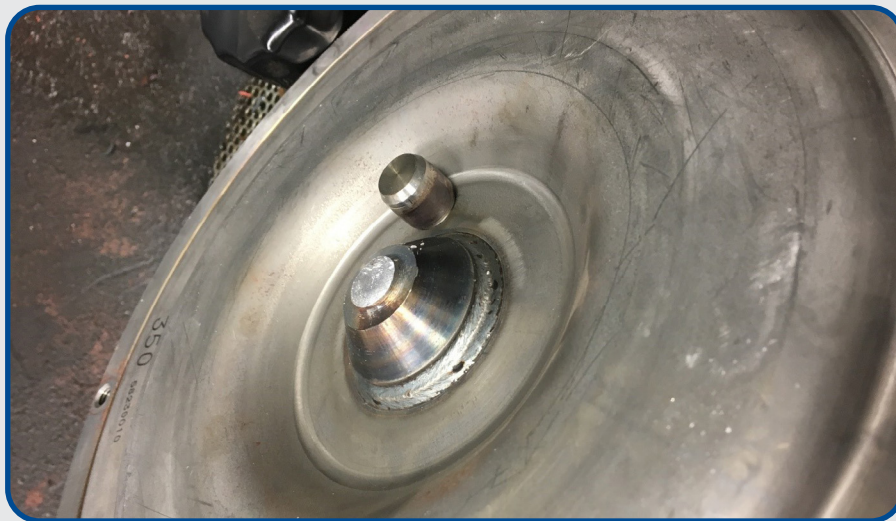
Torque converter with broken nose.

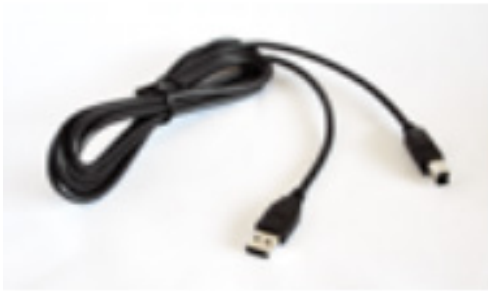
Nuspire Systems Integration
DENSO USB CABLE
5135

Techline has received an increase of concerns from technicians not being able to perform basic tasks when using the SSM4. This condition has been identified and is directly related to the use of aftermarket USB cables connected from the DST-i box to the SSM/Toughbook.

Techline would like to remind everyone to always use OE Denso USB Cable equipment when diagnosing or updating Flashwrite2 PAK files with the SSM/Toughbook. Reports of no communication with control modules, software updates crashing, and error messages being displayed has resulted in unrecoverable data leading to unnecessary control module replacement. There is no way to determine if an aftermarket cable will be able to perform all the tasks that the SSM4 or Flashwrite2 requires.

Please be sure that replacements for damaged USB cables are ordered directly through SubaruDT.com. Contact Subaru Dealer Technologies to order genuine Denso parts. Pricing is available in the RISE hyperlink under Service Operations & Technical in Subarunet.com.
