## P4 New Cascadia ABS Fault Code 520247/31 --Failure Memory Bit (ESC) Condition Exists

Model: NEW CASCADIA 126 INCH  
SLEEPER CAB

Model Year: 2020

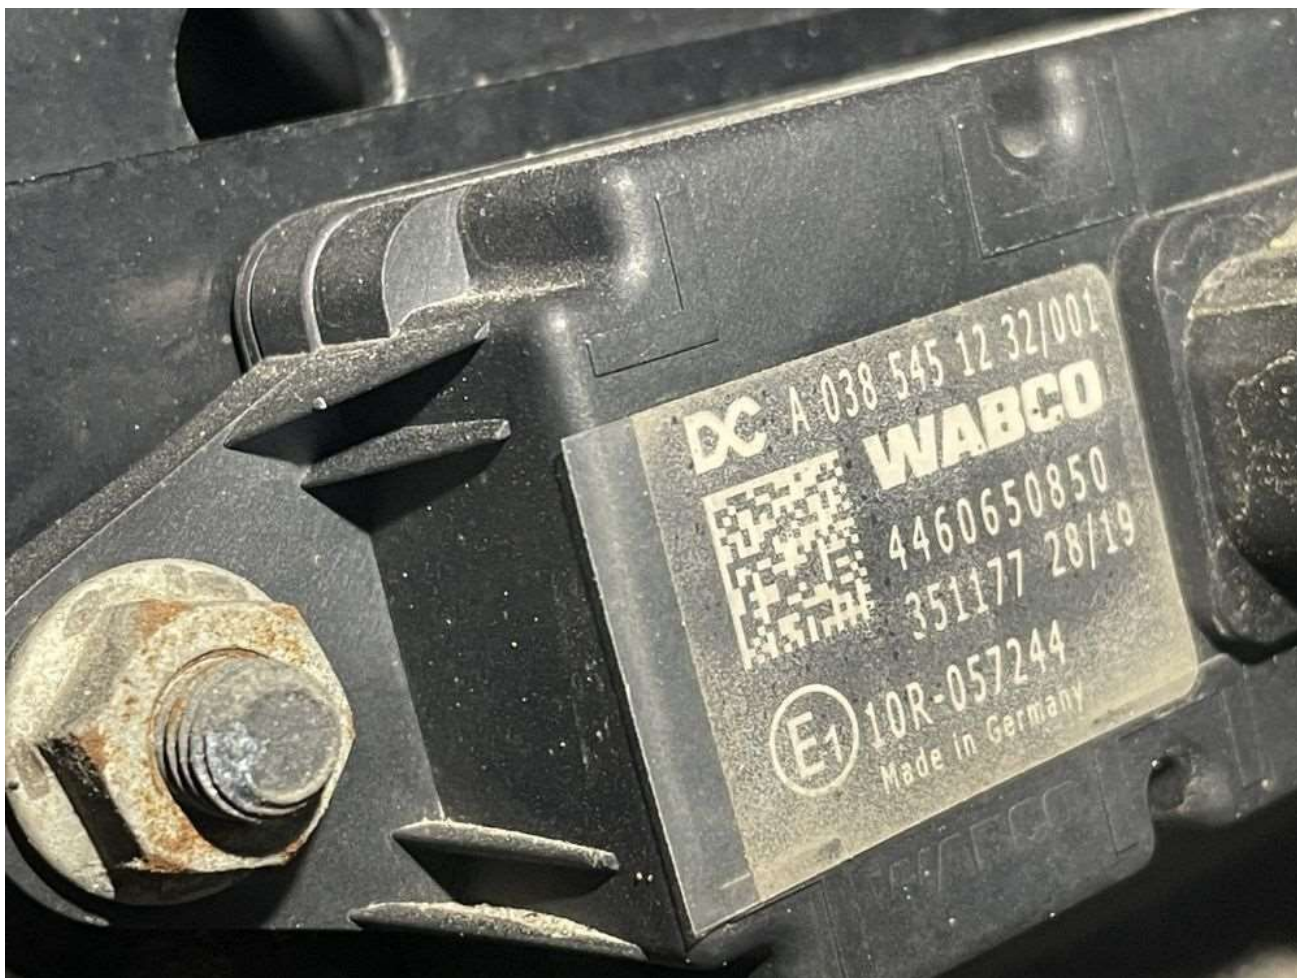
I Had code 520247/31 and followed SS 1033257 and it led me to replacing the ESC and i contacted WABCO to get approval and they had requested me to check to see if there was a loose or delaminated sticker on the esc module. The person at wabco explained to me that he had 4 other cases this week that had stickers on the ESC module causing this code because if vibration.

So the little flap at the left side of the sticker is causing this?

I had removed the sticker and performed EOL and the code went away.

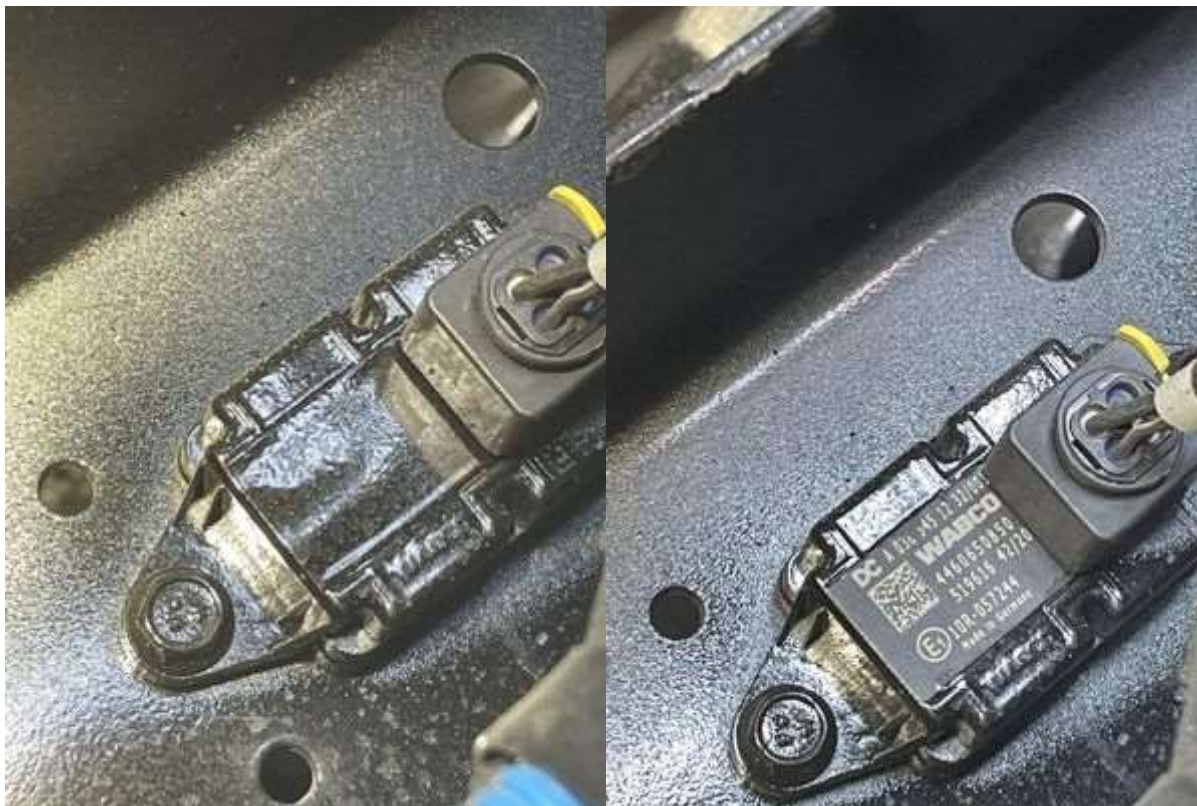
YES, i was told that little flap was vibrating and causing signal issues! I know it sounds crazy, but thats what someone at WABCO told me to check , and after i removed the sticker, did the EOL it passed. I also just recently found another one with the same issue.
