INSTRUCTION TO SERVICE

ITS: 59213 REV. A		04/30/2021
SECTION:	Option Group 549 HVAC System	
WRITTEN BY:	Scott Geier	
SUBJECT:	Rework AC compressor high side service port	
ISSUE:	90-degree high pressure service port elbow breaking	
SUMMARY:	Replace the 90-degree elbow with a straight adapter fitting.

ITS-59213

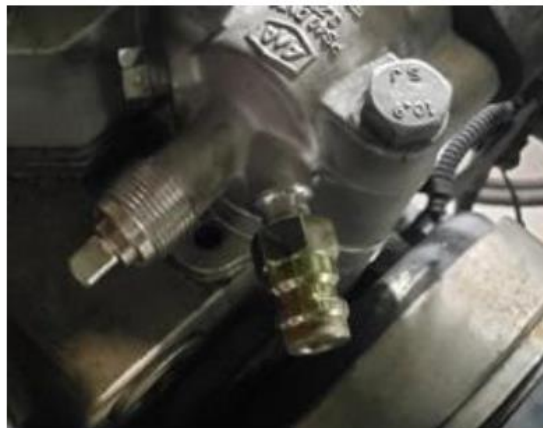
See below example of service valve fittings installed
