# INSTRUCTION TO SERVICE

ITS: 59239		May 6, 2021
<b>SECTION:</b>	460-Windows	
<b>WRITTEN BY:</b>	Troy Stutsky	
<b>SUBJECT:</b>	Inspect SDS Window Parts & Function and Rework if Required	
<b>ISSUE:</b>	Some SDS windows with T-Handle release and gas struts were not built to print which can cause the windows not to fully latch in the closed position. Part affected is NF PN 678774.	
<b>SUMMARY:</b>	Inspect the windows for any of the conditions outlined in this document and rework the windows as required.

# ITS59239

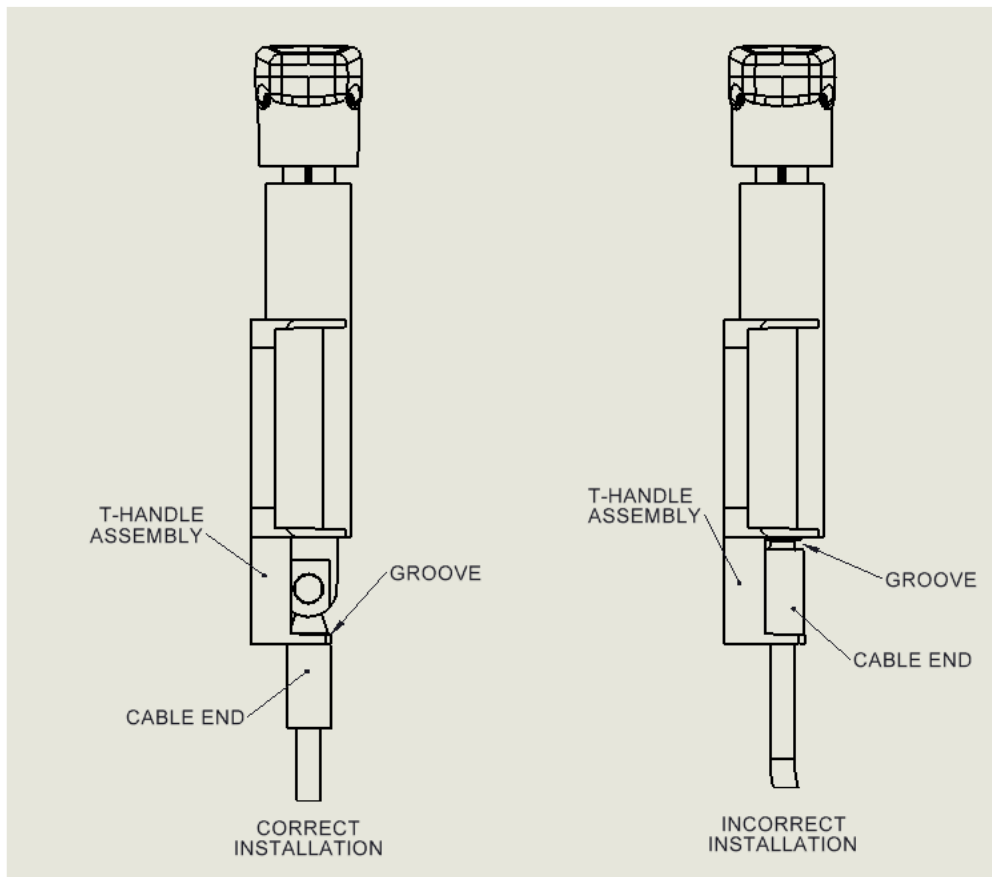
**Figure 1: T-Handle Cable Inspection and Repair**

1. Set park brake and chock wheels.
2. Turn the main battery disconnect switch to the “OFF” position.
3. From the inside of the bus, open the window located behind the SDS box by lifting the T-Handle to release the latches and lifting the window up from the outside of the bus.
4. From the outside of the bus, inspect the T-Handle assembly to make sure the T-Handle cable is installed in the correct location. The cable must be captured via the groove in the cable end. The cable cannot be fully captured within the T-Handle assembly. If the cable is captured fully in the T-Handle assembly this can be corrected by removing the cable from the T-Handle assembly and reassembling via the groove in the cable end. See Figure 1.

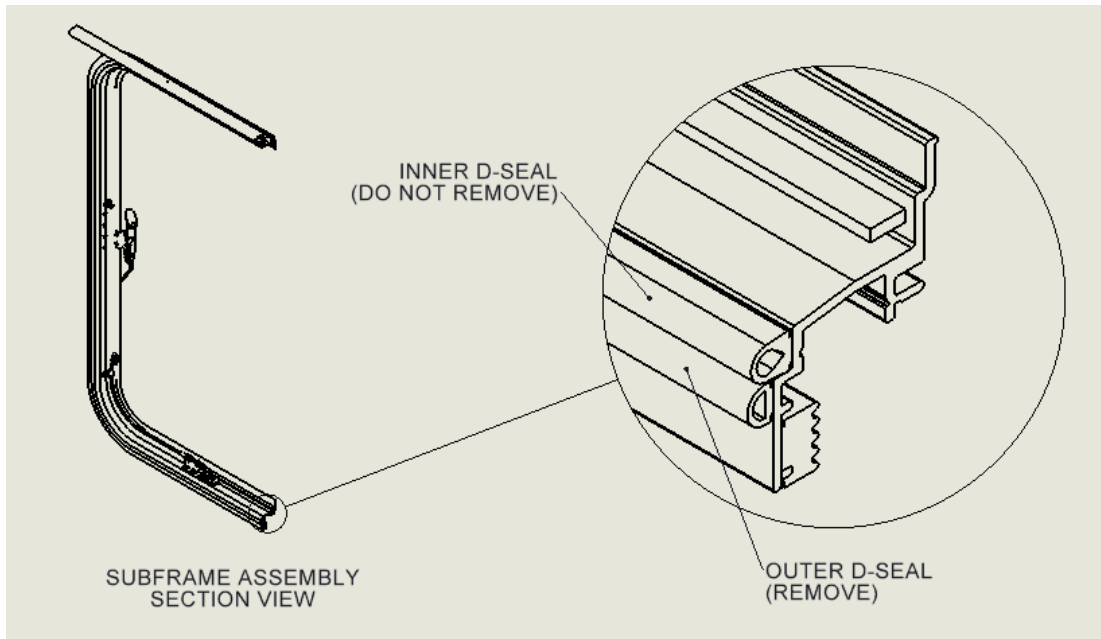
**Figure 2: Removal of Outer D-seal if Required**

5. Inspect the rubber seals on the subframe of the SDS window. If the window has two side-by-side D-seals on the subframe of the window, the outer D-seal must be removed. This D-seal has been found to restrict the window from being able to fully latch in the locked position. There is a detailed instruction on how to remove this D-seal in active ITS-59216 that can be obtained from your local New Flyer Service Representative. See Figure 2 for outer D-seal location reference.

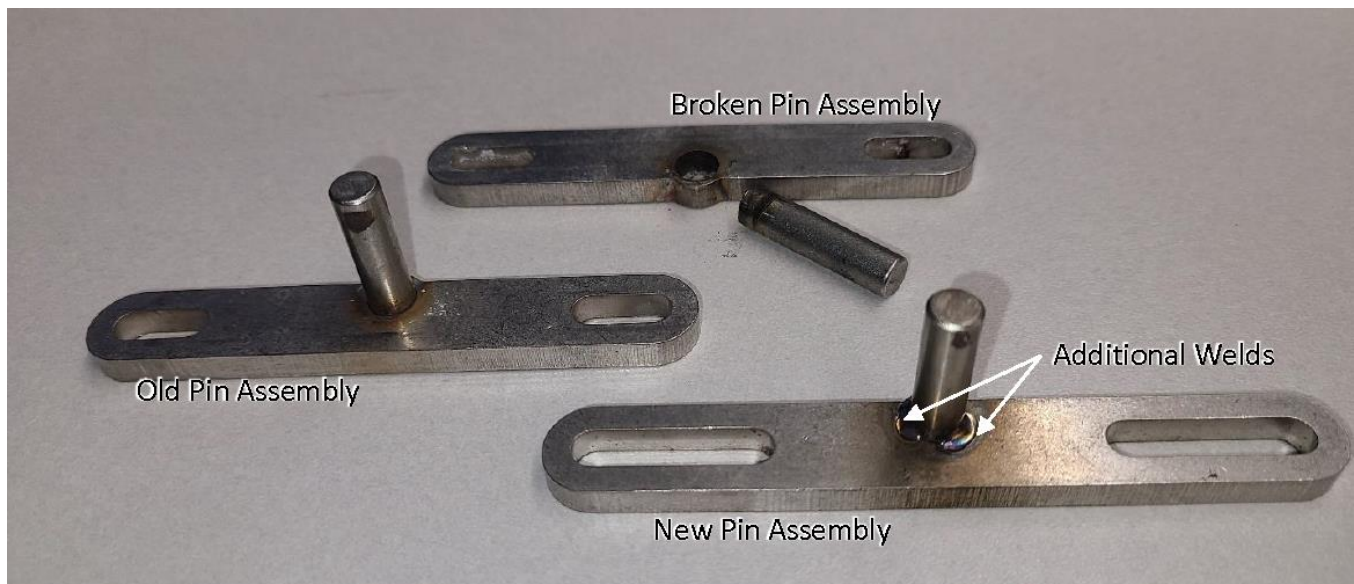
**Figure 3: Old Latch Striker Pin & New Latch Striker Pin Comparison**

6. Inspect the two latch striker pin assemblies located on the main frame of the window. If the pin assemblies do not have the double welds in the location where the pin joins to the pin bracket, the existing pin assemblies will need to be replaced with new pin assemblies (NF PN 6477370) and new hardware, screws (NF PN 6474082), nuts (NF PN 6487878). See Figure 3 for old pin assembly vs new pin assembly for inspection reference. There is a detailed instruction on how to remove and replace the latch striker pin assemblies in active ITS-59216 that can be obtained from your local New Flyer Service Representative. The new pin assemblies and hardware to secure them will be provided under ITS-59216.

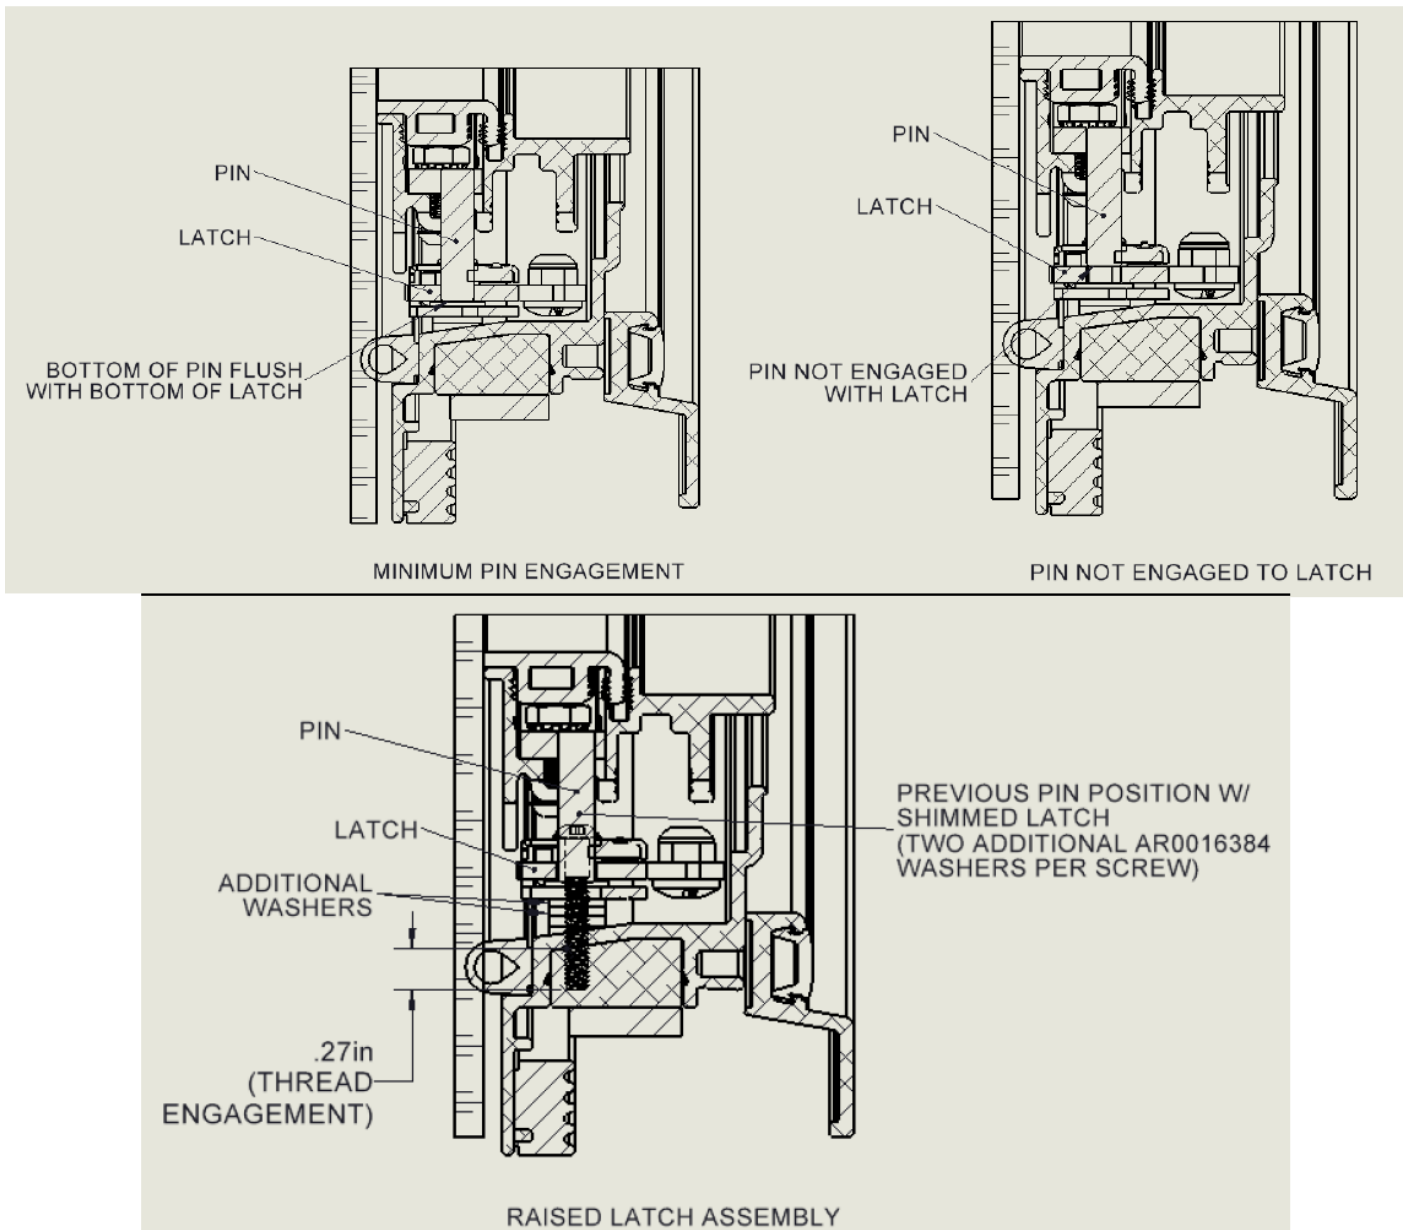
**Figure 4: Inspect and Shim Latches if Required**

7. Place the SDS window gently in the lowered position with out closing it. Inspect the vertical latch strike pin engagement within the rotary latch on both latches. Ensure that the bottom of the latch pins rest flush or slightly below the bottom of the rotary latch. Windows with inadequate pin engagement must have the rotary latch assembly shimmed with additional washers (NF PN 6488222) to achieve proper engagement. To maintain proper latch mounting screw engagement, no more than two additional washers (0.125" height) are to be added to the two that are existing per screw. It is acceptable to have a maximum total of four washers stacked on top of each other per latch screw to maintain proper screw engagement with the subframe. See Figure 4.

8. If the latch striker pins engage the latches at the proper depth as outlined in step 7, no additional washers are required however, the latch mounting hardware should be removed, 1-2 drops of Loctite 243 (NF PN 081034) added to the threads of the hardware and the hardware should be retightened, hand-tight, using a hand tool only.
