Title:	Cab Door Window Guide Adjustment

Number:	KA_575	Release Date:	05/07/2021	
Revision Number:	Not Applicable	Revision Date:	Not Applicable	
Chassis Type:	All chassis types			
Component Description:	Cab Door Window Guide			
Warranty:	Not Applicable			
Parts:	Not Applicable			
Tools:	Not Applicable

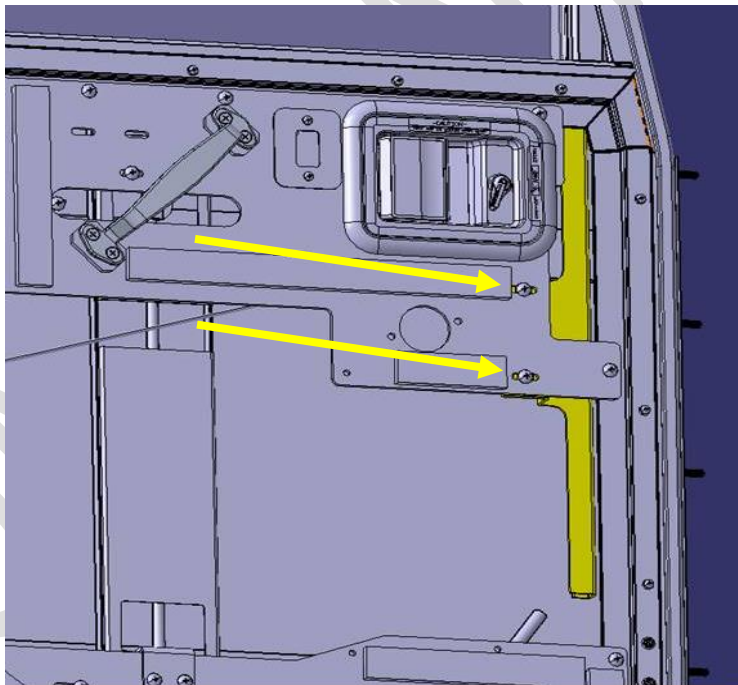
There have been reports of cab door windows sliding forward causing the window to “bind” when the window is operated. This knowledge article outlines the suggested adjustment to the door to resolve this issue.

1. Remove the inside panel of the door to expose window track system.
2. Located the two adjustment screws on the top inside corner of the door showing with yellow arrows below.

3. Loosen these two screws, if necessary, to give movement to the horizontal window trim bracket.
4. Move the window trim bracket back toward the cab to a position where it clears window regulator and latch linkages.
5. Tighten the screws showed in step 2 back down to hold the bracket in place.
6. Test the function of the window, if it continues to bind repeat steps 3-5 until the bracket is in a position where it clears the window regulator and latch linkages.
7. Reinstall the inner door panel.
