## Volvo Chassis - Model VNR With RH Side Fairing Only - Heat/Splash Shield Loose, Possible DTC P204800 And/Or P204713

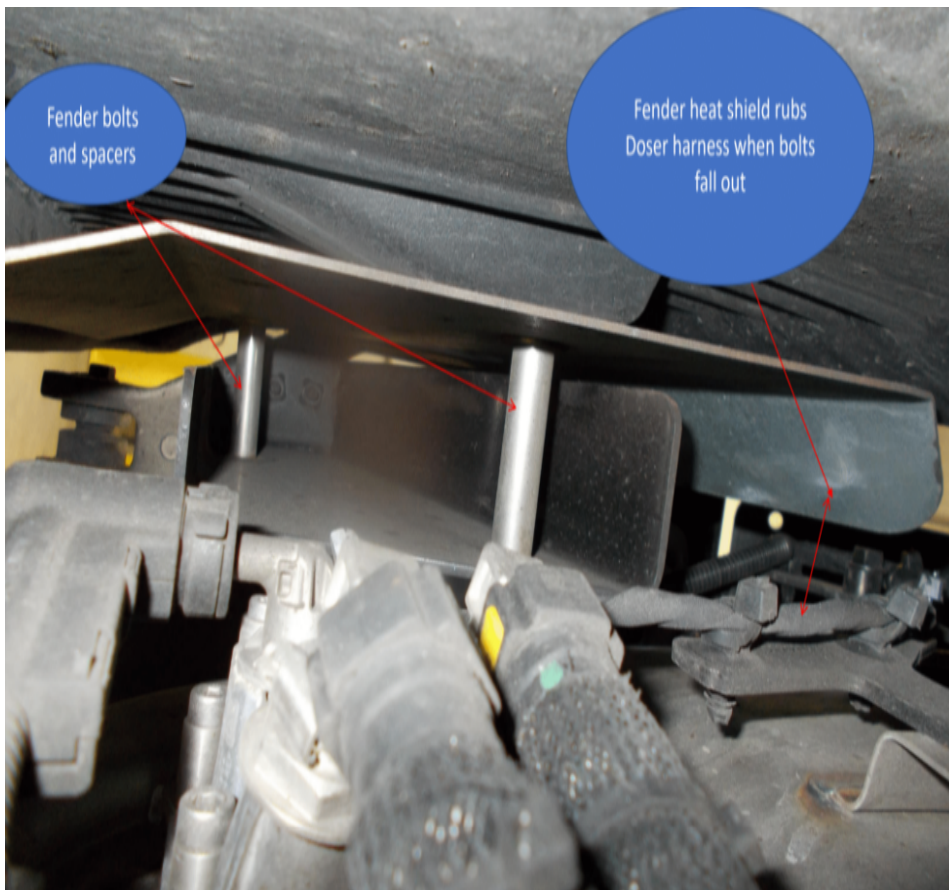
On certain Volvo VNR chassis equipped with a right-hand (passenger) side fairing, there is a possibility that the bolts securing the EATS heat shield/splash shield may become loose. This may lead the shield to rub on the EATS wiring harness, resulting in damage.

Diagnostic Trouble Codes (DTC) P204800 and P204713 may be observed as a result of the harness fatigue due to the loose shield.

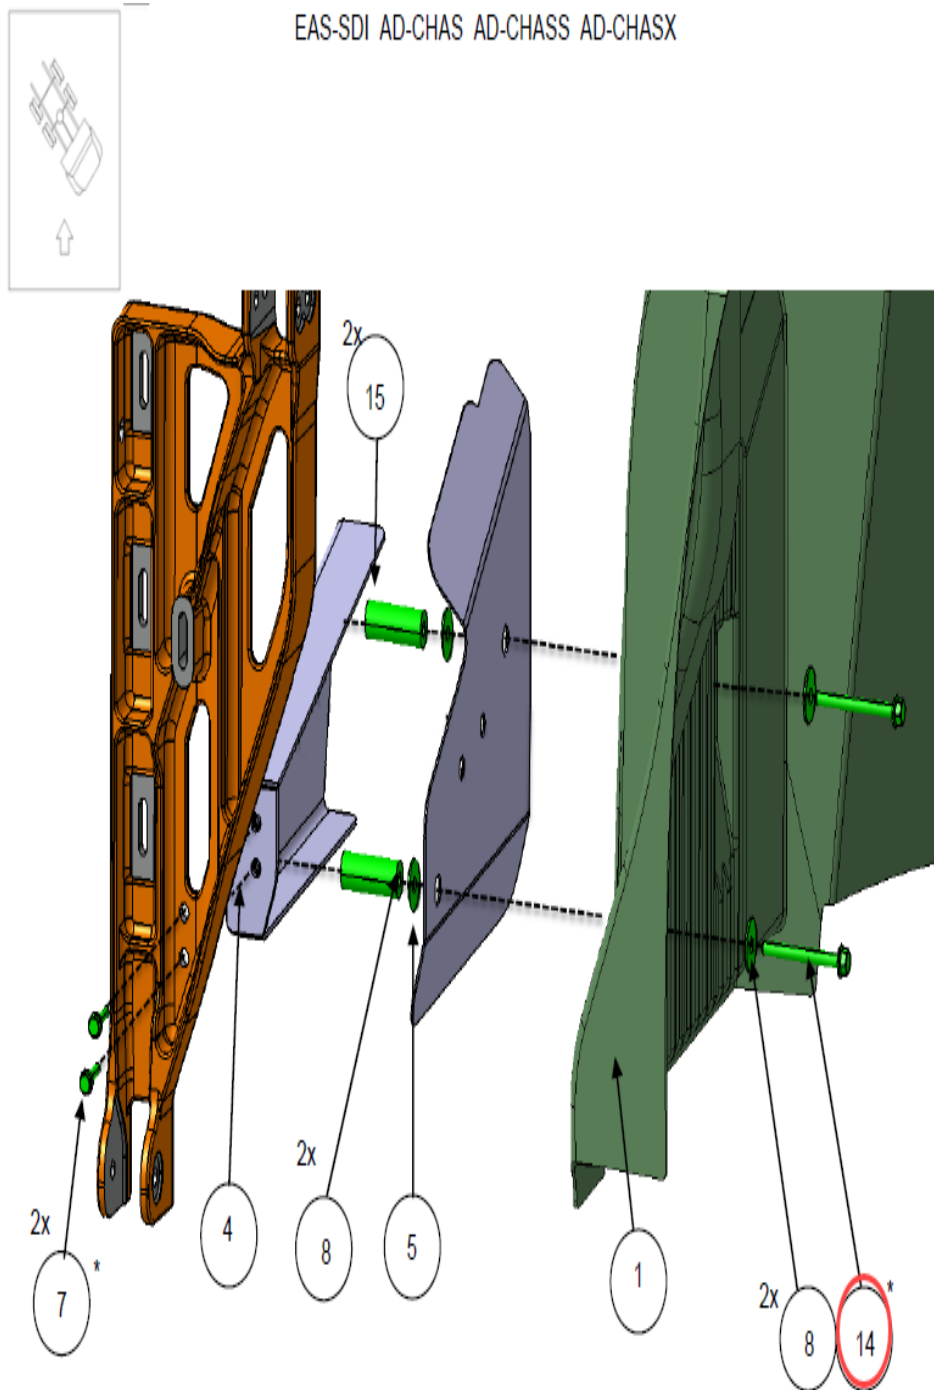
\* TORQUE TO  $12 \pm 2$  N-m

1. Remove the 2 bolts (#14 in the image below) securing the heat shield.
2. Apply blue Loctite to the threads of the bolts.

Install the bolts with the addition of a jam nut, part number 000050, to the end of each bolt.

- The bolts should be torqued to  $12 \pm 2$  Nm ( $9 \pm 1.5$  lbf)
