## Mack Chassis - Radio Loses Presets And Time Setting - Terrapro Models (MRU, TE)

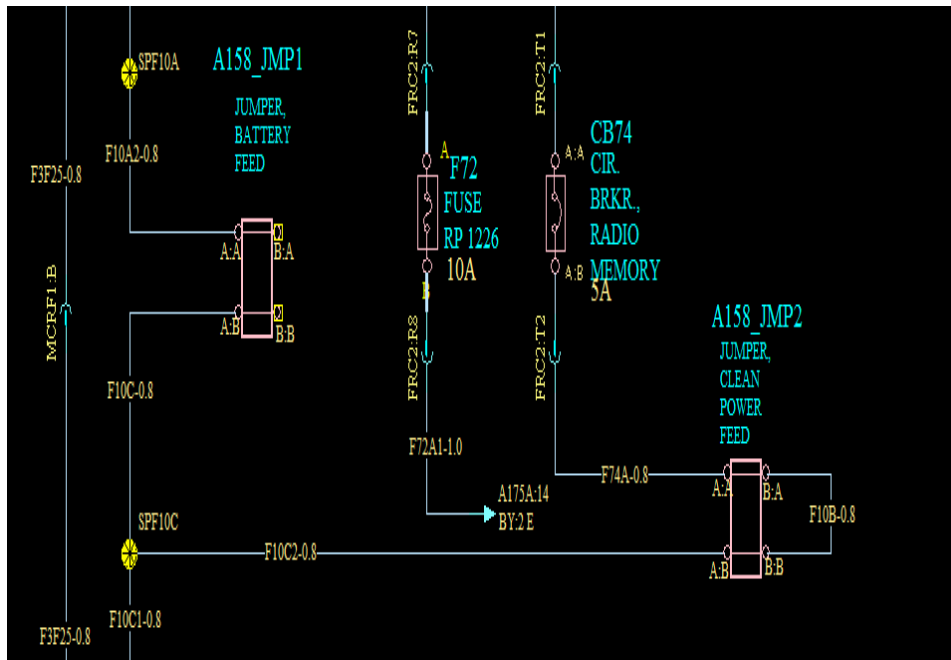
Mack Terrapro models built between 1 January 2017 and 15 February 2021 may lose radio memory after the battery switch is turned to the off position. If this symptom occurs, it may be due to the radio jumper harness being incorrectly connected to the main cab harness.

The connectors are located near FRC1 and labeled “A158\_JMP1.A” and “A158\_JMP2.A”.

The jumper connector P/N 25159660 should be connected in "A158\_JMP2.A" **not** "A158\_JMP1.A" to provide the memory fix.

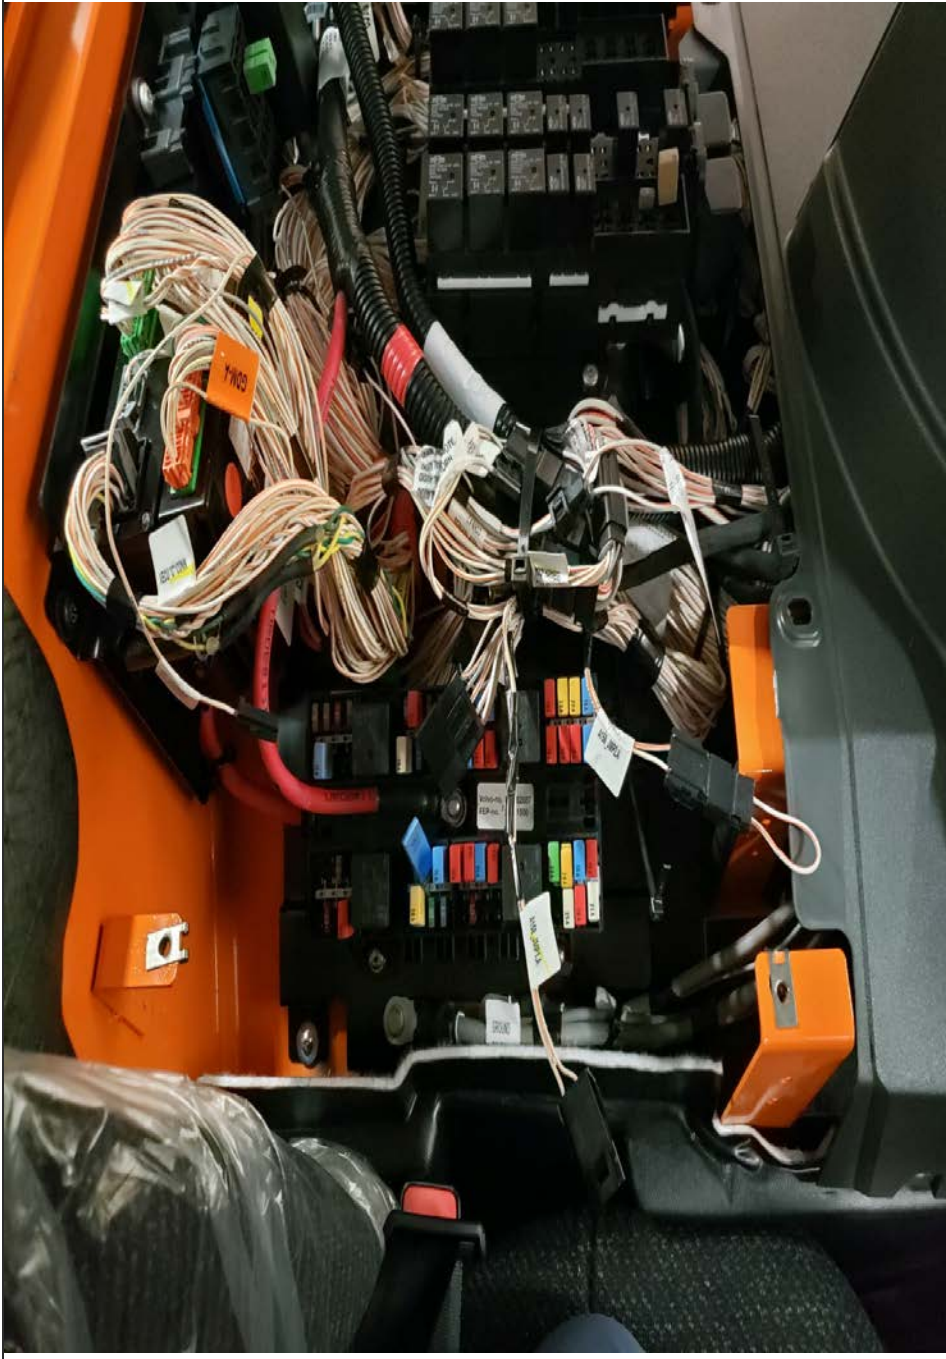
“A158\_JMP1.A” and “A158\_JMP2.A” pulled from the bundle
