**Special pre-delivery operation required:**  
**Horizontal and vertical head nut tightening check**  
Multistrada 950 Model Year 2021 (all versions)  
Service Repair Bulletin SRV-SRB-21-033

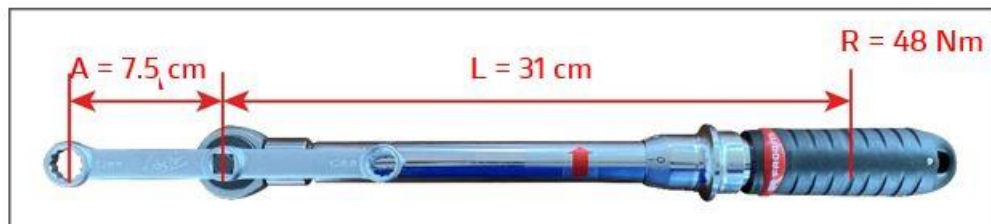
When using this type of adapter, it is necessary to apply a different tightening torque from the prescribed specification (60 Nm) as the lever arm is different. Use the below indicated formula and reference example for calculating the correct tightening torque depending on the adapter/torque wrench used:

$$R = (T \times L) / (L + A) \rightarrow R = (60 \times 31) / (31 + 7.5) \rightarrow R = (1860) / (38.5) \rightarrow R = 48.3 \text{ Nm}$$

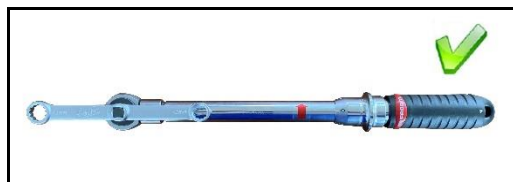
By varying the inclination angle of the adapter, the tightening torque to be applied varies. Therefore, use the adapter by orienting it ONLY as shown in the figure while using the above indicated formula:

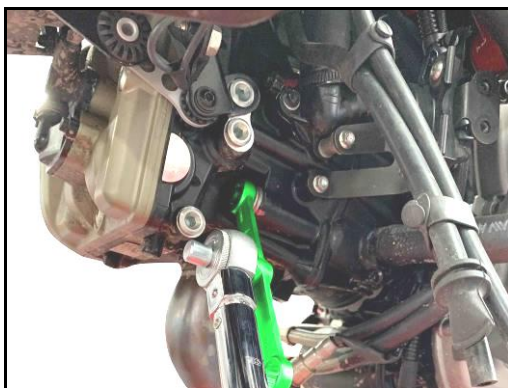
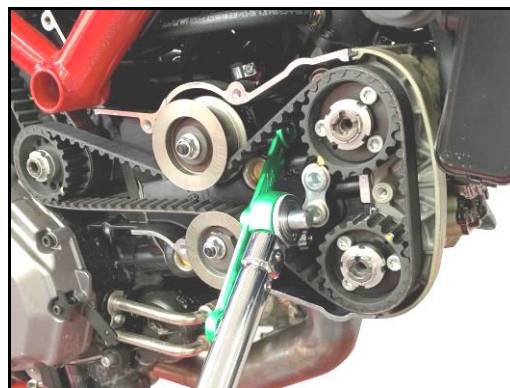
When tightening, ensure the torque wrench can rotate freely and is not hindered by other components (e.g., drive belts or pipes) causing incorrect tightening. Be careful to prevent applying undue force on any surrounding delicate components.

8. Using the torque wrench supplied and the adapter, tighten the horizontal cylinder head fixing nuts, on RH and LH side, to the tightening torque previously calculated.
