Tips & Tricks – All Models

no.	Symptom	Subject	Photo	Notes and Indications - Corrective action
1	<p><u>ONLY</u> <u>Monster 821</u> <u>Monster 1200</u> <u>SuperSport</u></p> <p>Possible engine popping sound during deceleration and/or irregular idling</p>	Airbox

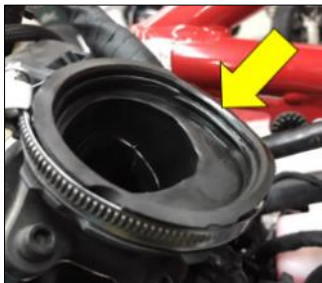
<p>We have received some complaints about a possible engine popping sound during deceleration. The performed analyses have shown that this symptom could be caused by an incorrect installation of the throttle bodies in the relevant intake manifolds (possible deformation of the rubber profile).</p> <p>Therefore, if you find any similar symptoms, we kindly ask you to check the correct installation of the Airbox on the motorcycle and that:</p> <ul style="list-style-type: none">- throttle bodies are correctly inserted inside rubber intake manifolds, along the whole perimeter;- the rubber profile of the intake manifolds is not deformed.- the 2 fastening ties are correctly positioned in the seat on the intake manifolds. <p>Please be reminded that, to make throttle body insertion easier on rubber intake manifolds, the use of silicone lubricant or similar product is absolutely necessary.</p>

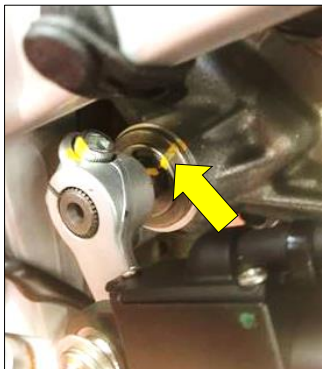
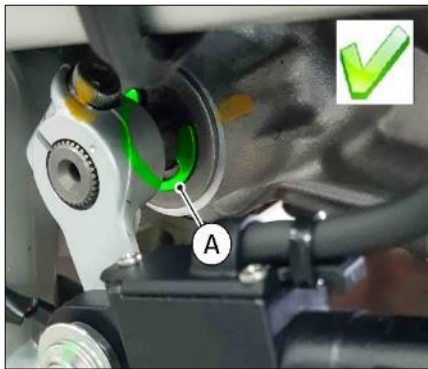
2	<p><u>ONLY</u> <u>Panigale V4</u> <u>(all versions)</u> <u>Streetfighter V4</u> <u>(all versions)</u></p> <p>Introduction gear selector shaft certification</p>	Gear selector

<p>We have received some isolated reports of a possible loss/absence of the snap ring (A) of the gear selector shaft. We would like to inform you that an additional certification on all Desmosedici Stradale engines between snap ring, washer, and crankcase at the outlet of the gear selector shaft has been added along the production line. The first engine serial number with this new certification is ZDM1100WC #001513#.</p> <p>Upon the first workshop service, you are thus invited to check for the presence of the snap ring (A) on all engine serial numbers preceding the one specified above.</p>

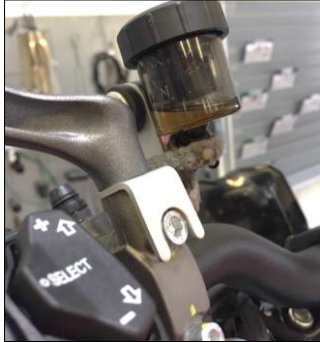
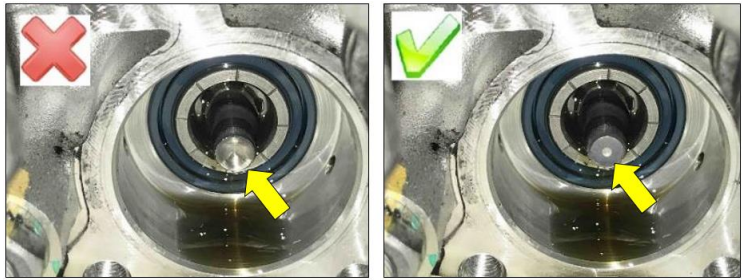
no.	Symptom	Subject	Photo	Notes and Indications - Corrective action
7	<p><u>ONLY</u> <u>models equipped with</u> <u>hydraulically controlled</u> <u>clutch lever</u></p> <p>Possible reduction of the clutch fluid level inside its reservoir</p>	Hydraulic clutch control

<p>We received a few claims concerning a reduction of the clutch fluid level inside its reservoir. We would like to inform you that it is not sufficient to carry out the bleeding procedure or top up the clutch fluid inside the reservoir. We suggest, at a preliminary stage, to check:</p> <ul style="list-style-type: none">• the play between the clutch master cylinder and the lever• if the clutch pushrod is worn or damaged in the area of contact with the clutch slave cylinder (ball)• the condition of the clutch slave cylinder protective diaphragm, which must not be torn. <p>According to our analyses, this phenomenon is due to a DOT4 leakage from the primary seal of the clutch slave cylinder (missing fluid in the reservoir builds up in-between the clutch slave cylinder diaphragms); in some cases, this phenomenon is also accompanied by wear of the clutch pushrod. We therefore ask you to replace the slave cylinder with a new part no. 19540091D featuring a new gasket in order to prevent the phenomenon described above.</p> <p>If the clutch pushrod is damaged as shown in the figure, replace it as well.</p> <div data-bbox="1256 727 1995 1007">

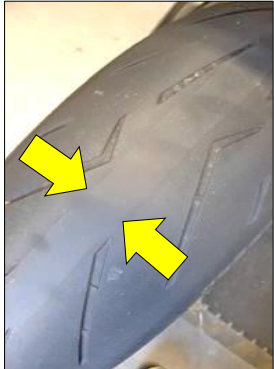
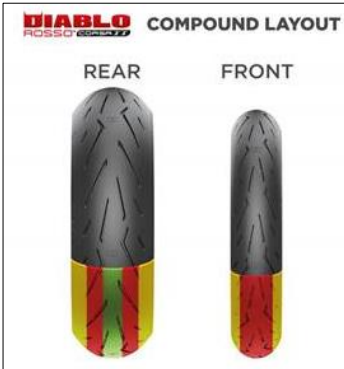
9	<p>Possible formation of a well-marked "band" in correspondence with the central area of the Pirelli Diablo Rosso Corsa II rear tire</p>	<p>Pirelli Diablo Rosso Corsa II rear tire</p>

<p>We have received some isolated reports of the appearance of a "band" in correspondence with the central area of the Pirelli Diablo Rosso Corsa II rear tire.</p> <p>We would like to inform you that, since these are extremely sporty tires with 5 different compound zones at the rear, it can happen that, depending on the type of use of the motorcycle, they wear out in a different way causing the above mentioned phenomenon to occur; sometimes this occurs on the shoulder area, sometimes in the central area but, in general, it is a purely aesthetic phenomenon that does not affect the performance of the tire itself.</p>

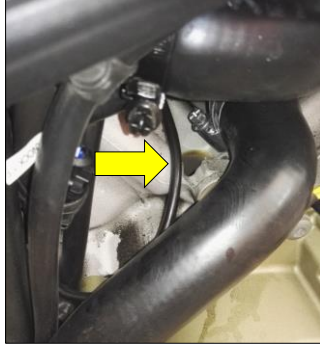
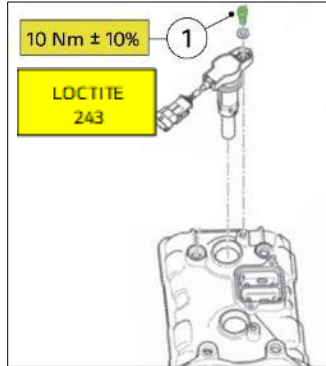
no.	Symptom	Subject	Photo	Notes and Indications - Corrective action
10	<p><u>ONLY</u> <u>Panigale V4</u> <u>StreetFighter V4</u> <u>(all model versions)</u></p> <p>Possible engine oil leakage from the water pump drain hole</p>	Water pump

<p>We have received some isolated reports of possible traces of engine oil leaking out of the drain hole of the water pump; the analysis has shown that this phenomenon is due to a possible incorrect installation of the oil seal by the supplier.</p> <p>We inform you that a new re-designed water pump Part no. 24920510H that avoids the phenomenon described above is now available as a spare part . Should you find traces of engine oil in the drain hole of the water pump on engines with serial number prior to the one indicated above, replace the component.</p>
11	<p><u>ONLY</u> <u>Panigale V4</u> <u>StreetFighter V4</u> <u>(all model versions)</u></p> <p>Possible engine power delivery discontinuity</p>	Engine power delivery	-	<p>We have received some isolated reports about a possible engine power delivery discontinuity.</p> <p>Before making further analyses, we would like to ask you to check coil fastening and, in particular, to <u>apply LOCTITE 243</u> along the threading of fastening screws and tighten them to a torque of 10 Nm ± 10%.</p> <div data-bbox="1865 683 2190 1050" style="border: 1px solid black; padding: 5px;">

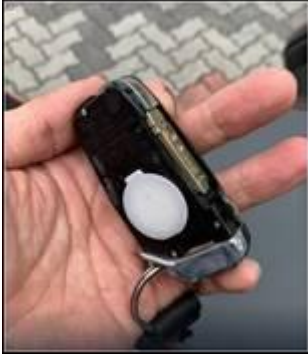
<p>We have received some isolated reports about the possible loss of the rear cover of the active key Part no. 59810361F. Analyses have shown that this phenomenon occurs after repeated opening/closing of the cover itself, resulting in the deterioration of the shell.</p> <p>We would like to inform you that the new rear cover Part no. 4601L831A, avoiding the phenomenon described above, is now available.</p>

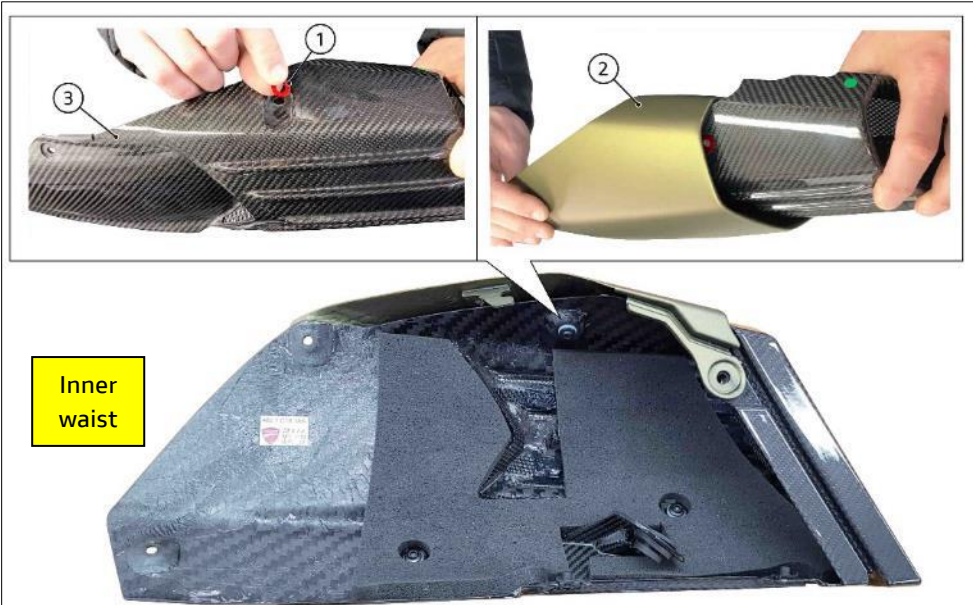
no.	Symptom	Subject	Photo	Notes and Indications - Corrective action
1	<p><u>ONLY</u> <u>Diavel Lamborghini</u></p> <p>Possible indentation of RH and/or LH outer cover of the air conveyor</p>	RH and LH air conveyor covers

<p>We have received some isolated reports about a possible indentation of the RH and/or LH outer cover of the air conveyor.</p> <p>To avoid this phenomenon, it is necessary to position washer (1) 4x14x1 Part no. 85240171A between outer cover (2) and carbon air conveyor (3) in the upper fixing point, as shown in the figure.</p>

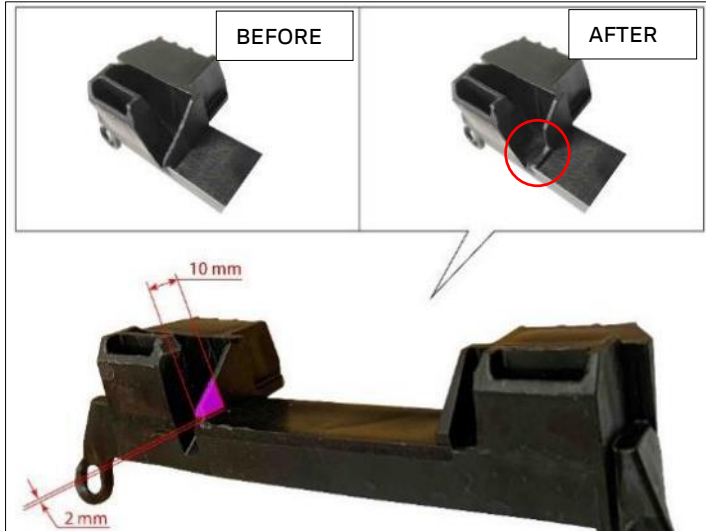
no.	Symptom	Subject	Photo	Notes and Indications - Corrective action
1	<p><u>ONLY</u> <u>Multistrada 1260</u> <u>(all model versions)</u></p> <p>Possible wrong coupling between rider's seat lower riser and RH side body panel in "high seat" configuration</p>	Rider seat

<p>When mounting the rider seat in "high configuration", an excessive gap can be seen between the lower trim and the RH side panel. This is due to interference between the central riser and its support. To avoid such interference and therefore improve the coupling between the rider seat and the side panel, it is necessary to:</p> <ol style="list-style-type: none"> 1) Remove the center riser from the seat; 2) Working on the RH side support, remove the excess material with a cutter, as shown in the figure. 3) Reinstall the center riser to the seat.

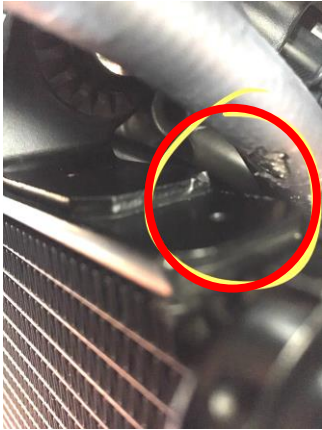
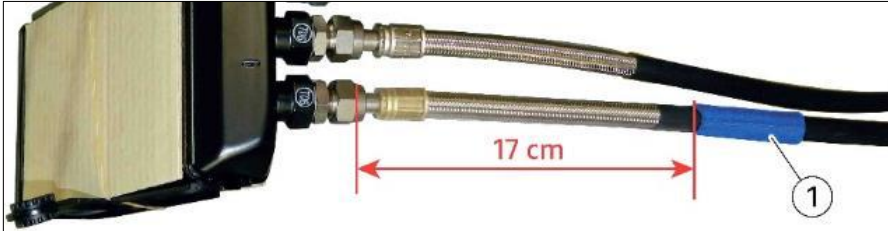
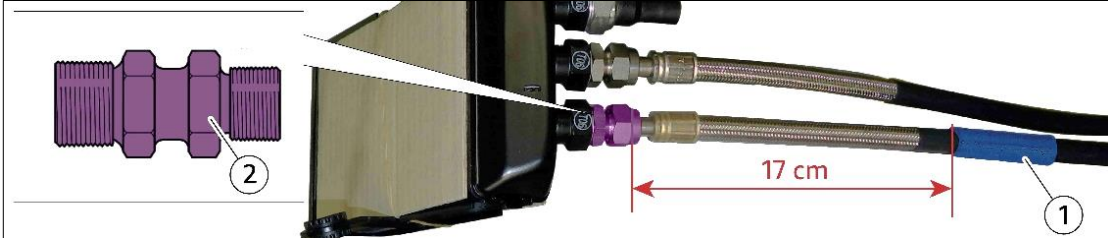
no.	Symptom	Subject	Photo	Notes and Indications - Corrective action
3	<p><u>ONLY</u> Multistrada 950 MY 17-20 Multistrada 1200 MY 15-17 Multistrada 1260 MY 18-20 (all model versions)</p> <p>Possible superficial damage to the oil cooler return pipe</p>	Oil cooler pipes

<p>We have received some isolated reports of possible surface damage to the oil cooler return pipe due to rubbing with the top of the coolant radiator, over time. <u>This phenomenon is purely aesthetic and does not affect the correct operation of the system.</u> We inform you that for the models:</p> <p>a) Multistrada 1260: starting from the frame number ZDMAC03AAAKB011354 (on 27/05/2019) the anti-abrasion sheath (1) part no. 4601H701A has been introduced on the oil cooler return pipe, positioned at a distance of 17 cm measured from the upper end of the fitting. (This solution is also applicable to all Multistrada 1200 versions Model Year 2015-2017).</p>

<p>b) Multistrada 950:</p> <ul style="list-style-type: none"> - starting from the frame number ZDMAD00AAKB002259 (on 10/05/2019) the anti-abrasion sheath (1) part no. 4601H701A has been introduced on the oil cooler return pipe, positioned at a distance of 17 cm measured from the upper end of the fitting; - starting from the frame number ZDMAD00AALB005691 (on 12/03/2020) the longer fitting (2) part no. 81510391A has been introduced at the oil return pipe outlet from the cooler.

<p>We ask you to always check the condition of the oil cooler return pipe, and to replace it ONLY if the rubber sheath is damaged and the metallic braided hose can be seen. Follow the assembly notes indicated above according to the reference model. The spare part catalogue has been updated.</p>

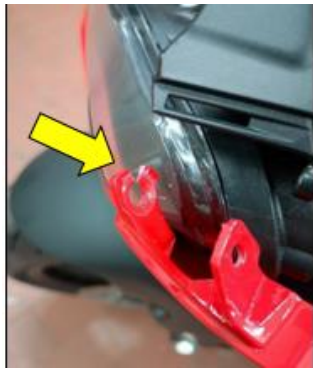
no.	Symptom	Subject	Photo	Notes and Indications - Corrective action
1	<p><u>ONLY Panigale V2</u></p> <p>Precautions during PDI: installation of the side half-fairings</p>	Side half fairings

<p>We received some isolated claims about the possible breakage of the top fastener retaining the LH side half-fairing to the headlight fairing.</p> <p>During PDI and whenever removing the side half-fairings, we remind you to pay utmost attention to the tightening of the 2 screws M5x0.8 (1) retaining the upper LH and RH half-fairings to the headlight fairing; always comply with the specified tightening torque of 2 Nm ± 10%.</p>

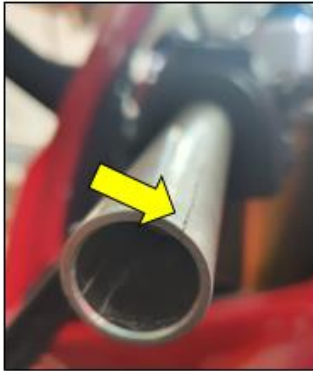
2	<p><u>ONLY Panigale V4</u></p> <p>Precautions during PDI: installation of the balancing weights on the handlebar</p>	Handlebar counterweights

<p>We received some isolated claims about the possible triggering of a longitudinal crack on the handlebar, on balancing weight side. Our laboratory analyses found that said crack is due to an excessive tightening torque applied when installing the balancing weights.</p> <p>When installing balancing weights on the handlebar, please comply with the tightening torque specified for the M6x55 screw of 8 Nm ± 10%, as indicated on the bulletin introducing the model and on the Workshop Manual.</p>

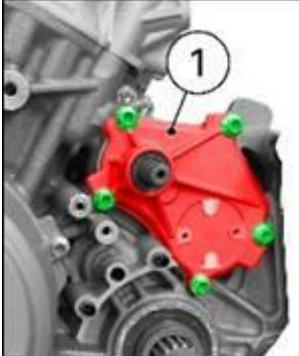
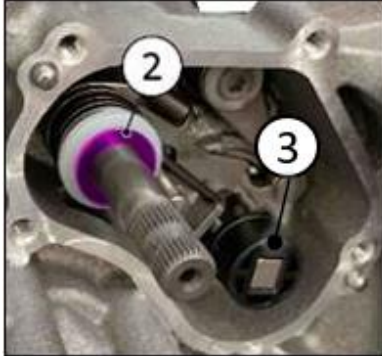
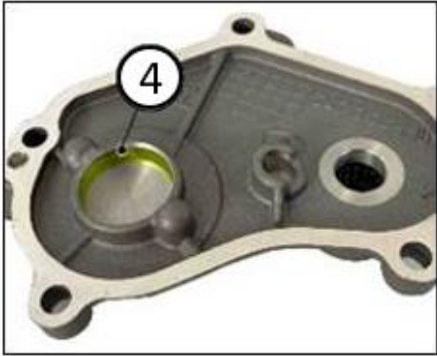
no.	Symptom	Subject	Photo	Notes and Indications - Corrective action
11	<p style="text-align: center;"><u>ONLY</u> 959 Panigale (all versions)</p> <p>Possible hardening of gear shift control with difficulty in shifting gears when hot</p>	Gear selector	-	<p>We have received some isolated reports about a possible hardening of the gear shift when hot with consequent difficult selection of gear ratios. Based on the analyses carried out, this phenomenon could be due to a hardening between the gearbox sensor magnet plastic support and the relevant seat inside the cover.</p> <p>You are kindly asked to carry out the following operations:</p> <ol style="list-style-type: none"> 1) Remove the gear shift cover (1) on motorcycle LH side; 2) Check for the presence of shim (2); 3) Mill the end face of the plastic cage for the selector magnet (3) shorter by 0.1 mm maximum and the outer curved edge where it enters the bore of the cover by 0.1 mm maximum, <u>or</u> mill the internal surface (4) of the cover highlighted in the figure and remove 0.1 mm maximum of material from the end and bore of the recess. Ensure the orientation of the magnet is not changed on the shift selector or the gear position will not be able to be determined by the sensor. <div style="display: flex; justify-content: space-around; margin-top: 10px;">

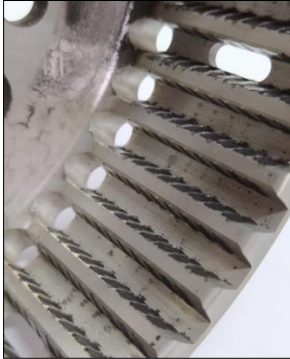
no.	Symptom	Subject	Photo	Notes and Indications - Corrective action	
17	<p><u>ONLY</u> Panigale V4R</p> <p>Introduction of clutch housing with deep anodizing</p>	Clutch housing

<p>We have received some isolated reports of possible clutch slipping, due to clutch housing indentation, which does not allow the drive and driven plates to come back into contact with each other correctly. This phenomenon depends on the use of the motorcycle and the user, therefore for racing use we suggest replacing the plates approximately every 5000km,.</p> <p>We would like to inform you that the new clutch housing with deep anodizing part no. 19810671C, replacing the natural grey one, is available as a spare part; this treatment improves the reliability of the clutch housing reducing the damaging of the drive plates on its contact surface.</p>	
<p>NEW</p> <p>18</p>	<p><u>ONLY</u> Panigale V4 MY21</p> <p>Error "P0919 - Gear sensor plausibility" with MIL warning light turning on and/or failed display of the engaged gear on the instrument panel</p>	Error "P0919 - Gear sensor plausibility"	-	<p>If the error "P0919 - Gear sensor plausibility" occurs, <u>do NOT replace the gear sensor.</u></p> <p>It is necessary to check that the engine control unit software version is updated, then access the "Settings" section and activate the "<u>Reset of the final drive adaptive parameters</u>".</p> <div data-bbox="1765 676 2213 1062" style="border: 1px solid black; background-color: #ffff00; padding: 5px;"> <ul style="list-style-type: none"> CCP Enabling/Disabling DQS adaptives reset Idle control adaptives reset Idle speed engine operation mode Knock sensor adaptives reset Reset gears <li style="border: 2px solid red; background-color: #ffff00;">Reset of the transmission adaptive values </div>

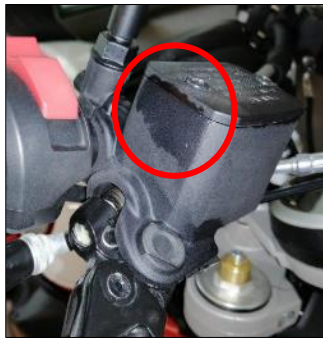
no.	Symptom	Subject	Photo	Notes and Indications - Corrective action
3	<p><u>ONLY</u> <u>Scrambler Desert Sled</u> <u>Scrambler ICON</u> <u>Scrambler Full Throttle</u> <u>Model Year 2019 - 2020</u></p> <p>Possible brake fluid leaks from reservoir cover</p>	Front brake fluid reservoir

<p>We inform you that in case of complaints from Customers about a possible oozing out of front brake fluid from the relevant reservoir, This condition does not affect the operation of the brake system. it is possible to order the following kit part no. 89340331A as spare part to avoid the symptom in question.</p> <p>The kit part no. 89340331A includes:</p> <ul style="list-style-type: none"> • 2 screws (1) • Cover (2) • Membrane (3) • Baffle (3)

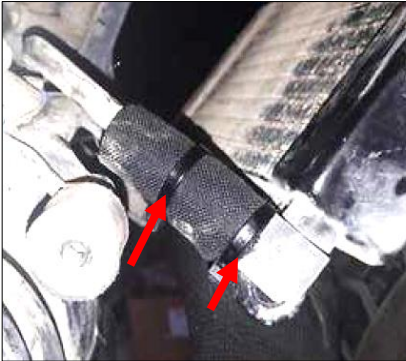
5	<p><u>ONLY</u> <u>Scrambler 1100 PRO</u> <u>(all versions)</u></p> <p>Irregular operation at idle speed and engine power loss</p>	Vertical cylinder LH spark plug cable	-	<p>As a result of continuous quality tests on the product, we have found a possible irregular operation at idle speed and engine power loss. This phenomenon is due to a settling of the vertical cylinder LH spark plug cable on the coil caused by the contact with the fitting of the oil return pipe from cooler (visible on motorcycle RH side). The MIL light does not come on.</p> <p>We ask you to always check the conditions of vertical cylinder LH spark plug cable and to apply the protective sheath Part no. 4601C581A (cut in half and secured in place with two small self-locking ties) on the fitting of the oil return pipe from cooler to avoid the above-described phenomenon.</p>
