## Tips & Tricks –Multistrada V4 Model Year 2021

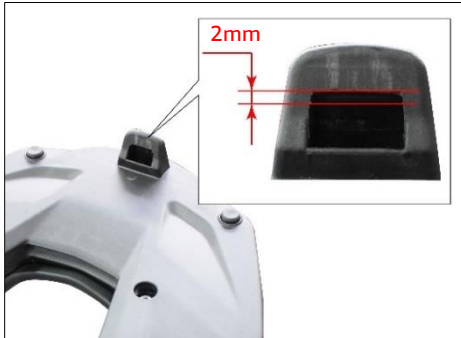
| no. | Symptom | Subject | Photo | Notes and Indications - Corrective action |
|---|---|---|---|---|
| 1 | Issues during Top Case fixing to the plate | Top Case Kit<br>Part no. 96781531AA | | <p>We have received some reports concerning the difficulty in securing the Top Case (Kit Part no. 96781531AA) to the top plate Part no. 8291M033A due to a machining error of the supplier. In particular, the locking tooth on the upper plate Part no. 8291M033A shows a hole 2mm narrower than specified. To eliminate this defect, the locking tooth of the plate must be milled by <u>2mm in the upper area</u> using a flat file, as shown in the figure.</p> <p>We inform you that the upper plates present inside the kits in stock have been restored.</p> |

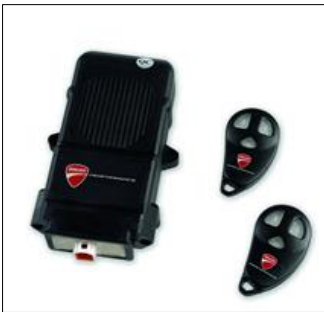
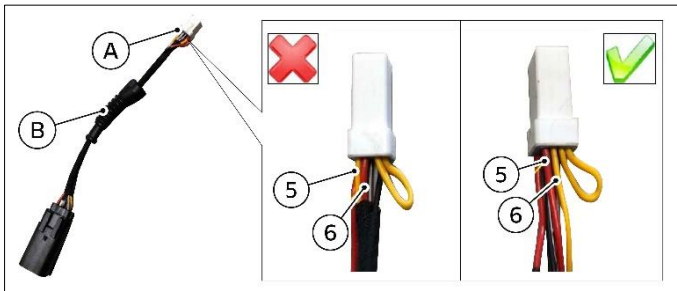
| no. | Symptom | Subject | Photo | Notes and Indications - Corrective action |
|---|---|---|---|---|
| 2 | Anti-theft system kit<br>Part no. 96681081AA<br>malfunction | Anti-theft system kit<br>Part no. 96681081AA | | <p>After having installed the anti-theft system Kit Part no. 96681081AA and enabled it on the BBS control unit, some malfunctions may occur during activation due to a possible incorrect pin arrangement in the connector of the wiring branch supplied with the kit.</p> <p>Follow the procedure described below:</p> <ol style="list-style-type: none"> <li>1) uncover <b>connector (A)</b> by moving <b>sheath (B)</b> backward;</li> <li>2) uncover the wiring by removing a portion of insulating tape to make operations easier;</li> <li>3) check the arrangement of <b>Pins 5</b> and <b>6</b> and the relevant color on the 8-pin connector. If the pin arrangement is not correct, extract them working from the front side with a needle inside the groove so as to lift the retainer and invert them.</li> <li>4) restore the cloth tape previously removed and the position of the protective <b>sheath (B)</b>.</li> </ol> <p>The kits currently in stock have been restored.</p> |

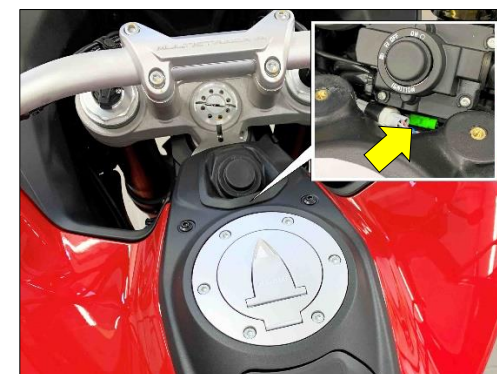
| no. | Symptom | Subject | Photo | Notes and Indications - Corrective action |
|---|---|---|---|---|
| 6 | Precaution during the installation of the heated handgrip kit part no. 96680702A | Heated handgrip kit part no. 96680702A | | <p>We inform you that for the installation of the heated handgrip kit part no. 96680702A, the main wiring harness connectors where to connect the heated handgrips, are positioned below the ignition switch cover as shown in the figure.</p> |

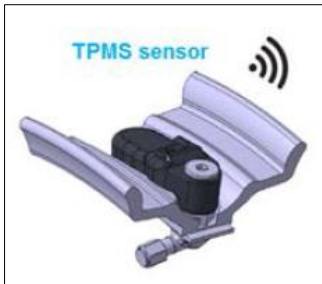
| no. | Symptom | Subject | Photo | Notes and Indications - Corrective action |
|---|---|---|---|---|
| 10 | Activation procedure for TPMS tire pressure sensor | TPMS (Tire Pressure Monitoring System) | | <p>The TPMS system (Tire Pressure Monitoring System) allows monitoring tire pressure value: if tire pressure deviates by 25% from the set reference value, the TPMS system displays a warning on the instrument panel. The sensor activates when speed exceeds 35 km/h and tire pressure is displayed on the instrument panel 1 minute later.</p> <p><u>We remind you that, before installing tyre pressure sensors on front and rear wheel rims, they must be coded through DDS 3.0 diagnosis instrument.</u></p> <p>To activate TPMS system, follow the procedure indicated below:</p> <ol style="list-style-type: none"> <li>1) using DDS 3.0, access the "Self-diagnosis → Settings" section of BBS control unit;</li> <li>2) select "Enable/Disable" TPMS;</li> <li>3) access the "Self-diagnosis → Settings" section of Hands Free control unit and perform "TPMS code writing" for front and rear wheel sensors by entering the 8-digit code written above the Qr-Code;</li> <li>4) access the instrument panel Settings menu and select "Tire Pressure" to set (and customize) the reference pressure values of the rear and front tires. The tire nominal pressure value specified inside the owner's manual can be used as a reference.</li> </ol> <p><u>Explain to the Customer the use of the "Tire Pressure" function to edit the reference pressure value of the front and rear tires. The information about the current pressure value of front and rear tires is also available inside instrument panel main menu.</u></p> |

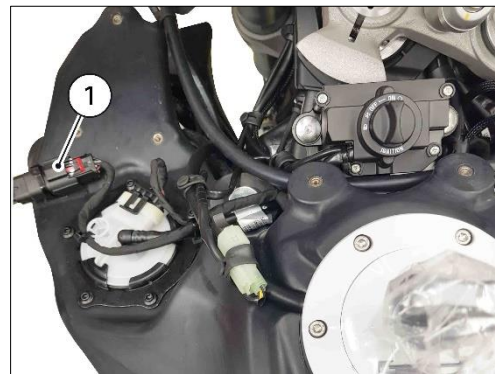
| no. | Symptom | Subject | Photo | Notes and Indications - Corrective action |
|---|---|---|---|---|
| 13 | Assembly precaution for the anti-theft system kit part no. 96681081AA | Anti-theft system kit part no. 96681081AA | | <p>We inform you that for the installation of the anti-theft system kit part no. 96681081AA, the <b>main wiring connector (1)</b> where to connect the anti-theft device, is positioned near the fuel pump flange, in the front left area of the fuel tank.</p> |

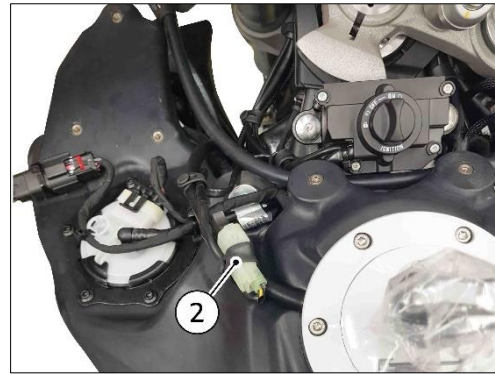
| no. | Symptom | Subject | Photo | Notes and Indications - Corrective action |
|---|---|---|---|---|
| 14 | Assembly precaution for the fuel tank cap kit Hands Free part no. 96681021AA | Hands Free fuel tank cap kit part no. 96681021AA | | <p>We inform you that for the installation of the Hands Free fuel tank cap kit part no. 96681021AA, the <b>main wiring connector (2)</b> where to connect the Hand Free fuel tank cap, is positioned near the fuel pump flange, in the front left area of the fuel tank.</p> |

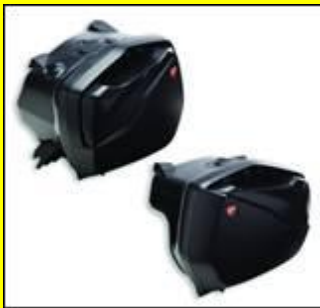
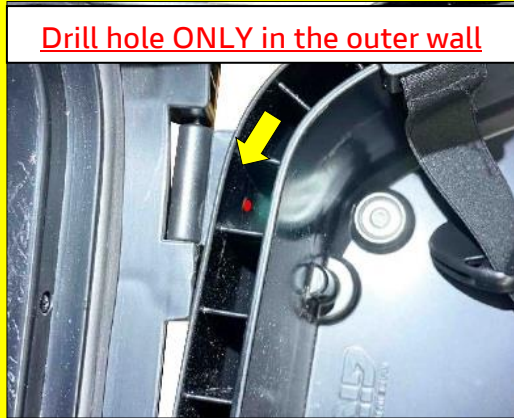
| no. | Symptom | Subject | Photo | Notes and Indications - Corrective action |
|---|---|---|---|---|
| <b>NEW</b><br>18 | Difficulties in opening the side panniers<br>part no. 96781551AA | Side panniers<br>part no. 96781551AA | | <p>We have received a few isolated reports of possible difficulties in opening the side panniers due to the “vacuum” effect that occurs when travelling with significant changes in altitude.</p> <p>To avoid this phenomenon, it is necessary to drill a venting hole with a maximum diameter of Ø 2 mm at the bottom of the bag, between the ribs near the rear hinge as shown in the figure.</p> <p><b><u>DO NOT drill through the second internal wall of the bag.</u></b></p> <p>This modification has also been implemented by the supplier and does not affect the water tightness.</p> <div><p>2.0 mm</p><p><b>Drill hole ONLY in the outer wall</b></p></div> |
