Tips & Tricks –Multistrada V4 Model Year 2021

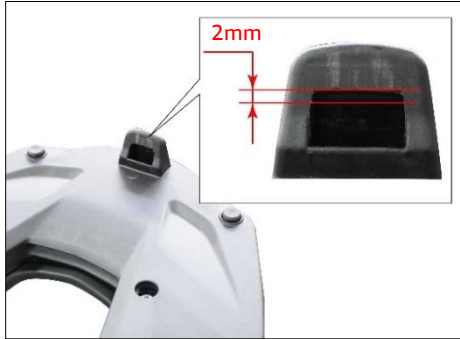
no.	Symptom	Subject	Photo	Notes and Indications - Corrective action
1	Issues during Top Case fixing to the plate	Top Case Kit Part no. 96781531AA

<p>We have received some reports concerning the difficulty in securing the Top Case (Kit Part no. 96781531AA) to the top plate Part no. 8291M033A due to a machining error of the supplier. In particular, the locking tooth on the upper plate Part no. 8291M033A shows a hole 2mm narrower than specified. To eliminate this defect, the locking tooth of the plate must be milled by <u>2mm in the upper area</u> using a flat file, as shown in the figure.</p>

<p>We inform you that the upper plates present inside the kits in stock have been restored.</p>
2	Anti-theft system kit Part no. 96681081AA malfunction	Anti-theft system kit Part no. 96681081AA

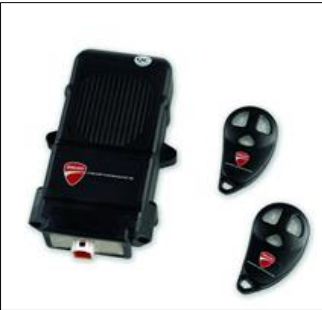
<p>After having installed the anti-theft system Kit Part no. 96681081AA and enabled it on the BBS control unit, some malfunctions may occur during activation due to a possible incorrect pin arrangement in the connector of the wiring branch supplied with the kit.</p>

<p>Follow the procedure described below:</p> <ol style="list-style-type: none"> 1) uncover connector (A) by moving sheath (B) backward; 2) uncover the wiring by removing a portion of insulating tape to make operations easier; 3) check the arrangement of Pins 5 and 6 and the relevant color on the 8-pin connector. If the pin arrangement is not correct, extract them working from the front side with a needle inside the groove so as to lift the retainer and invert them. 4) restore the cloth tape previously removed and the position of the protective sheath (B).

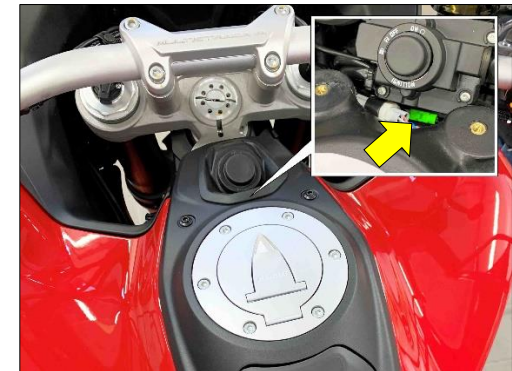
<p>We inform you that for the installation of the heated handgrip kit part no. 96680702A, the main wiring harness connectors where to connect the heated handgrips, are positioned below the ignition switch cover as shown in the figure.</p>

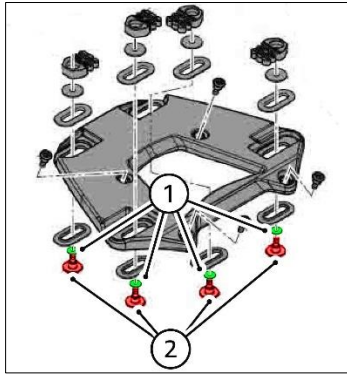
<p>We inform you that the first Top Case accessory kits part no. 96781531AA delivered may not operate correctly with the swinging system, which may seem “too braked”. To improve this condition, it is possible to insert 4 copper washers (1) part no. 85250231A on the 4 screws (2) retaining the bottom plate to the top one.</p> <p>For a better understanding of the assembly procedure of the Top Case accessory kit, a video has been made which can be viewed at the following link: https://youtu.be/DVEHKVvdKQI.</p> <p>All Top Case kits in stock will be restored by February.</p>

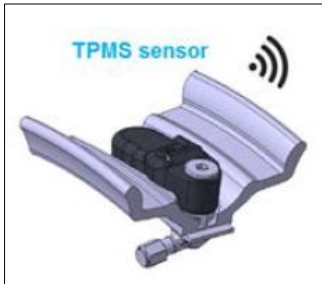
10	Activation procedure for TPMS tire pressure sensor	TPMS (Tire Pressure Monitoring System)		<p>The TPMS system (Tire Pressure Monitoring System) allows monitoring tire pressure value: if tire pressure deviates by 25% from the set reference value, the TPMS system displays a warning on the instrument panel. The sensor activates when speed exceeds 35 km/h and tire pressure is displayed on the instrument panel 1 minute later.</p> <p><u>We remind you that, before installing tyre pressure sensors on front and rear wheel rims, they must be coded through DDS 3.0 diagnosis instrument.</u></p>

<p>To activate TPMS system, follow the procedure indicated below:</p> <ol style="list-style-type: none"> 5) using DDS 3.0, access the "Self-diagnosis → Settings" section of BBS control unit; 6) select "Enable/Disable" TPMS; 7) access the "Self-diagnosis → Settings" section of Hands Free control unit and perform "TPMS code writing" for front and rear wheel sensors by entering the 8-digit code written above the Qr-Code; 8) access the instrument panel Settings menu and select "Tire Pressure" to set (and customize) the reference pressure values of the rear and front tires. The tire nominal pressure value specified inside the owner's manual can be used as a reference. <p><u>Explain to the Customer the use of the "Tire Pressure" function to edit the reference pressure value of the front and rear tires. The information about the current pressure value of front and rear tires is also available inside instrument panel main menu.</u></p>

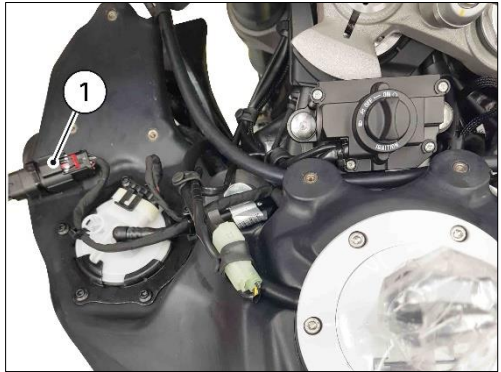
<p>We inform you that for the installation of the anti-theft system kit part no. 96681081AA, the main wiring connector (1) where to connect the anti-theft device, is positioned near the fuel pump flange, in the front left area of the fuel tank.</p>

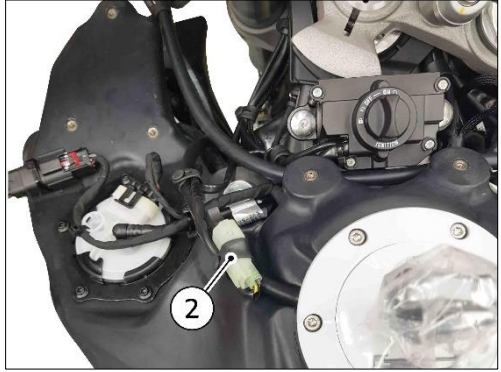
<p>We inform you that for the installation of the Hands Free fuel tank cap kit part no. 96681021AA, the main wiring connector (2) where to connect the Hand Free fuel tank cap, is positioned near the fuel pump flange, in the front left area of the fuel tank.</p>
