May 25, 2021

Version 3

MIL is Flashing with Loss of Power

Supersedes 20-053, dated April 15, 2021, to revise the information highlighted in **yellow**.

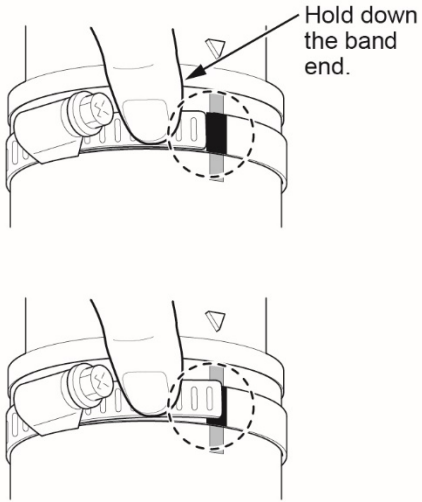
GOOD

The hose band end is **AT** or **WITHIN** the paint or hash mark on the hose band.

9. Tighten the hose bands to the specified condition below.

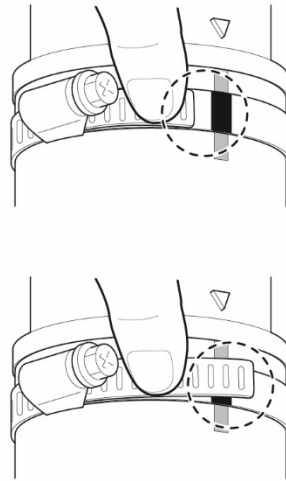
NO GOOD

The hose band end is **NOT AT** or **EXCEEDS** the paint or hash mark on the hose band.
