GROUP	MODEL
BOD	2021-2022MY K5 (DL3a)
NUMBER	DATE
210 (Rev 2, 06/04/2021)	September 2020

TECHNICAL SERVICE BULLETIN

COMBINATION TSB / SERVICE ACTION: CONSOLE SQUEAK NOISE INSPECTION AND REPAIR (SA436)

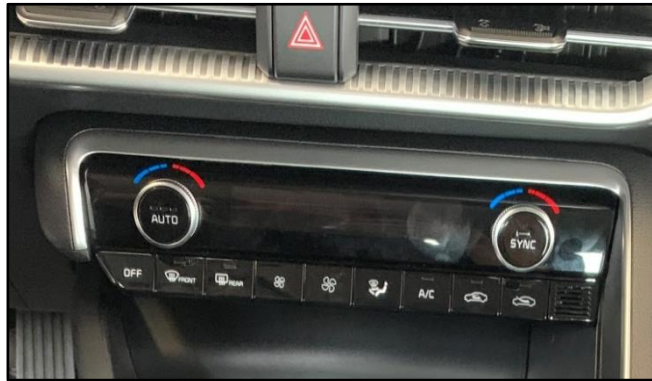
This bulletin provides information regarding a potential squeak noise between the Heating Ventilation Air Condition (HVAC) controller and the floor console upper garnish on some 2021-2022MY K5 (DL3a) produced from March 25, 2020 through June 8, 2021. Follow the inspection procedure to confirm if the squeak is present. If the squeak is present, technicians are instructed to apply Tesa® Tape to the right corner of the HVAC controller face. Before conducting the procedure, verify the vehicle is included in the list of affected VINs.

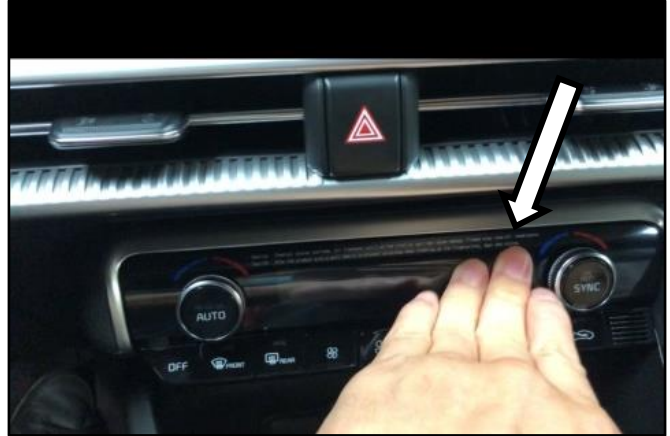
1. Inspect the HVAC controller for squeak by pushing in on the right upper corner of the HVAC controller in the location shown.

If the HVAC controller does not exhibit a squeak noise, no further action is required.

If the HVAC controller squeaks during inspection, follow the Repair Procedure outlined below.
