Technical product information

Topic	Bentayga Hybrid - PDC Multi switch not illuminated
Market area	China 796 VW Import Comp. Ltd (Vico), Beijing (6796),United States E05 Bentley USA and rest America (6E05)
Brand	Bentley
Transaction No.	2063348/1
Level	EH
Status	Approval
Release date

Bentayag Hybrid

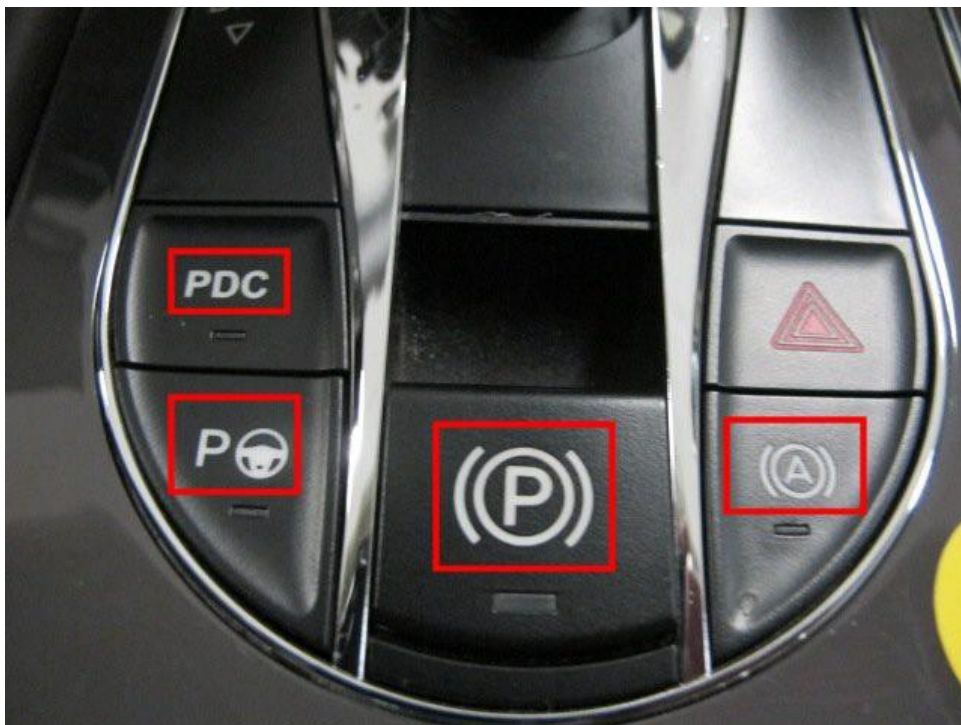
The PDC Multi-Switch (white backlight) illumination is not available (Figure 1)

IMPORTANT NOTE: Figure 1 shows the white backlight not illuminated

- 1) Refer to Elsa pro to confirm if EB97 is VIN applicable

NOTE: In the event that EB97 is VIN applicable - EB97 should now be conducted

VERY IMPORTANT: In the event that EB97 *Is Not* VIN applicable and the issue is evident the retailer must raise a DISS query stating the following:

- The issue described is evident - *PDC Multi-Switch (white backlight) illumination is not available*
- EB97 *Is Not* VIN applicable (Not visible within Elsa pro)
- IMPORTANT: Await feedback from Product Support before conducting the remaining instructions from Step 2

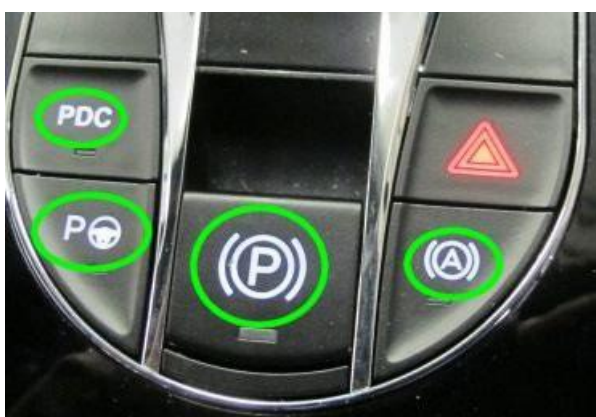
- Figure 2 shows the illumination working to specification (illuminated)

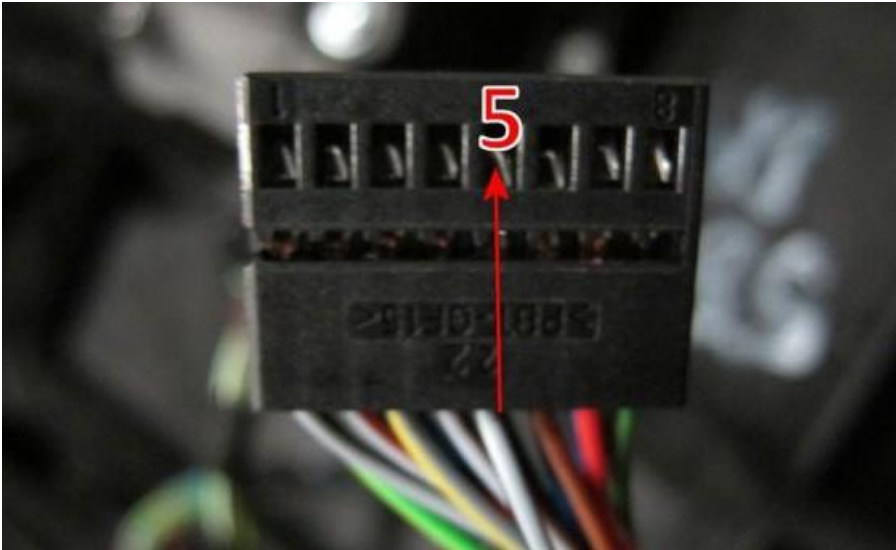
In the event that EB97 is not VIN applicable however cavity 5 is populated (as shown in Figure 5 grey/black) and the issue is evident, the retailer must continue with standard diagnosis Or raise a new DISS query requesting additional support

- Referring to Figure 5 - Locate cavity 5

- In the event that cavity 5 is not populated, please respond on the already opened query ensuring all information is attached including applicable photographs showing cavity 5 not populated
- Await feedback from Product Support before conducting the instructions within EB97
