## Technical product information

| <b>Topic</b> | New Continental GTC - Heated Armrest - De-activates |
| <b>Transaction No.</b> | 2059651/3 |

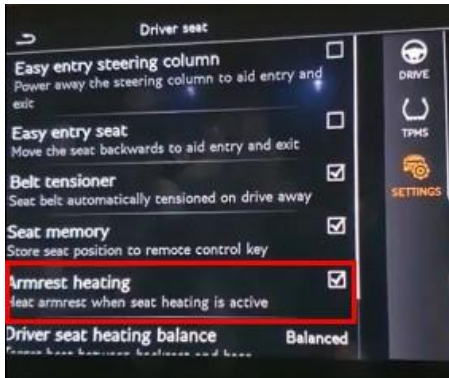
Figure 1

If "Armrest Heating" is selected on the Infotainment Touch Screen it should remain configured as a preference - Figure 1.

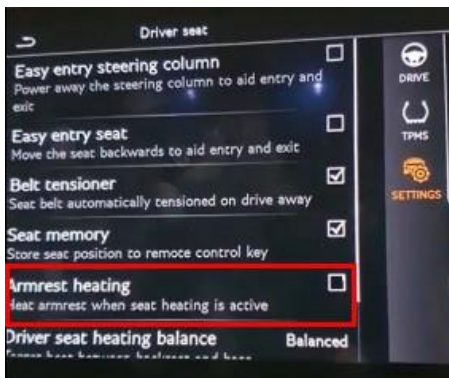
Figure 2

When a Controller Area Network (CAN) shutdown occurs the "Armrest Heating" selection box becomes "unticked" and has to be manually re-selected to enable "Armrest Heating" functionality - Figure 2.

"Armrest Heating" selection box becomes "unticked" every time a CAN shutdown occurs.

NOTE: A software update for address 08 – Air conditioning control unit is now available – Refer to the Measure section of this TPI
