SERVICE BULLETIN

Reference number:	SB-30-1497V4	Issued: 04 June, 2021
Subject:	Connector Repair Process for Weak GPS Signal	
Model(s):	DBX (up to VIN: V01738)	
Applicable to:	All Dealers	
Distribute to:	After Sales Manager Executive Manager Service Manager Sales Manager	Warranty Staff Technician(s) Parts Staff

Reason for this Service Bulletin

If a vehicle is reported to have a weak GPS signal, do the workshop procedure that follows to install harness repair tape and copper tape to the applicable connector locations. This will prevent interference and improve the GPS signal.

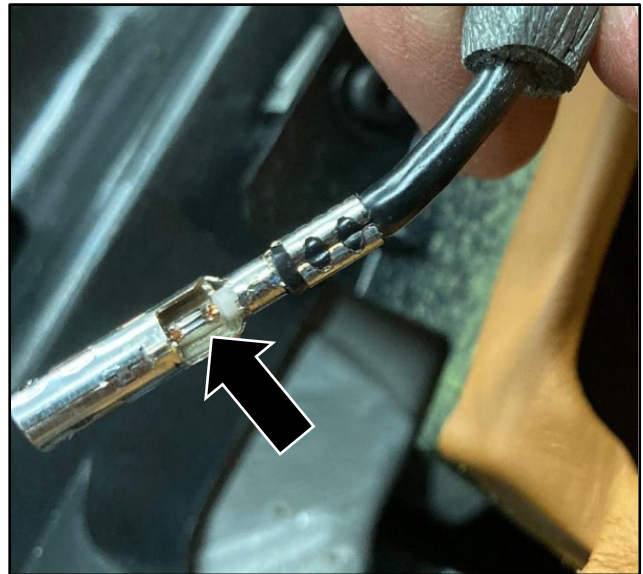
Figure 1

Note: This image shows a connector before any tape is applied.

6. Remove the connector from the applicable connector housing (refer to Figure 4).

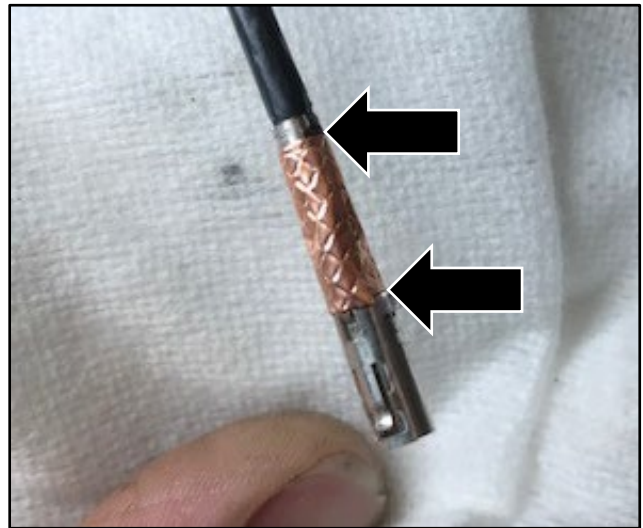
Figure 3

Note: Make sure the copper tape is applied tightly and neatly. Loose or untidy copper tape will prevent correct installation. It is possible that the loose copper tape will be compressed by the connector and cause the repair to not correct the problem.

8. Apply copper tape to the area shown. You must make sure there are no gaps to the areas shown as this will cause electromagnetic interference (refer to Figure 6).

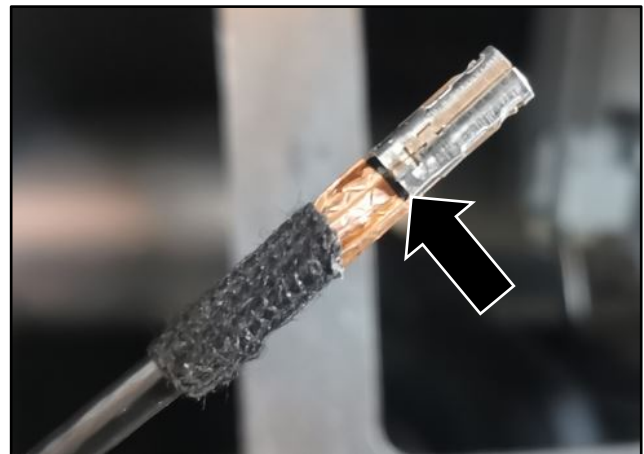
Figure 4

9. This image shows copper tape, that has ***not*** been applied correctly (refer to Figure 7).

Note: The gap shown will allow electromagnetic interference and cause the repair to not correct the problem.

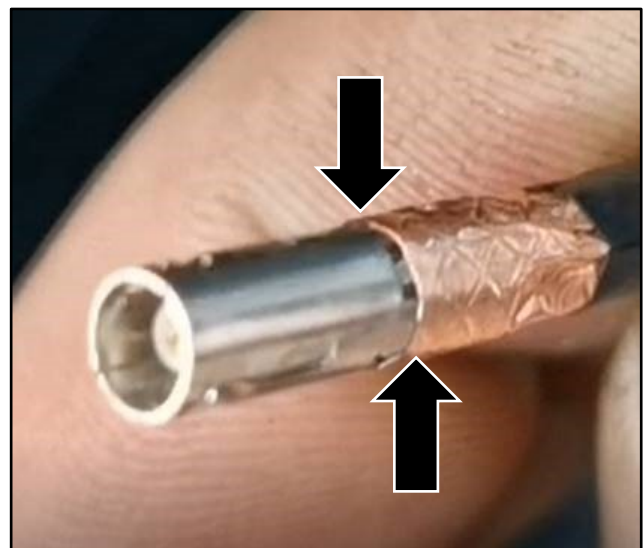
Figure 5

10. This image shows copper tape, that has been applied correctly (refer to Figure 8).

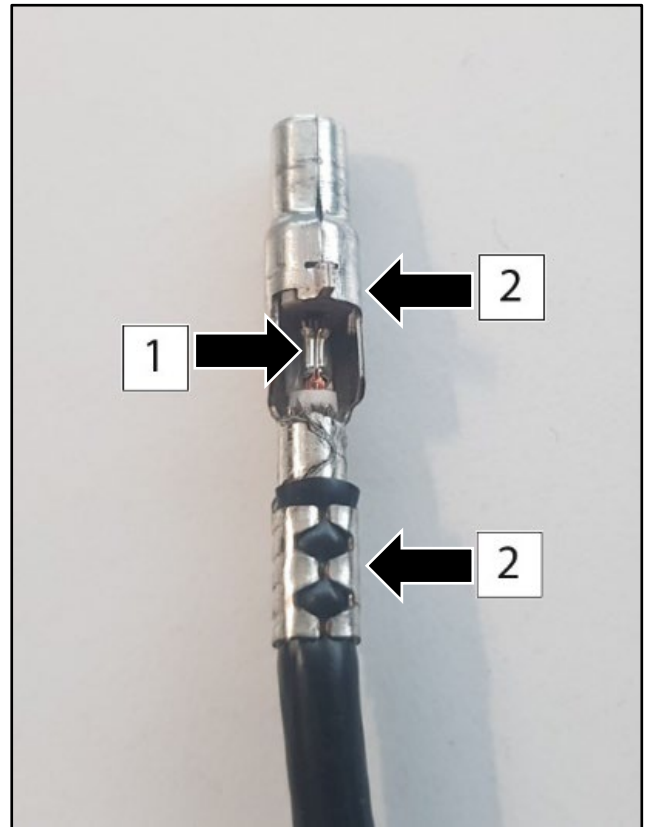
Figure 6

CAUTION: DO NOT CAUSE A CONNECTION BETWEEN THE INNER AND OUTER PART OF THE CONNECTOR WHEN YOU APPLY THE COPPER TAPE. IF THE TWO PARTS OF THE CONNECTOR ARE IN CONTACT, THE CONNECTOR WILL NOT FUNCTION CORRECTLY.

- 11. Make sure the inner part of the connector (1) is isolated from the outer part of the connector (2) when you apply the copper tape (refer to Figure 9).
