QUARANTINE NOTICE

Reference number:	QN-30-1497V2	Issued: 04 June, 2021
Subject:	Connector Repair Process for Weak GPS Signal	
Model(s):	DBX	
VIN Range:	Refer to the separately published list of affected Vehicle Identification Numbers (VINs)	
Applicable to:	All Dealers	
Distribute to:	After Sales Manager Executive Manager Service Manager Sales Manager	Warranty Staff Technician(s) Parts Staff

Reason for this Quarantine Notice

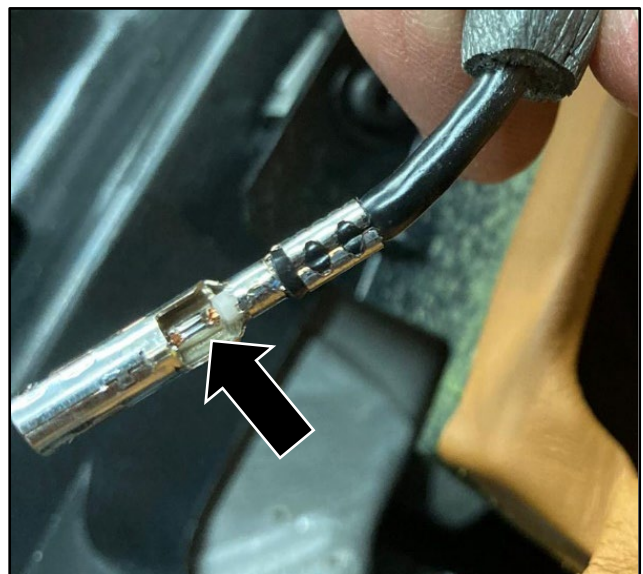
Figure 4

Note: This image shows a connector before any tape is applied.

6. Remove the connector from the applicable connector housing (refer to Figure 4).

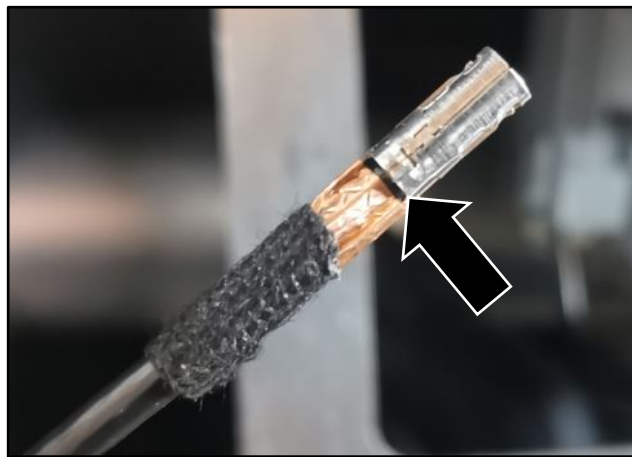
Figure 7

9. This image shows copper tape, that has ***not*** been applied correctly (refer to Figure 7).

Note: The gap shown will allow electromagnetic interference and cause the repair to not correct the problem.

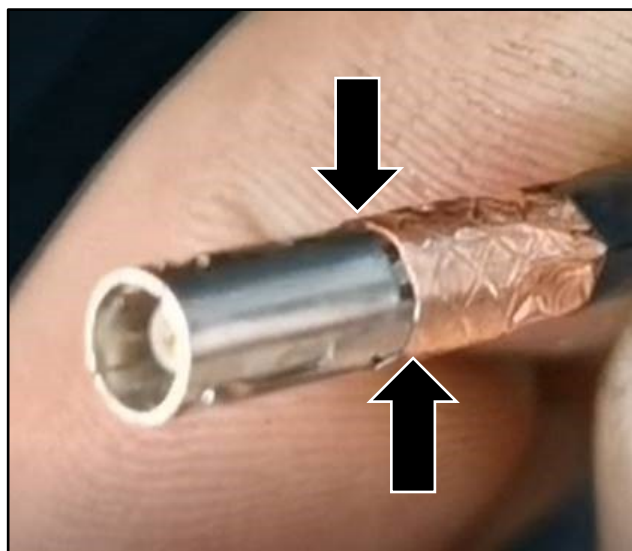
Figure 8

10. This image shows copper tape, that has been applied correctly (refer to Figure 8).

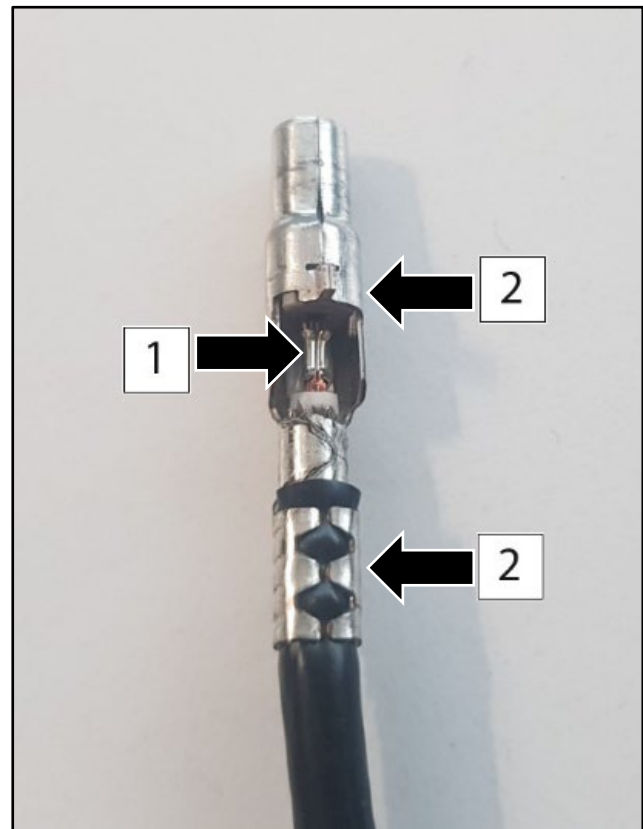
Figure 9

CAUTION: DO NOT CAUSE A CONNECTION BETWEEN THE INNER AND OUTER PART OF THE CONNECTOR WHEN YOU APPLY THE COPPER TAPE. IF THE TWO PARTS OF THE CONNECTOR ARE IN CONTACT, THE CONNECTOR WILL NOT FUNCTION CORRECTLY.

11. Make sure the inner part of the connector (1) is isolated from the outer part of the connector (2) when you apply the copper tape (refer to Figure 9).
