## System response of Park Assist - model series 213 face- lift / 238 facelift with option code 235 and option code 501

| Topic number | LI54.65-P-072065 |
| Function group | 54.65 - Parking assist |
| Validity | 213 facelift / 238 facelift with option code 235 and option code 501 |

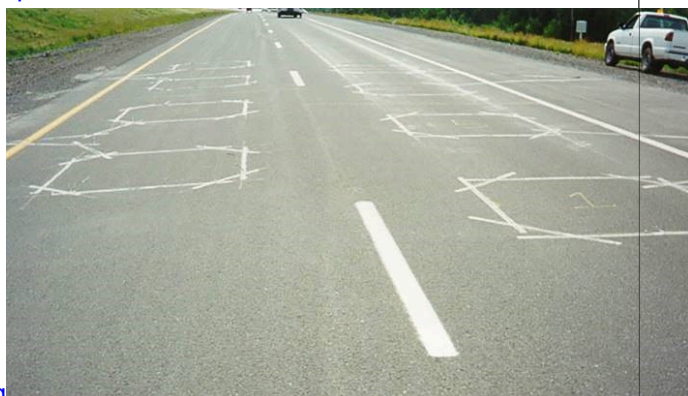
1.jpg

9. In underground electric induction loops, at traffic lights or in parking garages. These are identified by tarred outlines in the road, as shown in the example in the attachments.

## Inductive loop outline example

Re. 1 to 12: Address these causes or factors in the usual way or explain them to the customer.
