## Technical Service Bulletin

GROUP <b>Campaign</b>	NUMBER <b>21-01-038H</b>
DATE <b>May, 2021</b>	MODEL(S) <b>Accent (HC)</b>

**SUBJECT:** TCU UPDATE AND / OR IVT REPLACEMENT  
(SERVICE CAMPAIGN T6J)

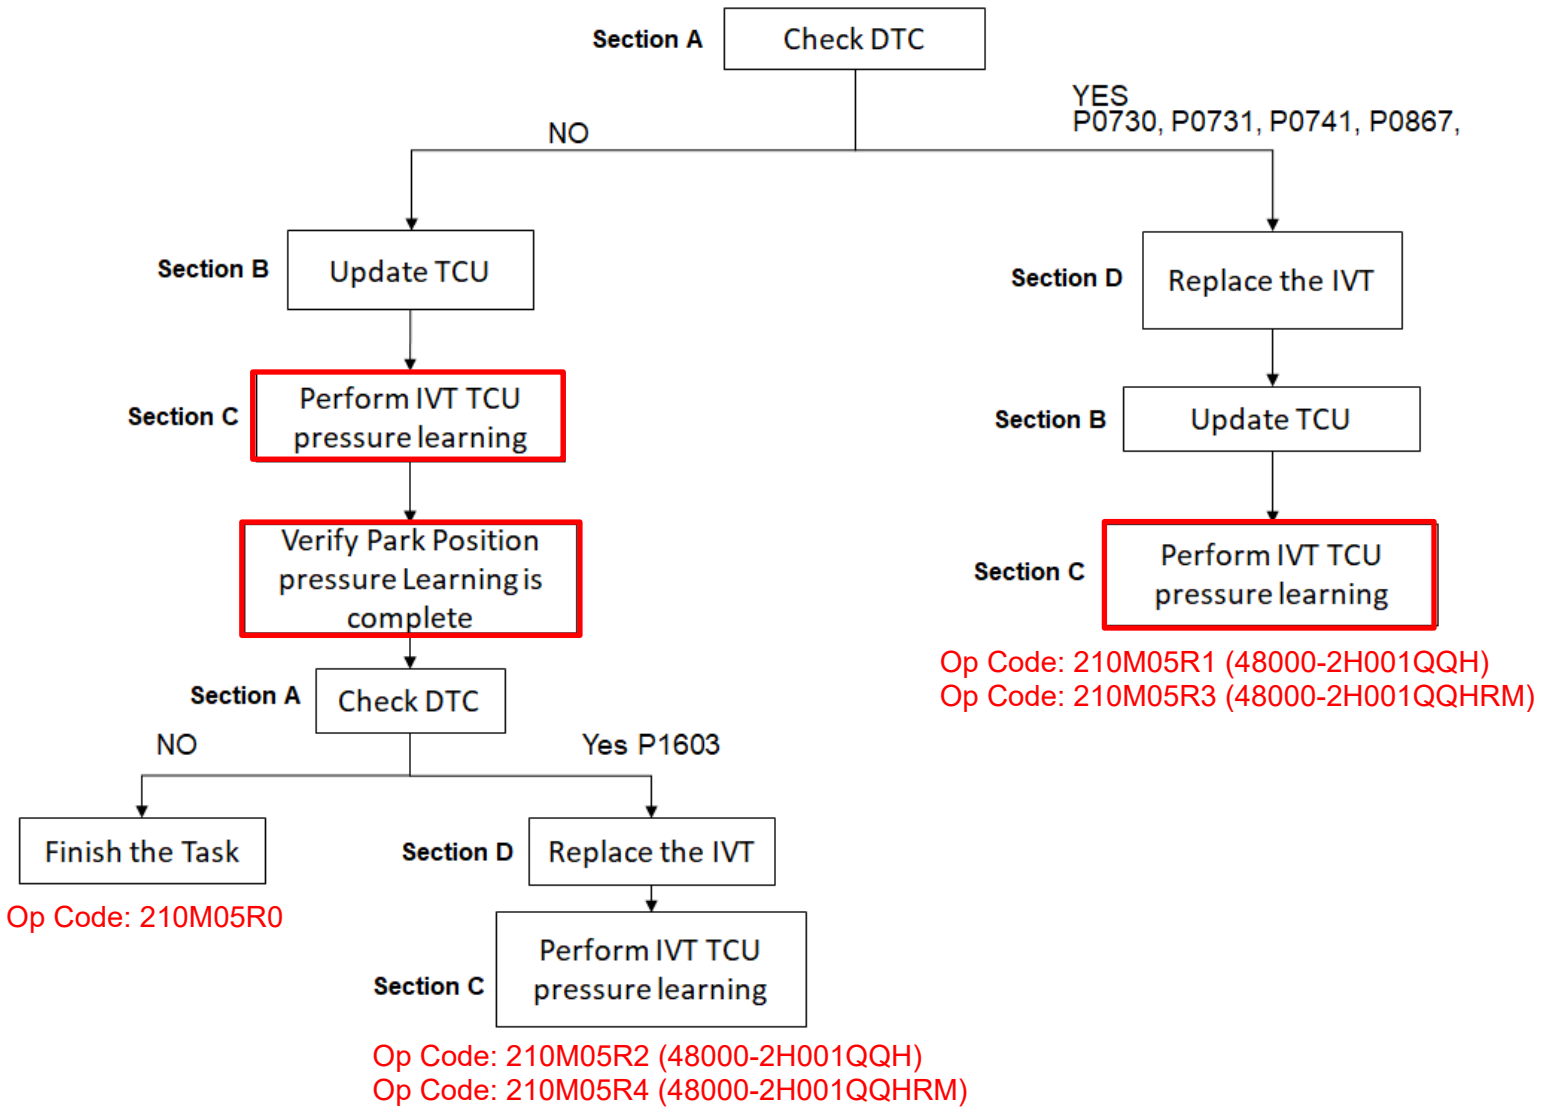
**TCU Update Flow (HC with IVT)**

1. Refer to the flowchart below to update the procedure.

1. Use the GDS-M to check the TCU DTC.
2. If one of the DTC(s) P0730, P0731, P0741, P0867, P1603 applies (History, Current, or Pending), replace the IVT.
3. Replace the IVT according to the applicable vehicle shop manual.
4. After IVT replacement, perform TCU update first, then perform the IVT resetting auto T/A values, TCU adaptive values learning procedure.

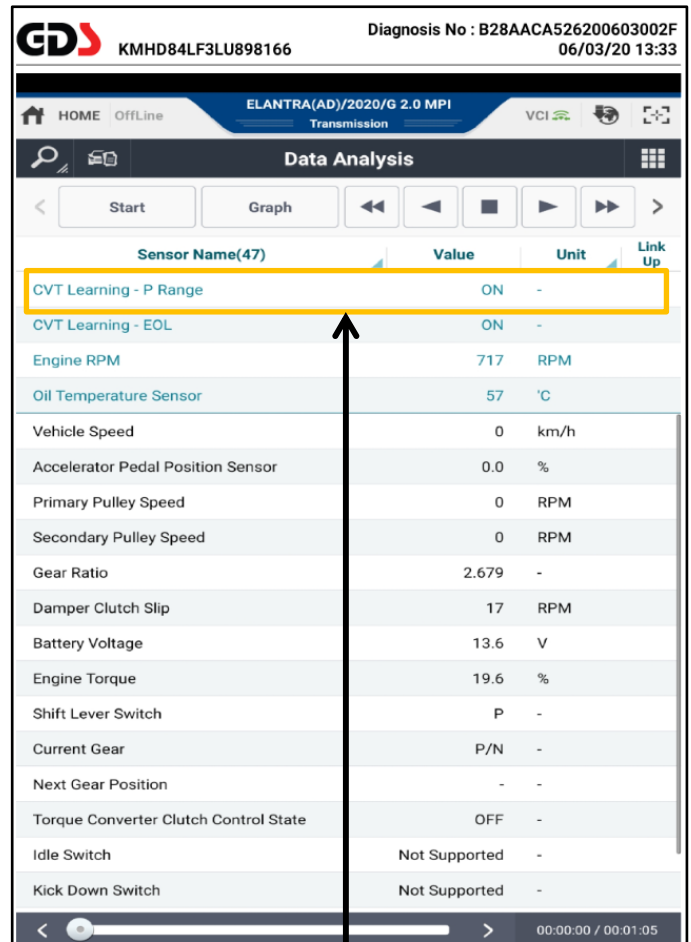
Use the GDS-M to verify the IVT P-Range learning is complete, and check TCU for DTC P1603 (EOL P-Range Pressure Learning Failed).

(1) If IVT- P Range learning is not complete, and P1603 is present, Replace the IVT (Refer to **Section D.**)

(2) If IVT-P Range is not complete, and P1603 is not present, the learning condition has not been met. Re-perform **Section C - IVT, TCU Learning.**
