HYUNDAI Technical Service Bulletin

GROUP Campaign	NUMBER 21-01-039H
DATE May, 2021	MODEL(S) Elantra (AD/ADa)

SUBJECT: TCU UPDATE AND IVT REPLACEMENT
(SERVICE CAMPAIGN 963)

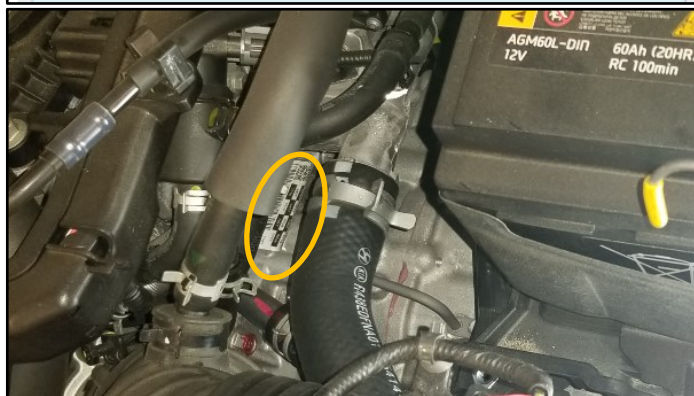
IVT oil pressure characteristics label is located on the IVT bell housing.

1. Perform IVT Resetting Auto T/A Values and Oil-pressure Characteristics Input procedures using the GDS-M.

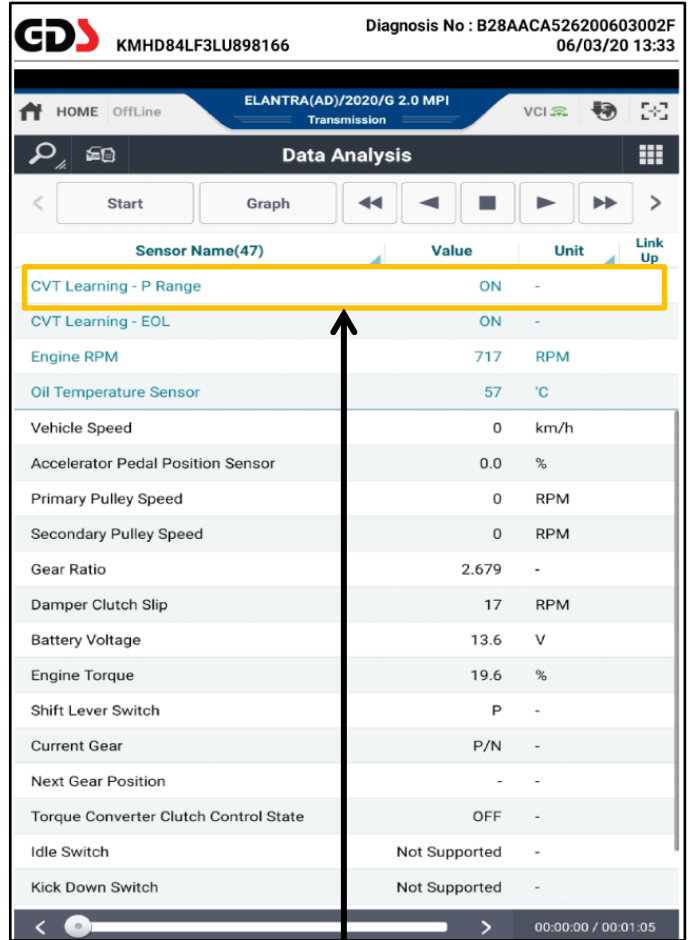
Use the GDS-M to verify the IVT P-Range learning is complete, and check TCU for DTC P1603 (EOL P-Range Pressure Learning Failed).

(1) If IVT- P Range learning is not complete, and P1603 is present, replace the IVT (Refer to **Section D.**)

(2) If IVT-P Range is not complete, and P1603 is not present, the learning condition has not been met. Re-perform **Section C** - IVT, TCU Learning.

Learning completion can be confirmed by using GDS-M to verify the IVT (“CVT”) P-Range learning value is “ON”. (“OFF” learning has not been completed)
