HYUNDAI Technical Service Bulletin	GROUP BODY ELECTRICAL	NUMBER 21-BE-008H
	DATE May, 2021	MODEL(S) Santa Fe (TMa), Sonata (LFa)
SUBJECT: SOFTWARE UPDATE FOR MODEM INFORMATION DISPLAYING ALL ZEROS

Description: Certain vehicles may experience 504 Time Out errors when using the Blue Link Mobile App. When asked to provide Modem Information (IMEI/USIM), the Head Unit (HU) displays all zeros. This bulletin describes the procedure to update the Head Unit Software to correct this condition.

Applicable Vehicles: All 19MY & 20MY Santa Fe (TMa), 18MY & 19MY Sonata (LFa) Equipped with Standard AVN 5.0 or Display Audio.

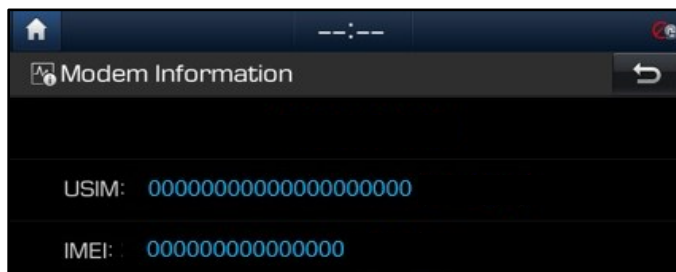
6. USIM & IMEI information will display all zeros.

You must attach a picture of the head unit displaying all zeros in order to submit the warranty claim. Claims submitted where the picture does not have the head unit displaying all zeros will be subject to charge back.
