Service Bulletin

20-036

Rattling from the Front of the Vehicle

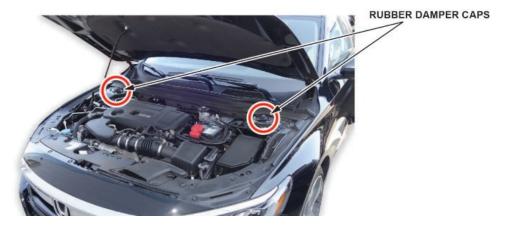
Remove the rubber damper caps, then test-drive the vehicle.

- If you no longer hear a rattling from the front of the vehicle with the caps removed, go to REPAIR PROCEDURE.
- If you still hear a rattling from the front of the vehicle with the caps removed, this bulletin does not apply. Continue with normal system troubleshooting.

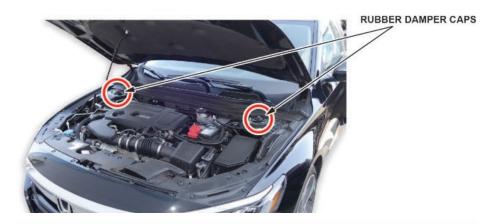
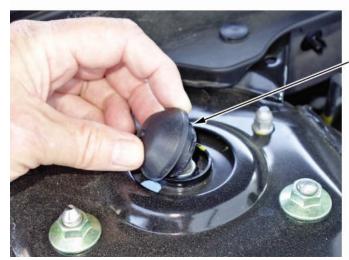
RUBBER DAMPER CAP

The rubber damper cap(s) are faulty.

Install the new rubber damper caps on both sides.
