Product Update: 2016-20 HR-V Software Update and CVT Inspection

Supersedes 21-046, Dated April 27, 2021, to revise the information highlighted in **yellow**.

AFFECTED VEHICLES

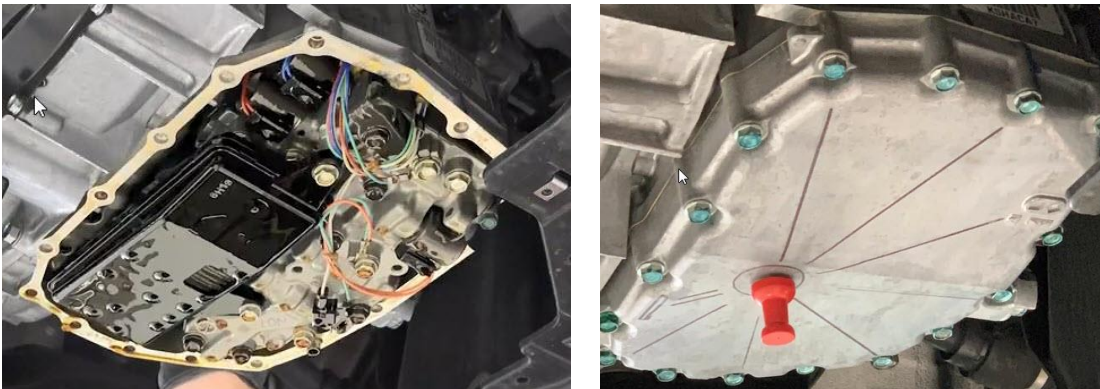
NOTE: While sliding the magnet on the oil pan, you may feel the magnet sticking in some areas shown on illustration below. This is normal as there are some bolts under the oil pan that attach the valve body to the transmission.

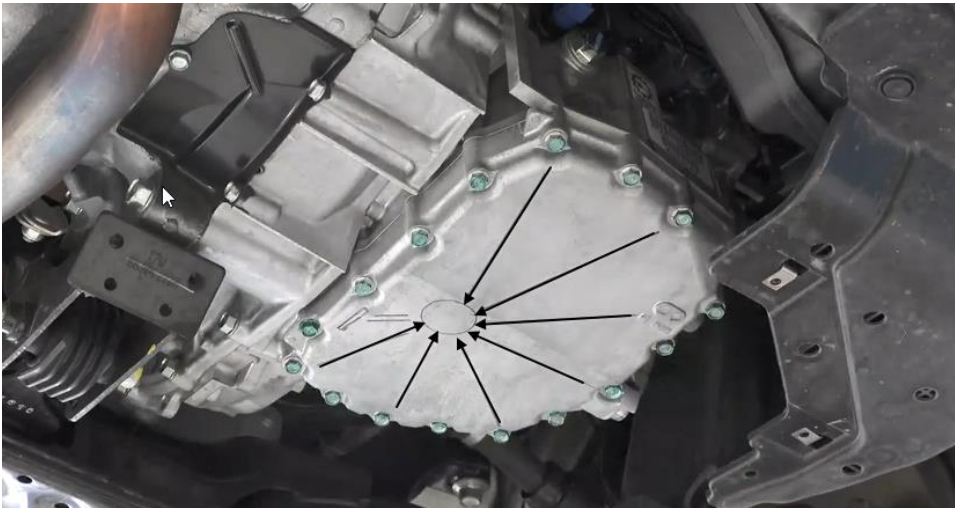
10. After tracing all 7 lines from the outside to the inspection area, let go of the magnet to see if it sticks in place. If the magnet sticks to the oil pan in the inspection area there is a problem with the transmission, **take a clear picture of the magnet sticking to the oil pan in the inspection area, then** go to service bulletin 21-047, *Warranty Extension 2016 - 20 HR-V CVT Premature Belt Deterioration*. If the magnet does not stick to the oil pan, go to the next step.

7. Remove the template from the oil pan.
8. Starting on line #1, place a magnet on each of the lines starting from the outside, slowly trace each line to the center inspection circle on the template, then lift the magnet off the inspection area (shown in black below).
