GROUP	MODEL
BOD	2021MY K5 (DL3a)
NUMBER	DATE
215	June 2021

## TECHNICAL SERVICE BULLETIN

### SERVICE ACTION: PANORAMA SUNROOF INSPECTION AND REPAIR (SA481)

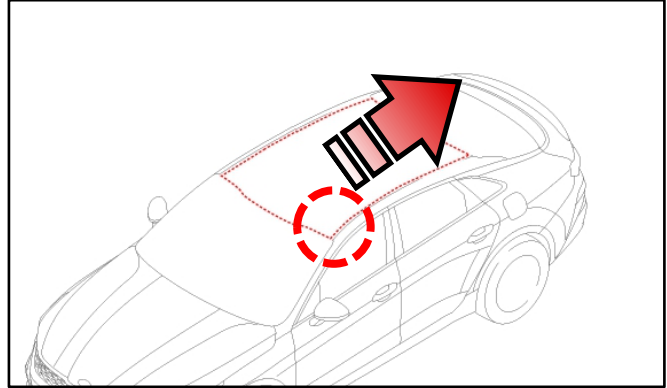
- 1. Open the panorama sunroof to access the inner left front tracking area.

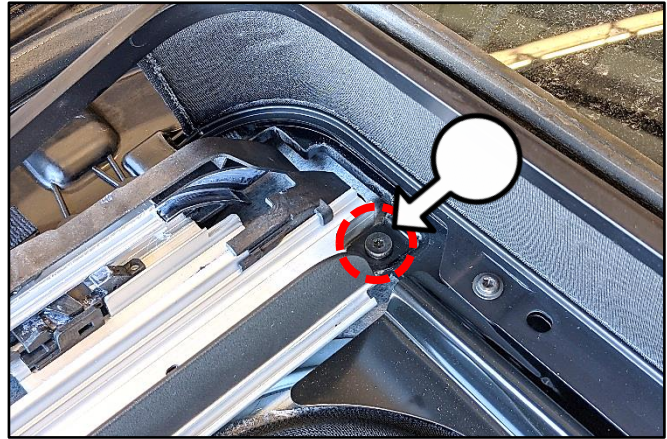
- 2. Locate the bolt (A) shown on the left front corner.

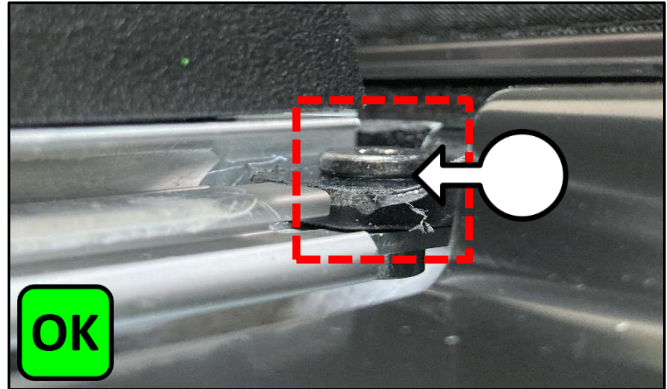
- 3a. Check the bolt (A) and confirm it is properly installed flushed and tightened (OK).

Tightening torque for bolt (A):  
3.70 lb.ft (5.0 N.m, 0.51 kgf.m)  
T20 Torx bit

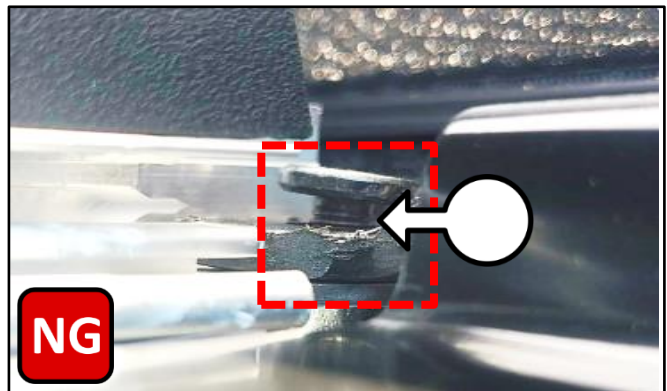
- 3b. If the bolt (A) is not flush (installed diagonally) and cross threaded tight (NG), then proceed to page 3 to the 'Repair Procedure'.
