SERVICE BULLETIN

Classification: EL21-009	Reference: NTB21-031	Date: May 18, 2021
-----------------------------	-------------------------	-----------------------

BCM REPROGRAM TO DISABLE FOG LAMP OPERATION DURING HIGH BEAM OPERATION

APPLIED VEHICLES: 2020 Sentra (B18) – SR

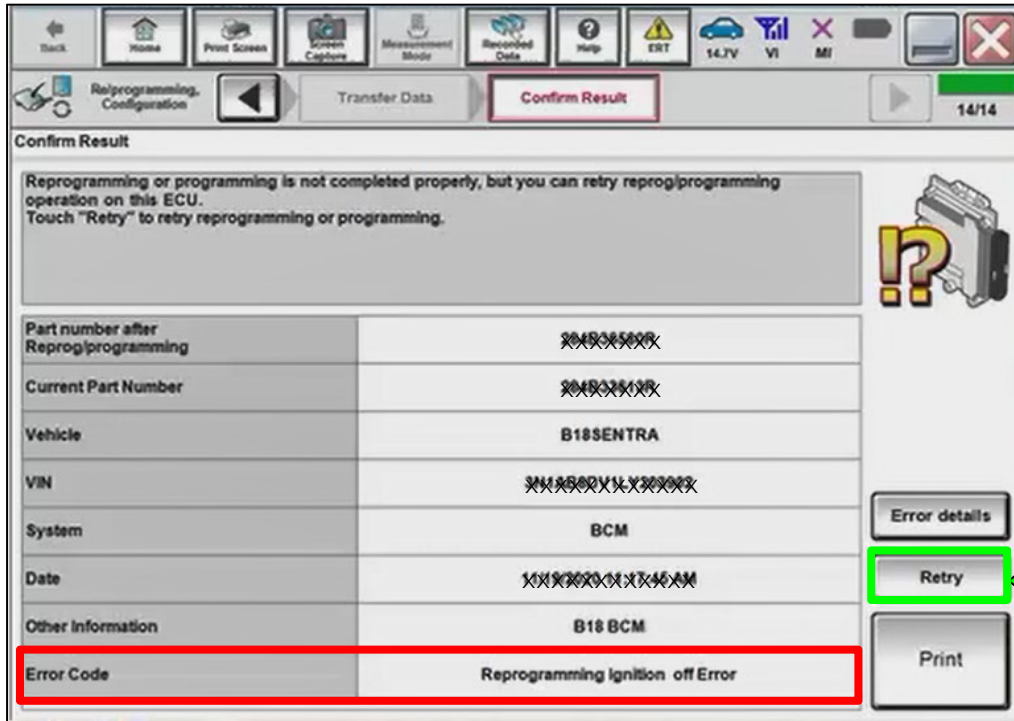
Figure 20

22. Toward the end of the reprogram, the CONSULT will show an Error Code “**Reprogramming Ignition off Error**” and the vehicle ignition will turn off.
- a) Turn the ignition ON, engine OFF.
 - b) Select **Retry**.

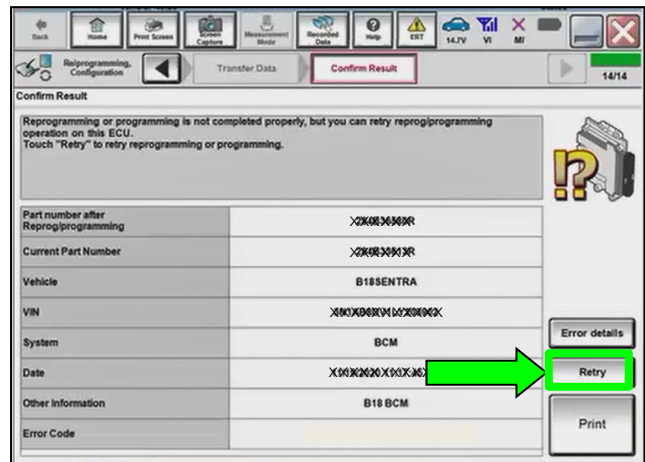
Figure 22

If reprogramming does not complete and the “!?” symbol displays as shown in Figure 22:

- Check battery voltage (12.0 – 15.5V).
- Ignition is ON, engine is OFF.
- External Bluetooth® devices are OFF.
- All electrical loads are OFF.
- Select **Retry** and follow the on screen instructions.

NOTE: **Retry** may not go through on first attempt and can be selected more than once.

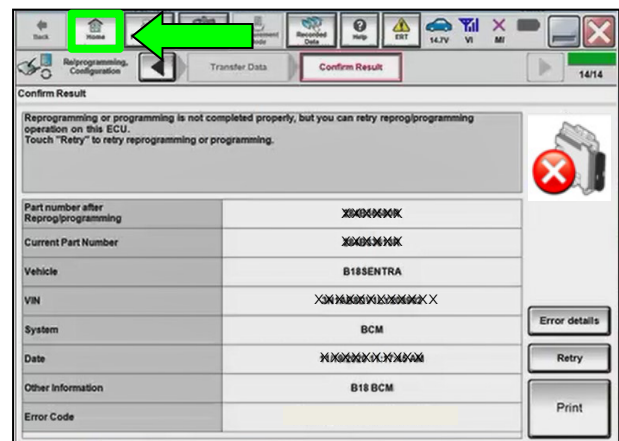
Figure 23

If reprogramming does not complete and the “X” symbol displays as shown in Figure 23:

- Do not disconnect the VI or shut down C-III plus if reprogramming does not complete.
- Check battery voltage (12.0 – 15.5V).
- CONSULT A/C adapter is plugged in.
- Ignition is ON, engine is OFF.
- Transmission in Park.
- All C-III plus / VI cables are securely connected.
- All C-III plus updates are installed.
- Select **Home**, and then restart the reprogram procedure from the beginning.

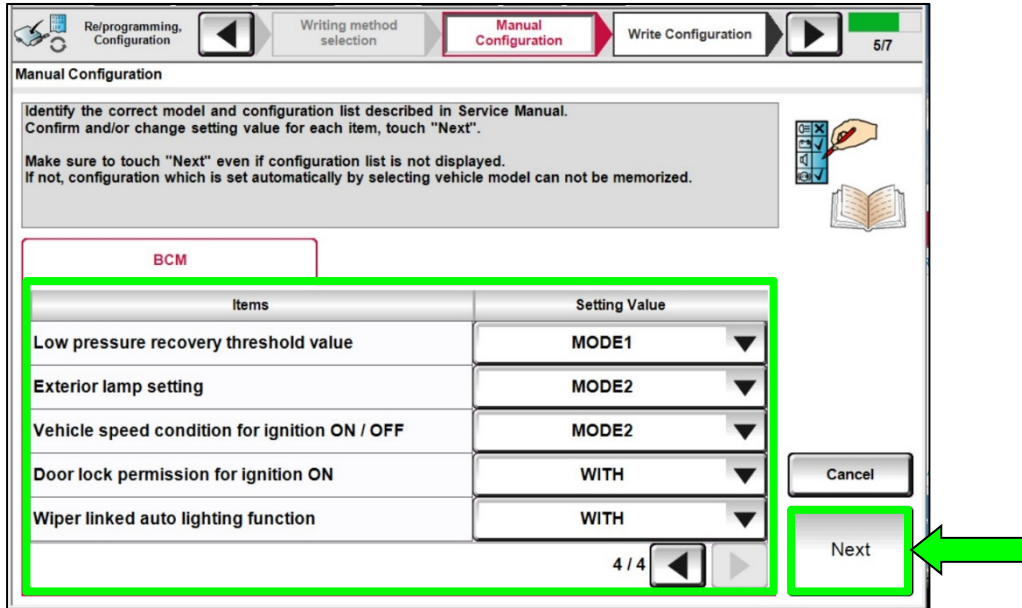
Figure 27

To prevent damage to the BCM, be sure the correct BCM settings are selected for the proper vehicle EIM code. Failure to select the correct BCM settings will require the BCM to be replaced.

28. Using the EIM code documented in step 24 on page 16, select the correct **Setting Value** for each **Item**, and then select **Next**.
- Refer to **Table A** on page 19 for the correct **Setting Value**.
