Preliminary Information

PIT5839A Radio System Settings Lost or Returning to Default Values

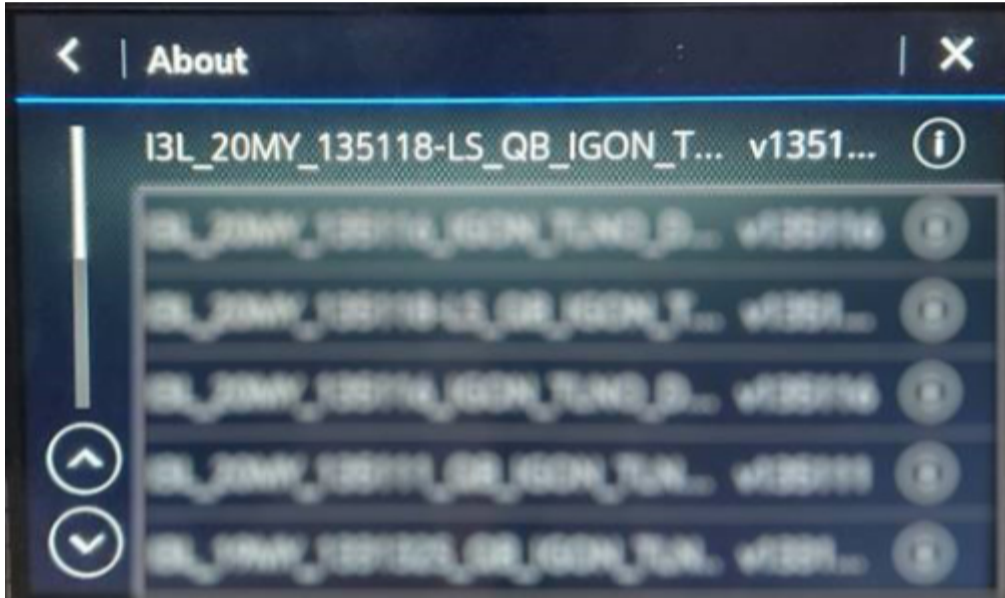
1. Verify the radio software version as this issue only pertains to version V135118. On the radio display, select Home, Settings, About. On this page will be what appears like a long file name. In the middle of this file name will be 135118.

- If the version is V135118 proceed to Step 2.
- If the version is numerically less than V135118 then this PI does not apply. Refer to SI for diagnostics.
- Tip: Before resetting the radio, please record the customer's stored Favorites so that they can be re-entered afterward. Once selected it is important to wait for the radio to complete this process and reboot itself before the ignition is turned off.
