Preliminary Information

PIP5806 Intermittent Extended Crank No Start and a possible DTC P0341 set

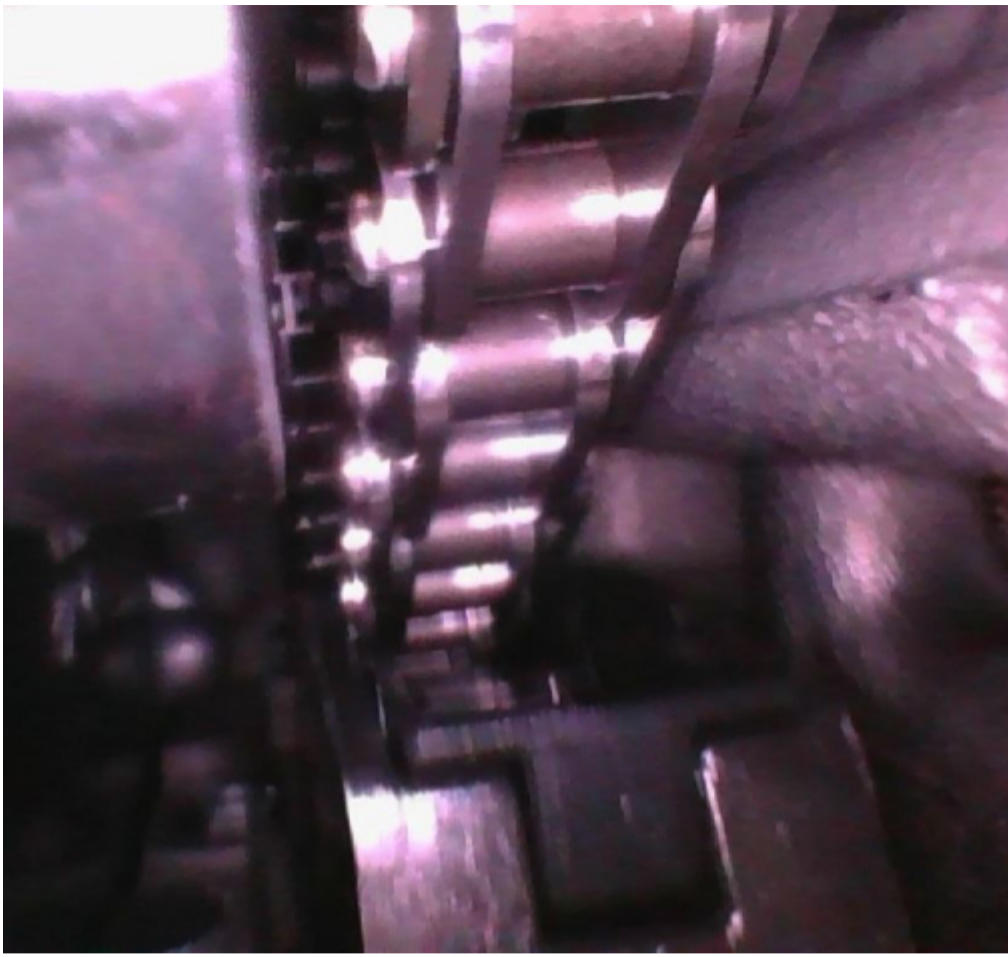
Above is a normal trigger wheel.

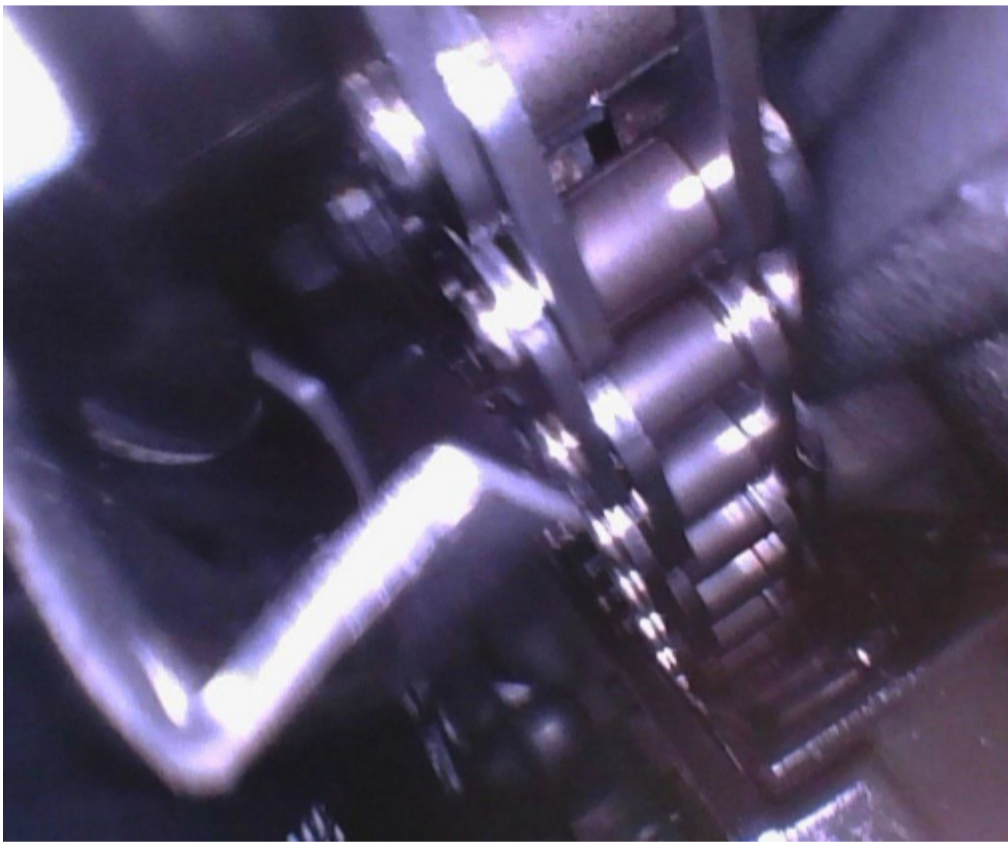
Involved Region or Country:	North America
Condition:	Some customers may experience an intermittent extended crank or intermittent crank/no start, and may find DTC P0341 set.
Cause:	This may be due to a bent trigger wheel on the camshaft.

Above is a bent trigger wheel. It may or may not make contact with the timing chain.

If you find the cam sensor trigger wheel bent, replace it.

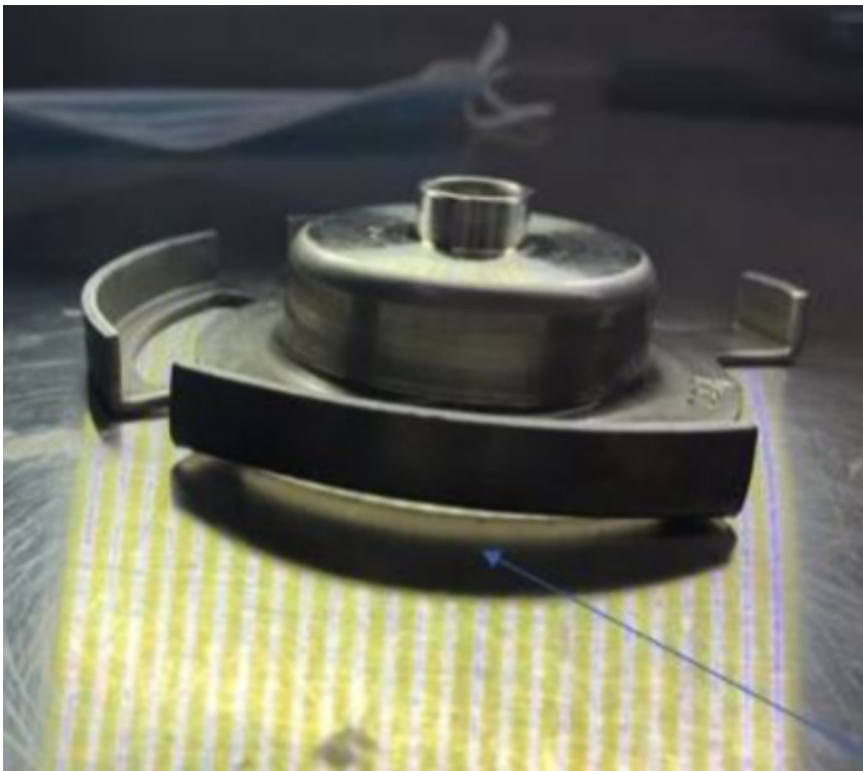
This is a bent trigger wheel.
