GLOBAL SAFETY FIELD INVESTIGATIONS  
DCS5782  
URGENT - DISTRIBUTE IMMEDIATELY

Subject: N212335340 - Customer Satisfaction Program  
ECM Calibration Causing Battery Drain

Models: 2021 Chevrolet Silverado 1500  
2021 GMC Sierra 1500

## N212335340 ECM Calibration Causing Battery Drain

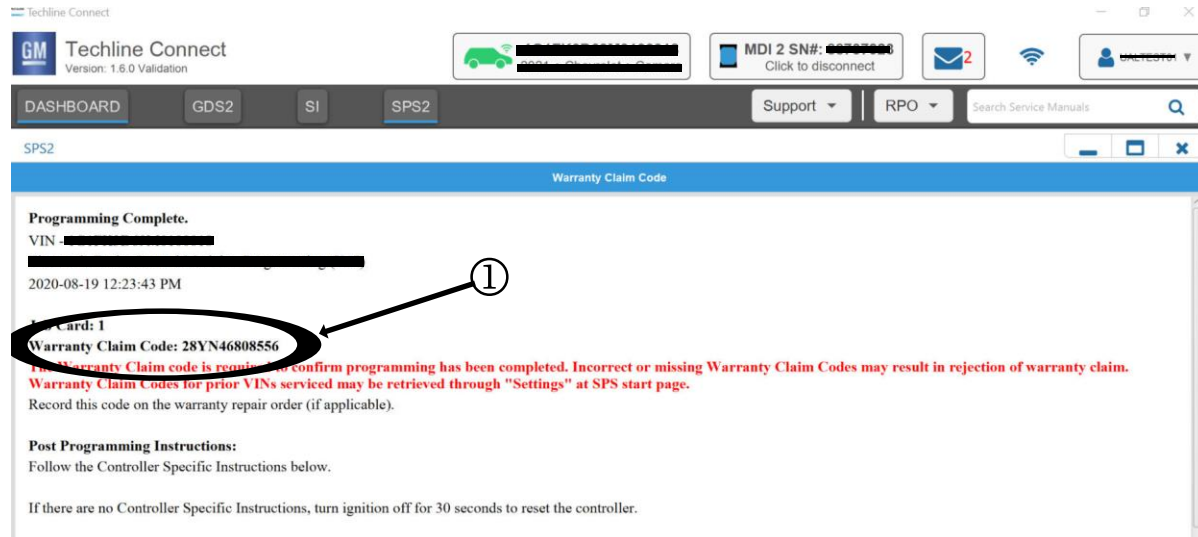
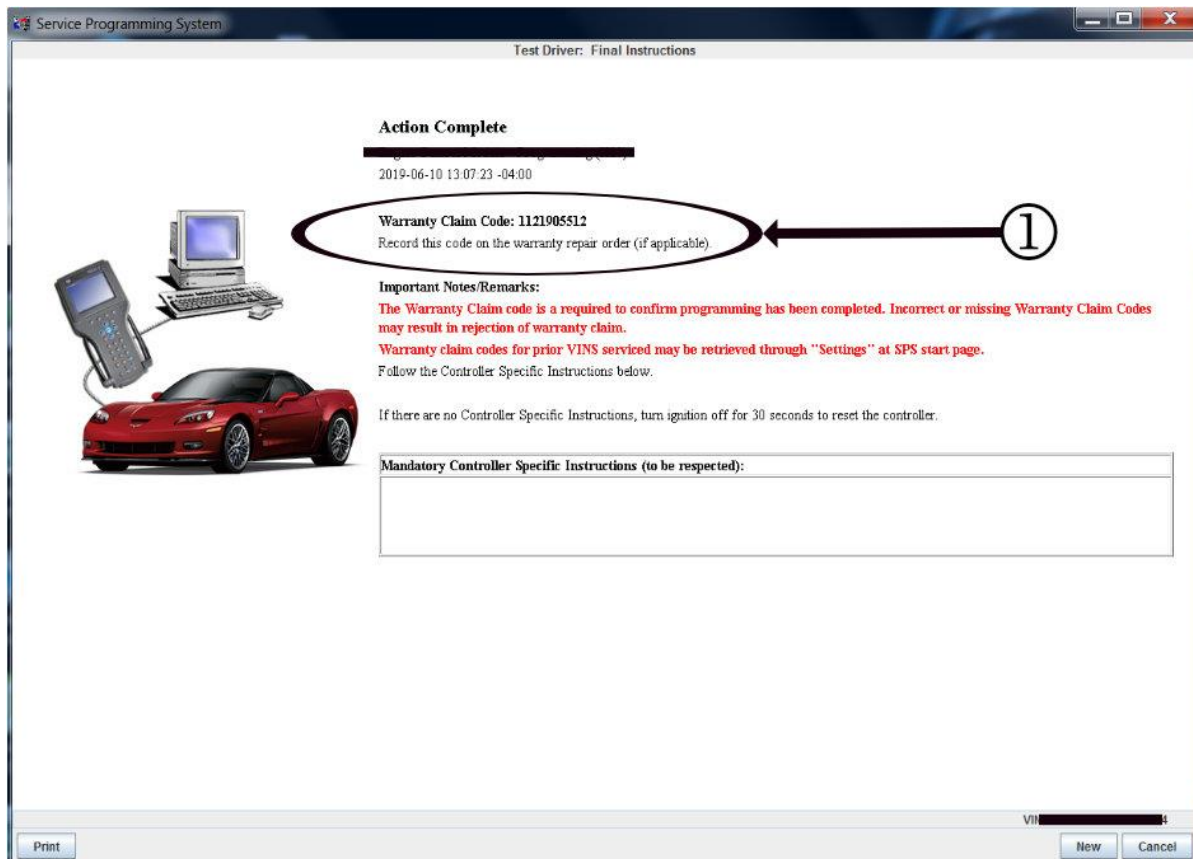
**Note:** The screenshots above are an example of module programming and may not be indicative of the specific module that is being programmed. Module selection and VIN information have been blacked out.

1. Reprogram the Engine Control Module. Refer to *K20 Engine Control Module: Programming and Setup* in SI.

**Important:** To avoid warranty transaction rejections, you **MUST** record the warranty claim code provided on the Warranty Claim Code (WCC) screen shown above on the job card. Refer to callout 1 above for the location of the WCC on the screen.
