**XC40 Recharge: Charging Issues at Signet Charging Stations  
(Information Only)**

<b>REF NO:</b> TJ 35801.1.2	<b>ISSUING DEPARTMENT:</b> Technical Service	<b>CAR MARKET:</b> United States and Canada	
<b>PARTNER:</b> 3 US 7510 Volvo Car USA		<b>ISSUE DATE:</b> 2021-05-17	<b>STATUS DATE:</b> 2021-05-17
<b>FUNC GROUP:</b> 3234	<b>FUNC DESC:</b> Onboard charger, high voltage	Page 1 of 3

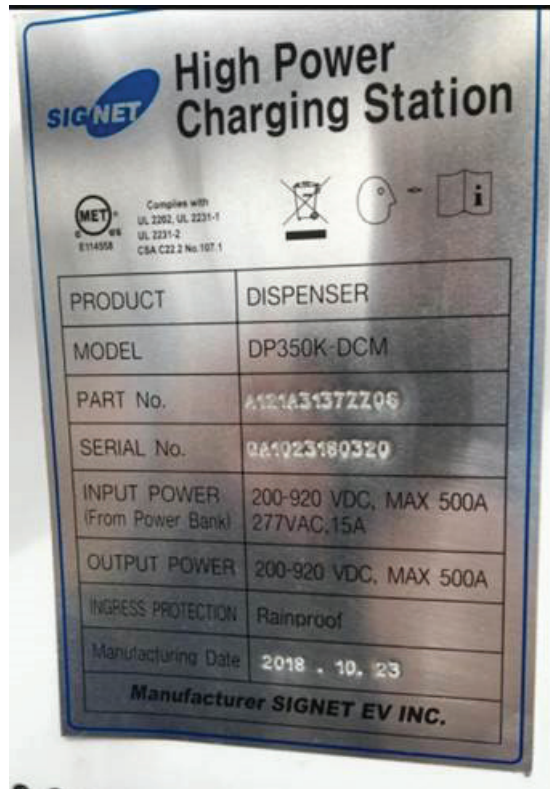
File Name	File Size
Example_Signet_Metal_Sign.jpg	0.0392 MB

Please submit a Vehicle report if this issue is encountered and include a picture of the metal sign (see Example\_Signet\_Metal\_Sign.jpg) on the side of the HV charging station whenever possible.
