01-20-05 - MIL ON, DTC P0111

Release date: 6/10/2021

Technical Background

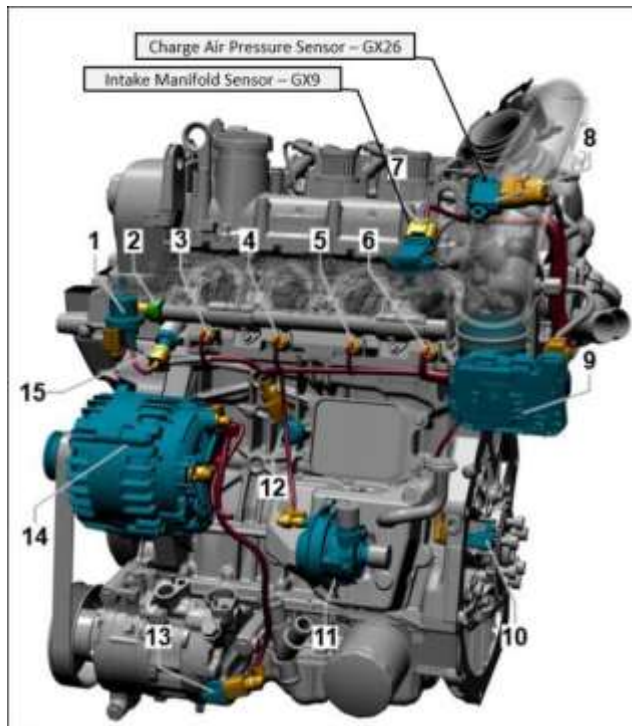
Figure 1: DGXA

For Golf DGXA engine, inspect both the Charge Air Pressure Sensor -**GX26**- and Intake Manifold Sensor -**GX9**- part numbers to insure they are the correct and that both sensors are in the correct location (Charge Air Pressure Sensor -**GX26**- is not in the Intake Manifold Sensor -**GX9**- location and vice versa).

For Golf DGXA engine, if the sensors are the wrong part number or in the wrong location, this Technical Bulletin no longer applies and the correct sensor part number needs to be installed into the correct location.

If both part numbers are correct and the sensors are in the correct location, install the engine hood blanket (including CZTA applications).
