**S21AZ**

**Subject:** S21AZ, Ford 6.8L Air Compressor Belt

**Models Affected:** Model Year: Certain 2013 through 2022  
Model: Vision School Bus and Non-School Bus

## S21AZ Ford 6.8L Air Compressor Belt

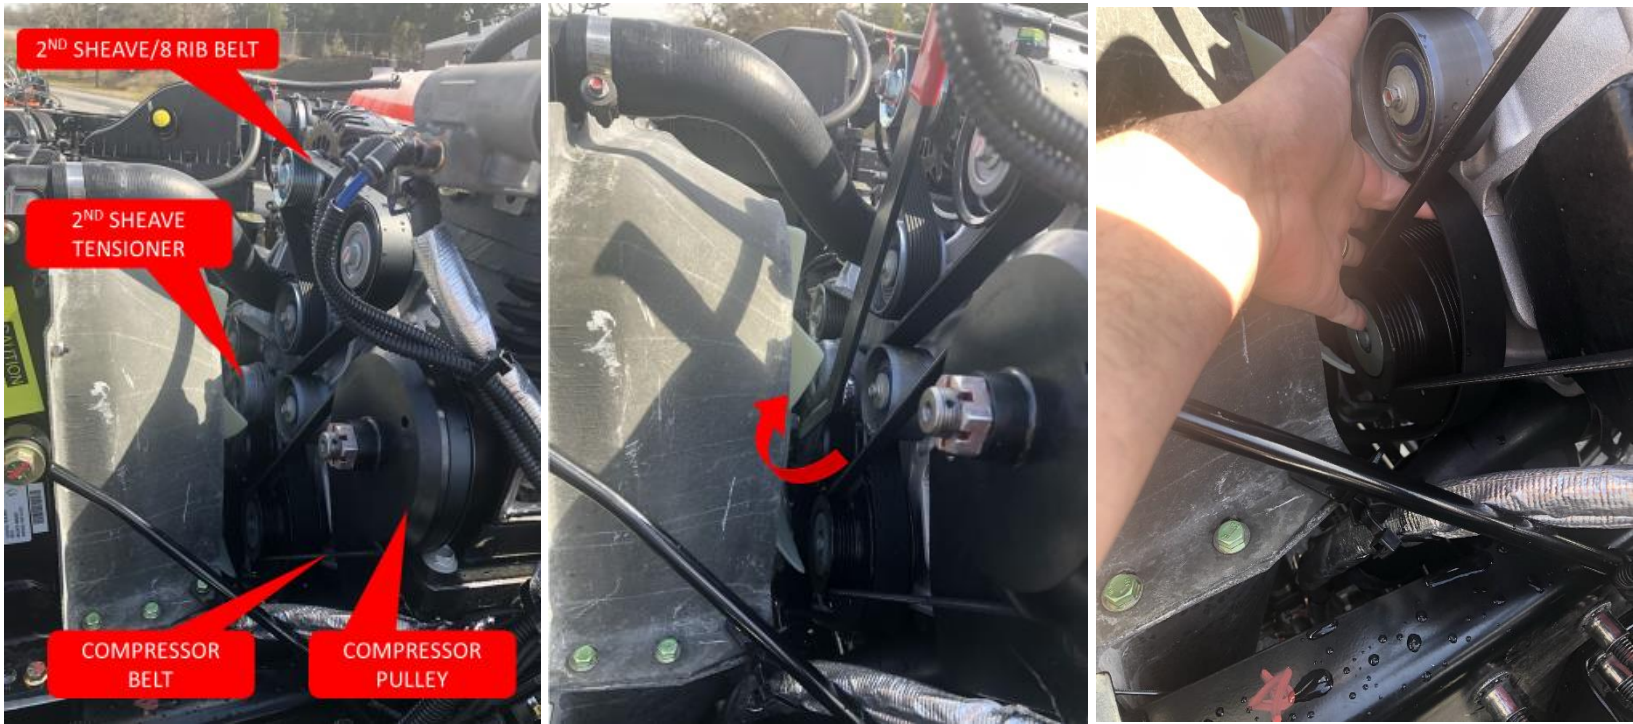
**NOTE:** Photo below is Gen 4, which is identified by the solid compressor pulley. Gen 3 will have a spoked pulley. Failure to install the correct belt will result in pre-mature failure.
