# Service Action

## Code: 72M1

<b>Subject</b>	<b>Backrest Remote Release Mechanism</b>																																		
<b>Release Date</b>	June 15, 2021																																		
<b>Affected Vehicles</b>

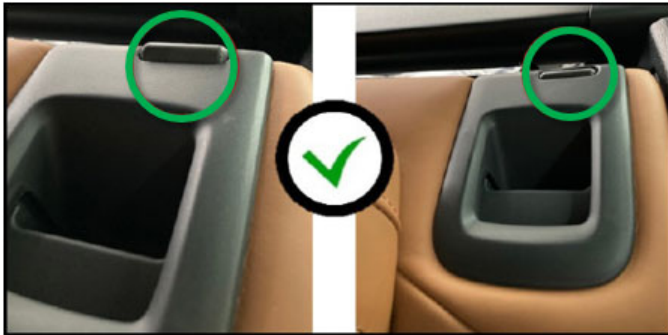
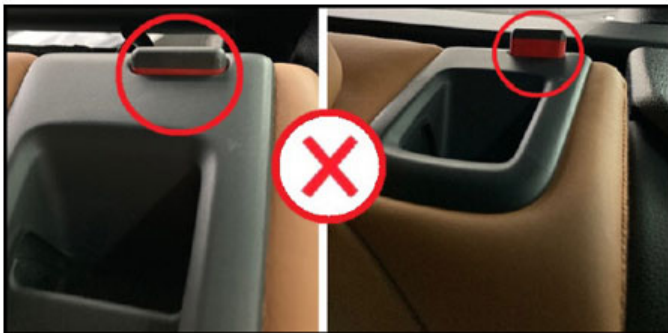
- The left and right lock indicators must be checked.
- When rear seat backrest is locked completely in place, check whether indicator is flush with backrest latch trim.
- The red section of the indicator must not be visible.
- Repeat check 5 times (fold down the backrest and then fold it back up) and check each time that the backrest locks into place correctly.
- If both backrest remote release mechanisms lock into place as described and the indicator is flush with the backrest latch trim:
  - No further work is necessary.
  - Proceed to Section D.
- If either indicator does not lock into place so that it is flush with the backrest latch trim:
  - The affected release cable must be reworked.
  - Proceed to Section C.
