Service

Category Engine/Hybrid System

# **MIL ON With Companion Cylinder Misfire DTCs**

L-SB-0008-21

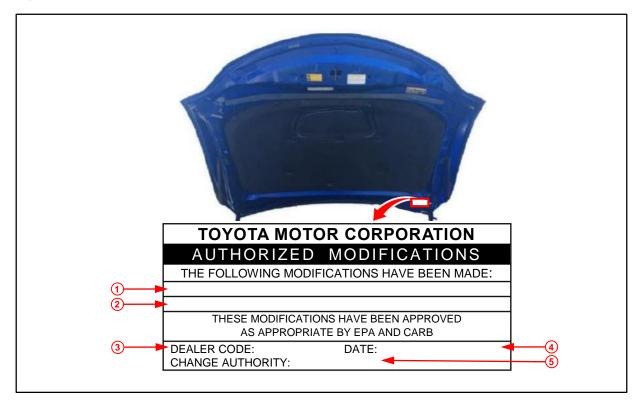
Figure 2. Location of Authorized Modifications Label on 2018 - 2021 RX 350

1. Use Techstream to confirm if the ECM (PCM) calibration has been updated and check for the Authorized Modifications Label affixed to the vehicle in the location shown below.

- 3. Prepare and install the Authorized Modifications Label.
  - A. Using a permanent marker, enter the following information on the label:
    - ECM (PCM) part number [Refer to the Parts Information section for the NEW PART NUMBER].
    - Calibration ID(s) [Refer to the Calibration Information section for the NEW CALIBRATION ID].
    - · Dealer Code.
    - Repair Date.
    - Change Authority [This bulletin number].
  - B. Install the Authorized Modifications Label onto the vehicle at the location shown in Figure 1. The Authorized Modifications Label is available through the MDC, P/N 00451-00001-LBL.
- 4. Test-drive the vehicle to confirm the condition no longer exists.
