Technical Service Bulletin

87 Air conditioning does not cool

87 21 15 2063575/1 June 16, 2021.

Model(s)	Year	VIN Range	Vehicle-Specific Equipment
Q5, SQ5	2020	073111 - 999999	Not Applicable
Q5, SQ5	2021	All	Not Applicable

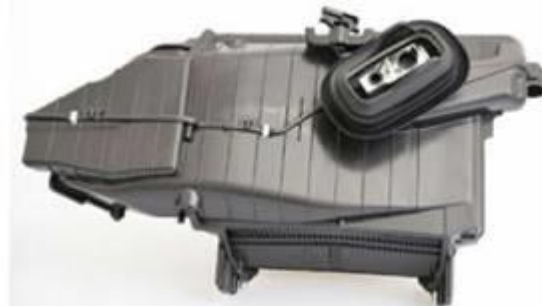
The refrigerant circuit head pressures are checked and the diagnostic finding is determined that the refrigerant volume in the circuit is very low or empty. DTC B10AE21 (High-pressure sensor Lower limit not reached) may be stored in the Heating/Air Conditioning Electronics control module, E87 (address word 0008). Leak identification dye is added to the refrigerant circuit along with a full charge of the refrigerant and the vehicle is test driven. No obvious leak can be seen under UV lighting. When using an electronic refrigerant leak detector at all of the connections in the refrigerant circuit no leak can be detected, however, when testing the central vents and condensate drain it alerts that the evaporator core may be the source of the leak. The evaporator core is replaced and normal HVAC system operation is restored.

Figure 1. HVAC evaporator and housing.

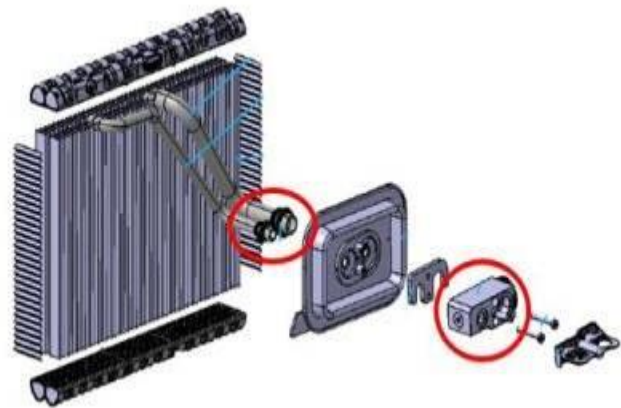
All evaporator cores replaced in the Q5 models for which this TSB appears have been returned, laboratory tested, and found to not have any leak whatsoever. This evidence confirms that while replacement of the evaporator core solves the refrigerant leak, the root cause of the leak is not the evaporator core itself but likely a compromised connection at the expansion valve either from the evaporator to the expansion valve, from either of the refrigerant hose connections to the expansion valve or the expansion valve itself. This can conclude in a false positive reading from the evaporator core and a positive refrigerant reading from a compromised connection instead.

Figure 2. Refrigerant connections in need of closer observation.

1. Should your diagnostic process conclude that any and all possible refrigerant leaks have been systematically excluded with the only confirmed leak being detected at the evaporator core apply a high level of scrutiny to the connection junction at the evaporator core /expansion valve/refrigerant lines for a possibly overlooked leak in these areas (Figures 2 - 3).

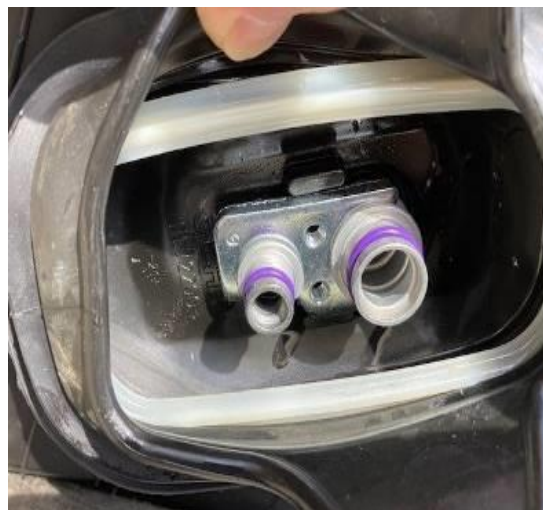
Figure 3. Refrigerant connections to the expansion valve.

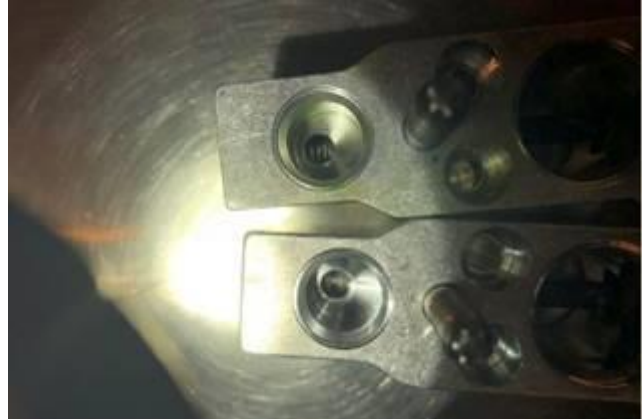
Figure 4. Leak at expansion valve connection evidenced by residue from the contrast agent.

2. If a refrigerant leak is detected from the evaporator core/expansion valve/refrigerant line junction, then replace the expansion valve and all four O-rings without replacing the evaporator (Figure 4). Re-test to ensure that the refrigerant leak is solved without the replacement of the evaporator core.
