June 17, 2021

Version 6

2021 Passport/Pilot: Popping or Crackling from the Speakers; No Sound from the Audio System; Network Loss Message and/or Display IssuesSupersedes 20-058, dated May 03, 2021, to revise the information highlighted in **yellow**.**AFFECTED VEHICLES**

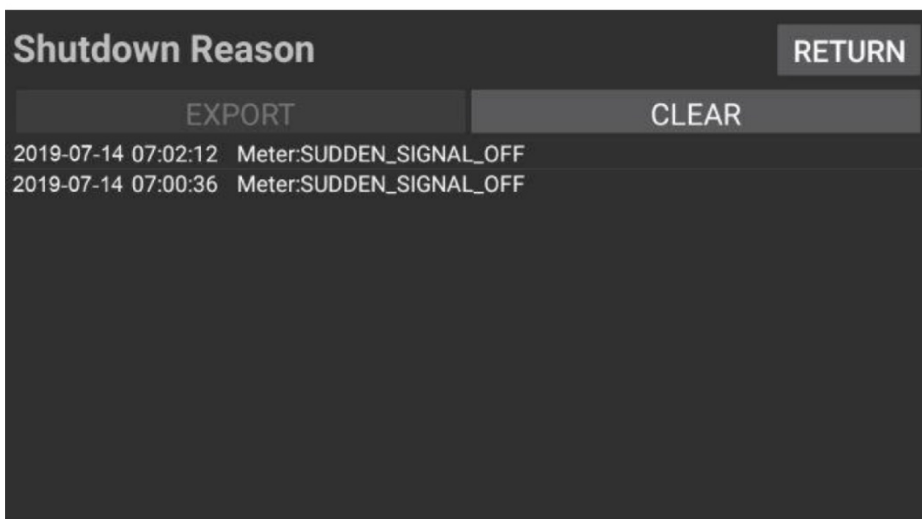
In this example, the cause of the failure can be identified as **Meter:SUDDEN_SIGNAL_OFF**.

Write down any failures; they will be collected on the warranty claim. Then, clear the data.

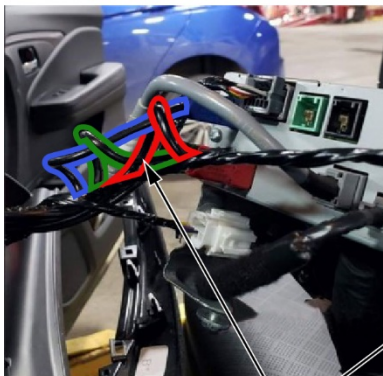
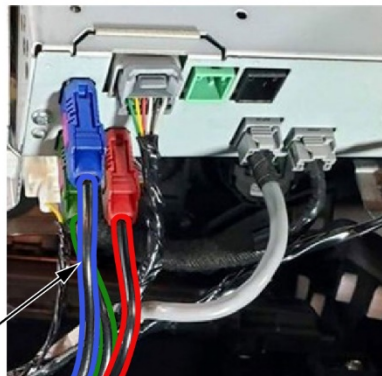
HARNESS
Reroute.

23. Install all of the removed parts in the reverse order. When installing units, make sure the harness is routed correctly. A mis-routed harness can put pressure on the wires and connectors causing connection issues. Do not pull on the units or MOST feeders while the FAKRA connectors are connected to help prevent communication issues.

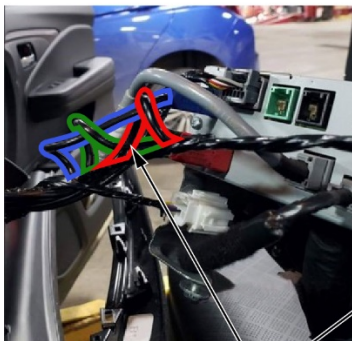
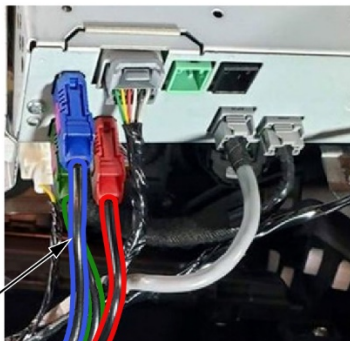
HARNESS
Reroute.

27. Install all of the removed parts in the reverse order. When installing units, make sure the harness is routed correctly. A mis-routed harness can put pressure on the wires and connectors causing connection issues. Do not pull on the units or MOST feeders while the FAKRA connectors are connected to help prevent communication issues.
