Technical Service Bulletin

68 Noises from the front center console

68 21 34 2063737/1 June 21, 2021.

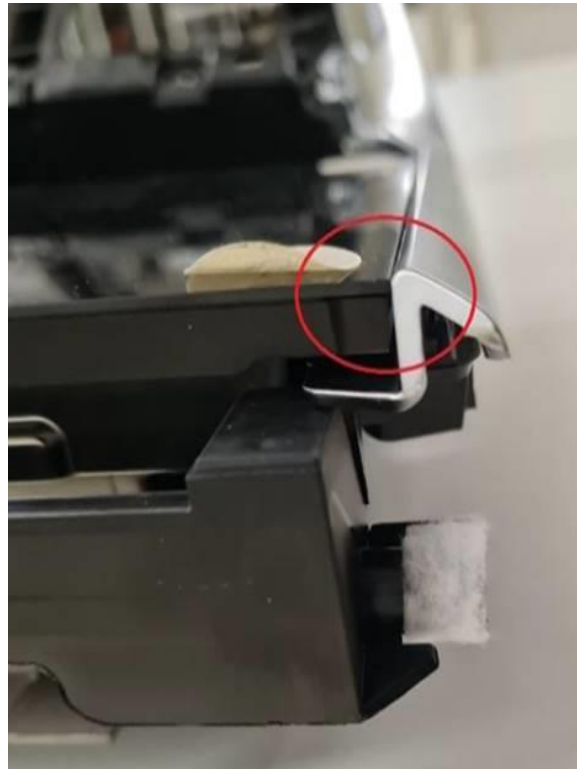
- There is hard contact between lower MMI display and front center console insert/trim.

Due to the tight assembly tolerances, the lower MMI display may make contact with the center console insert/trim (Figure 1).

Figure 1. Hard contact between lower MMI display and center console insert/trim.

1. Check the gap between the lower MMI display and the center console insert/trim on both sides.
2. Make a note on what side the MMI display is touching the center console insert.
3. Remove the lower MMI display according to the repair manual in Elsa.

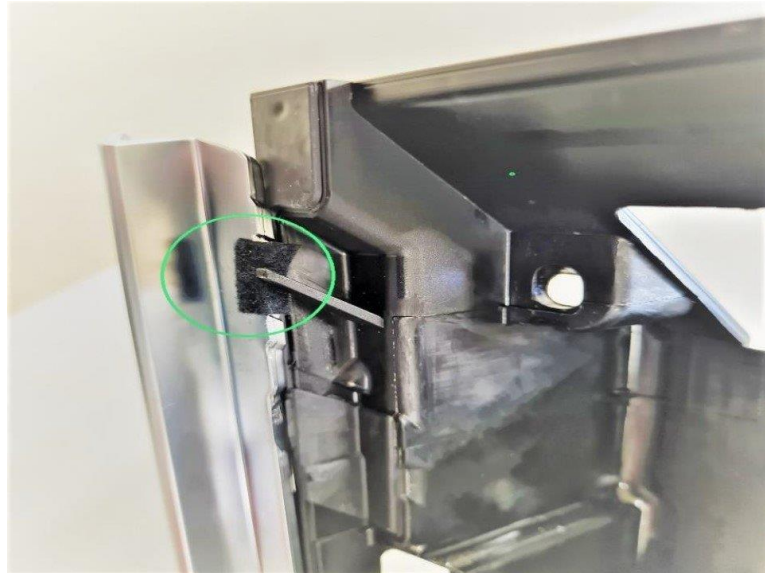
Figure 2. Felt tape applied between the rib of the display mount and the trim frame.

- Only on the side of the contact, apply a strip of felt tape (approx. 3/4 x 3/8 inch) between the rib of the display mount and the trim frame to increase the gap to the display on that side only (Figure 2).
