SS 3078-FTL2021 New Cascadia No Start and or Stalk Switch Shift Lever Right Active Fault(s)

The solution applies to New Cascadia vehicles built from 1/1/2020 with Detroit Engines and DT12 transmissions.

No engine crank and or fault codes 0/521006/14 and 33/520848/31 being active.

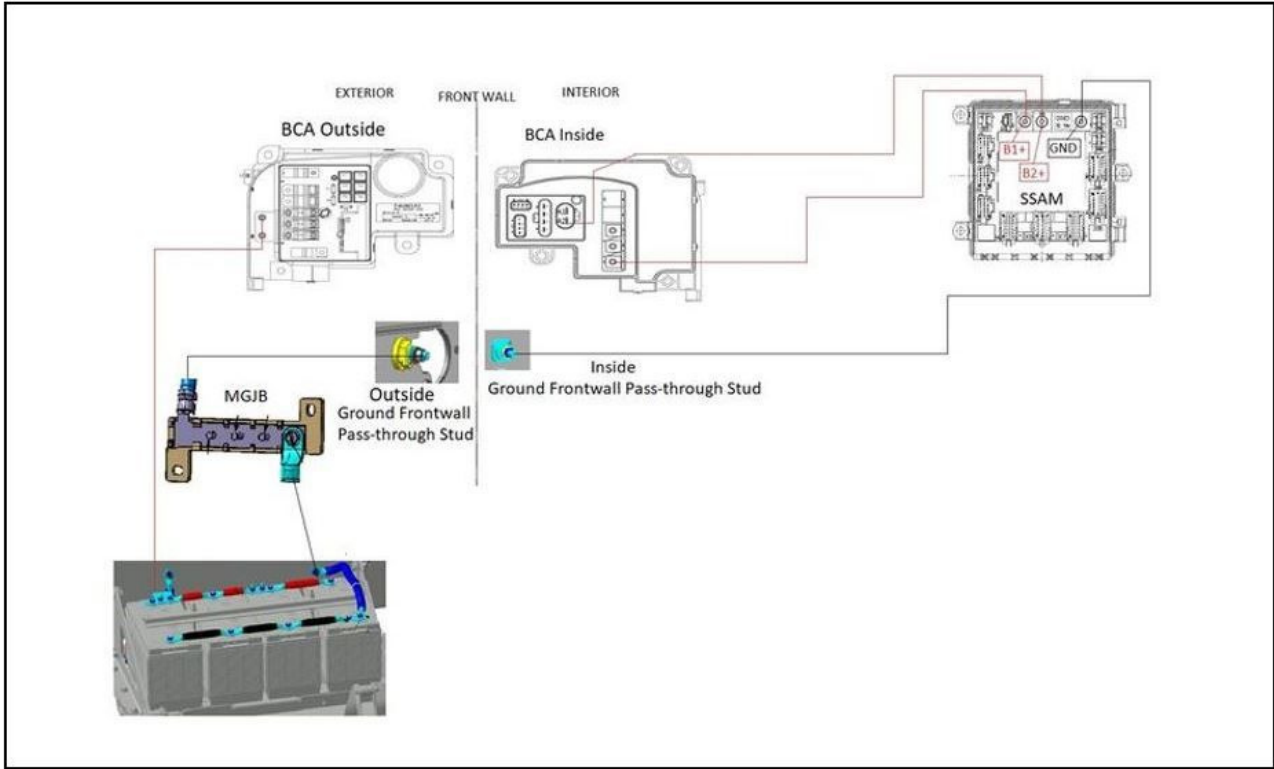
2. sSAM requires a good power and ground connection to function properly. If power or ground connections is compromised, or voltage drops occur between the sSAM and the power and ground sources, then sSAM function can be affected.

The figure below is a reference of the power supply path to the SSAM. Reference the figure when tracing out voltage drops if needed.

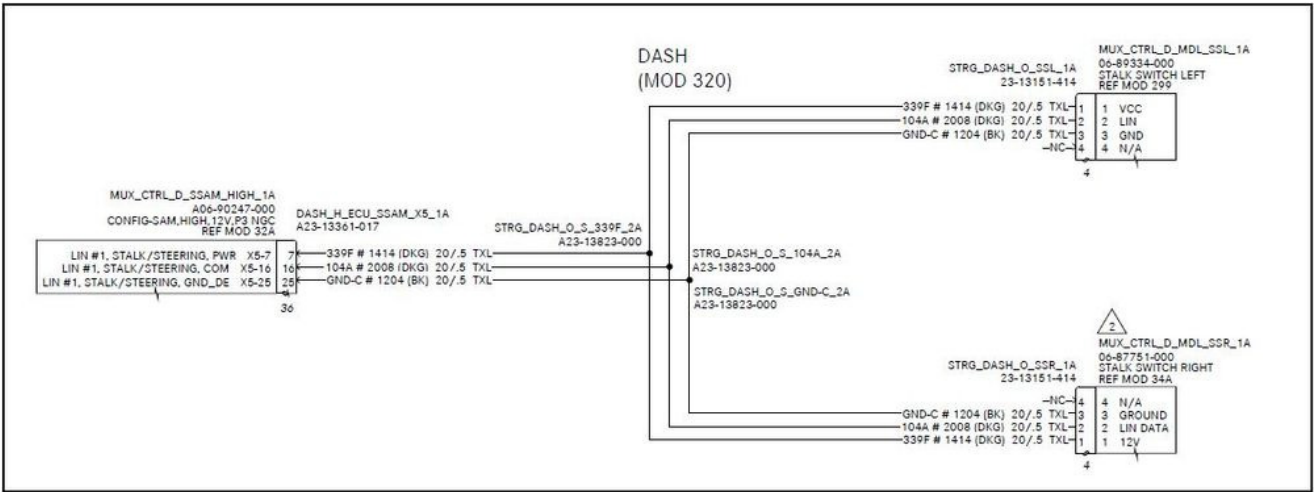
Lin wiring example for stalk switch (per S/N schematic from module 54C should be used for troubleshooting)

3. Faulty wire / harness and or poor connections of wiring going to the stalk switch right can also result in fault codes 0/521006/14 and 33/520848/31 becoming active. Typically, when this occurs both left and right stalk switches do not function. Below is the LIN wiring for stalk switches. If only these codes are active then insure the wiring between the sSAM and the stalk switch has continuity and no shorts and open are present. Also validate that power and ground is present at the stalk switches. If all of the wiring and connections are good and only the right stalk switch is still not functioning, then the right stalk switch has most likely failed.
