# Technical Service Bulletin

| <b>Technical Service Bulletin:</b> TSB170024 | <b>Released Date:</b> 11-May-2021 |
| <b>Air Compressor Malfunction Caused by Water Ingestion from Charge Air Cooler</b> | |

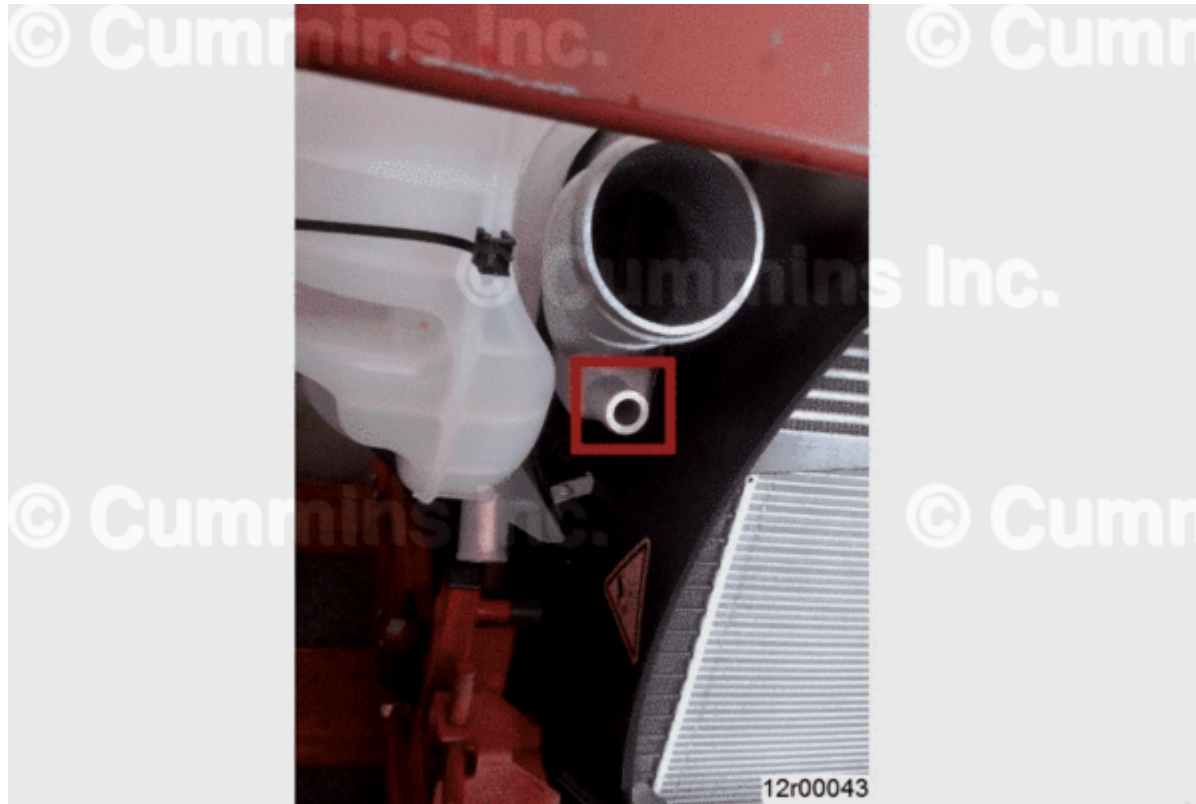
- Air compressor ingesting moisture from air compressor inlet tube supplied by Navistar. Air compressor inlet tube is connected at charge air cooler and condensation can collect at connection because of charge air cooler casting design.

- Verify air compressor inlet tube is connected to port on charge air cooler below charge air cooler outlet pipe. See Figure 1 below.
- Verify air compressor inlet tube is connected from charge air cooler connection referenced in Figure 1 to inlet connection on air compressor. Air inlet tube will either be bulk hose in convolute or a formed rubber hose. See Figure 2 below.
- Verify air compressor malfunction was caused by water ingestion. Air compressor unloader and valve assembly or air compressor cylinder can show signs of corrosion. See Figures 3 and 4 below.
- There can be damage to air compressor connecting rod assembly or air compressor crankcase caused by hydro locking.

Figure 1, Air Compressor Inlet Tube Port on Charge Air Cooler Causing Water Ingestion.

- For International® authorized repair locations, open a Navistar® Tech Support Case File for repair direction pertaining to malfunctioned parts on engine as well as for changing air compressor inlet tube configuration.
- If repair location is **not** authorized by International, please contact closest International® authorized repair location.

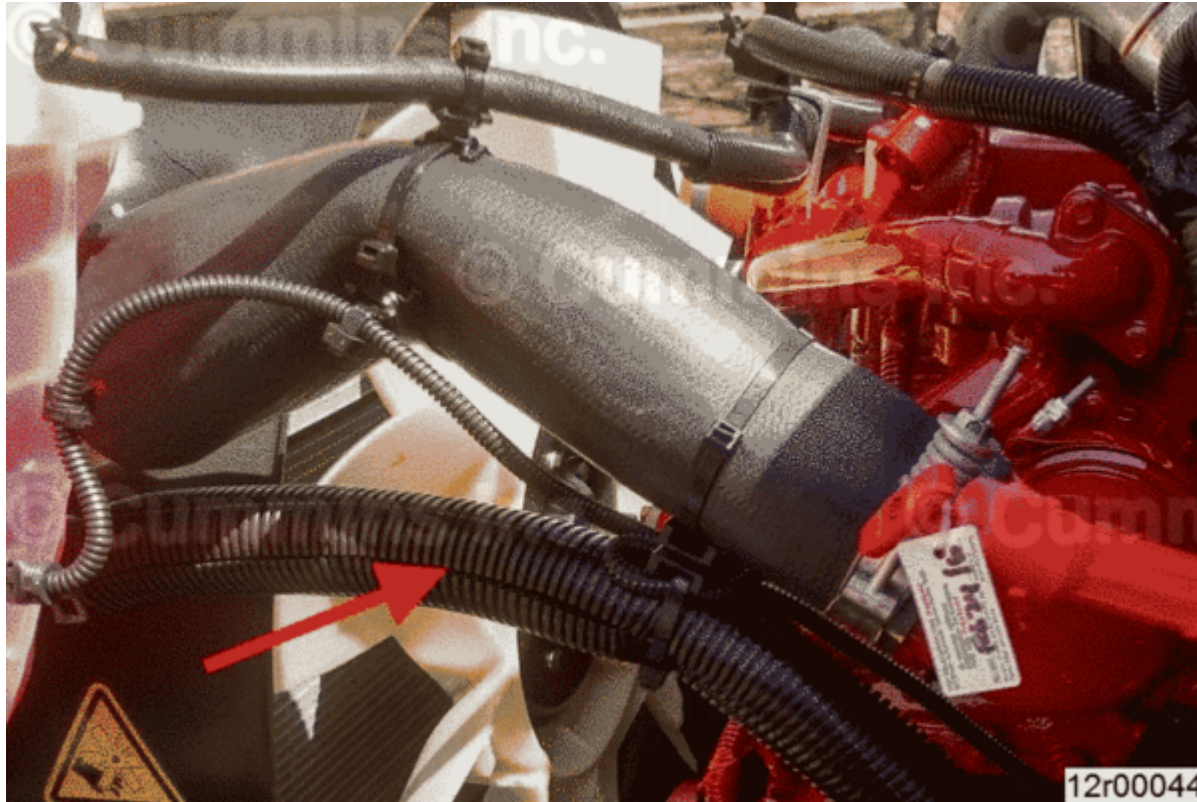
Figure 2, Air Compressor Inlet Tube from Charge Air Cooler to Air Compressor Inlet.

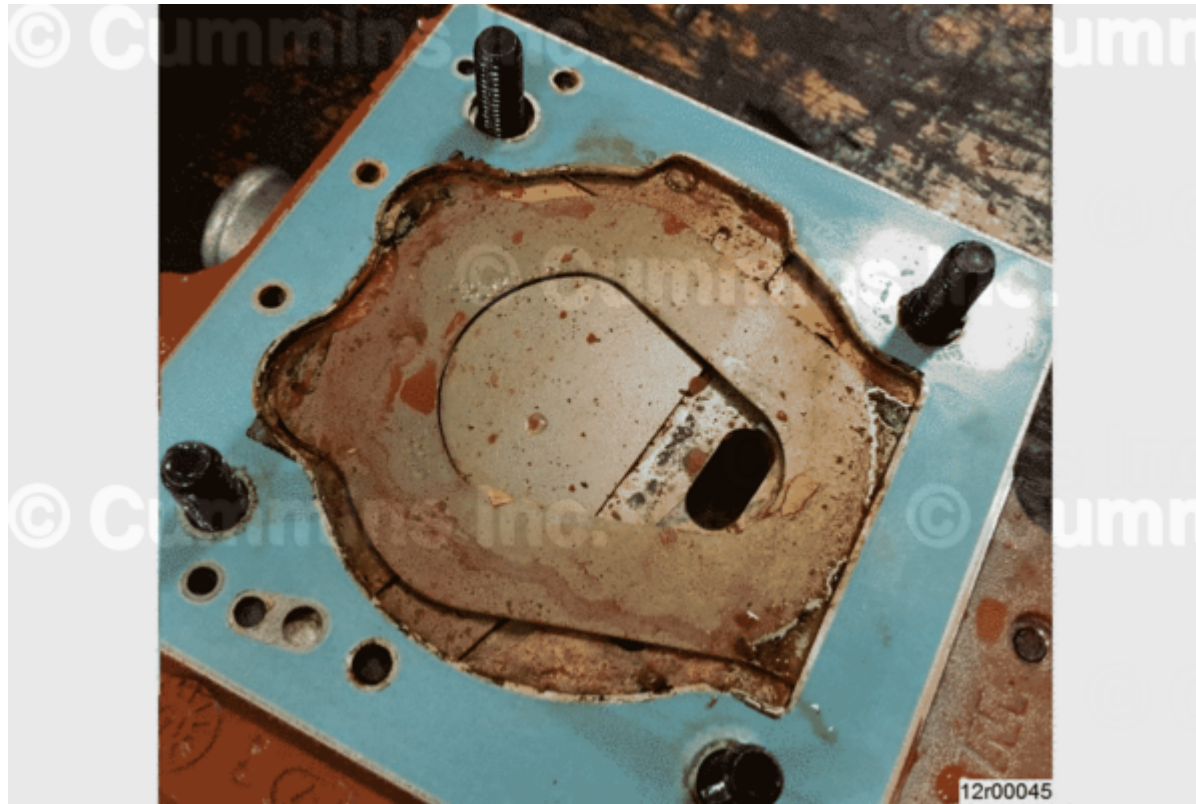
Figure 3, Corrosion Present On Air Compressor Unloader and Valve Assembly.

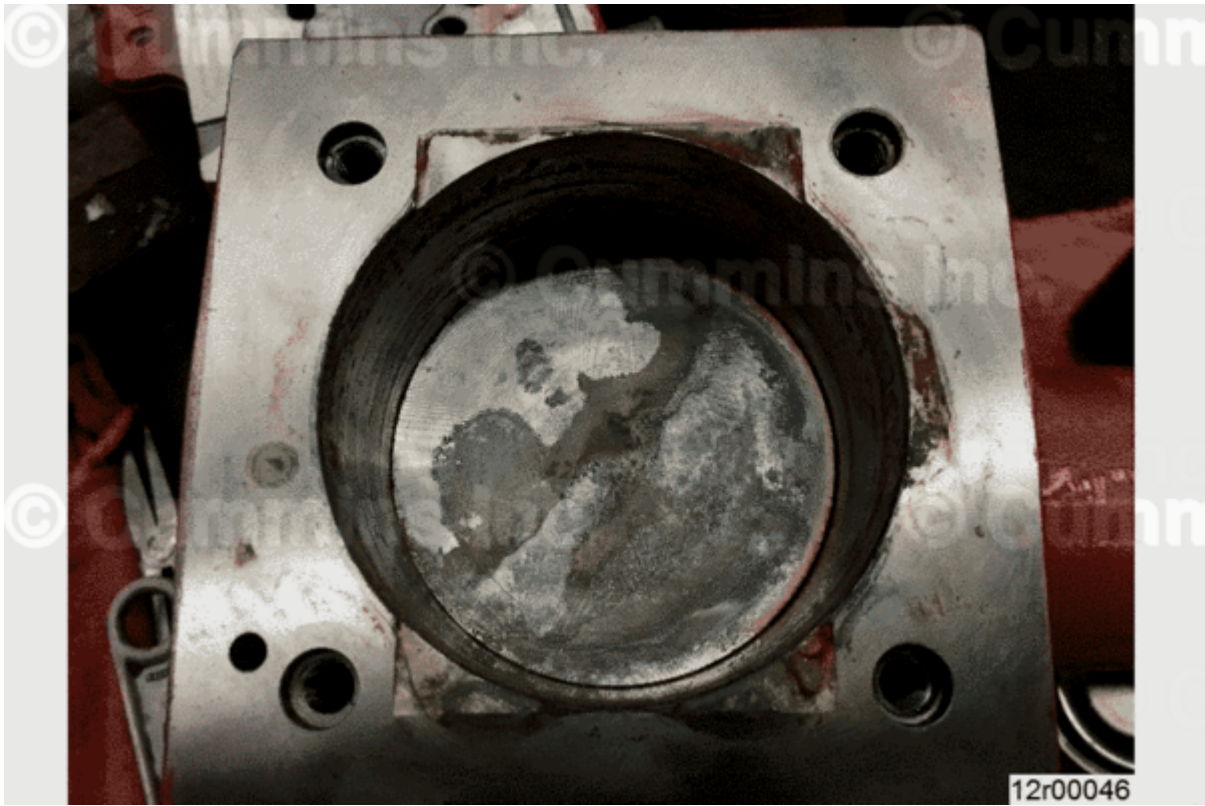
Figure 4, Corrosion Present in Air Compressor Cylinder.
