<b>Technical Service Bulletin:</b> TSB210032	<b>Released Date:</b> 20-May-2021
<b>Intake Air Heater Stuck Relay and Intake Air Heater Damage: Fault Code 383</b>

## Intake Air Heater Stuck Relay and Intake Air Heater Damage: Fault Code 383

- ISB6.7 CM2350 B101
- B6.7 CM2350 B121B
- B6.7 CM2450 B155B

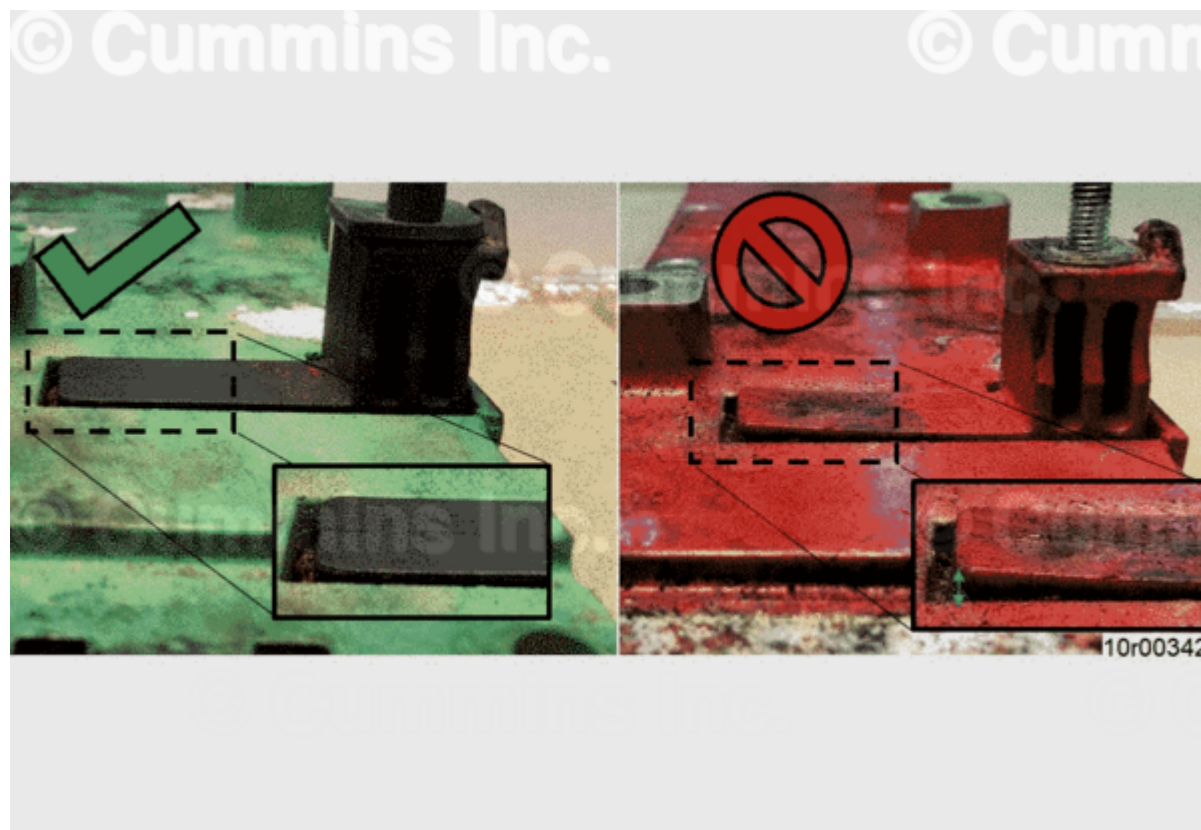
- Intake air heater relay stuck closed leading to extended on-time of the heater. Units experiencing Fault Code 383 may have experienced extended on-time of the intake air heater with no air flow entering the system caused by a stuck relay, causing the air heater to overheat. The isolated power connection bar may expand and lift from the top surface of the intake manifold cover due to extended on-time (Figure 1). The isolated power connection bar may also become loose. The issue may progress and exhibit electrical arcing damage to the intake air heater internal joints (Figure 2), with potential for arcing to cause debris to drop into the intake system.

Figure 1, Example View of Power Bar Deformation from Top Surface of Intake Manifold Cover.

- Intake air heater damage that exhibits power connection bar deformation or movement of the terminal back and forth is due to intake air heater relay failure and is **not** covered under Cummins ® warranty. Repair locations are to contact the OEM for further repair direction.
- For Navistar® and IC Bus applications reference iKnow article IK1201457.

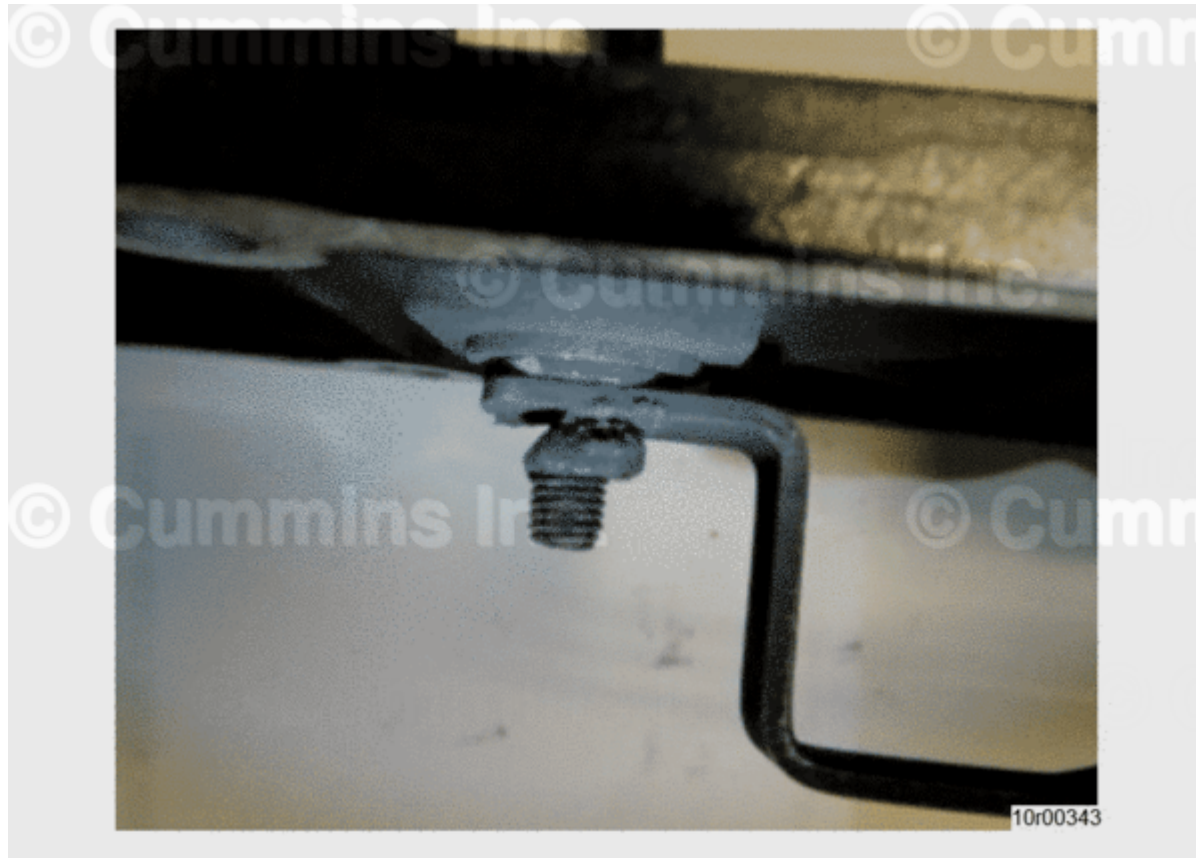
Figure 2, Example of Arcing Damage on Internal Joints of Intake Air Heater.

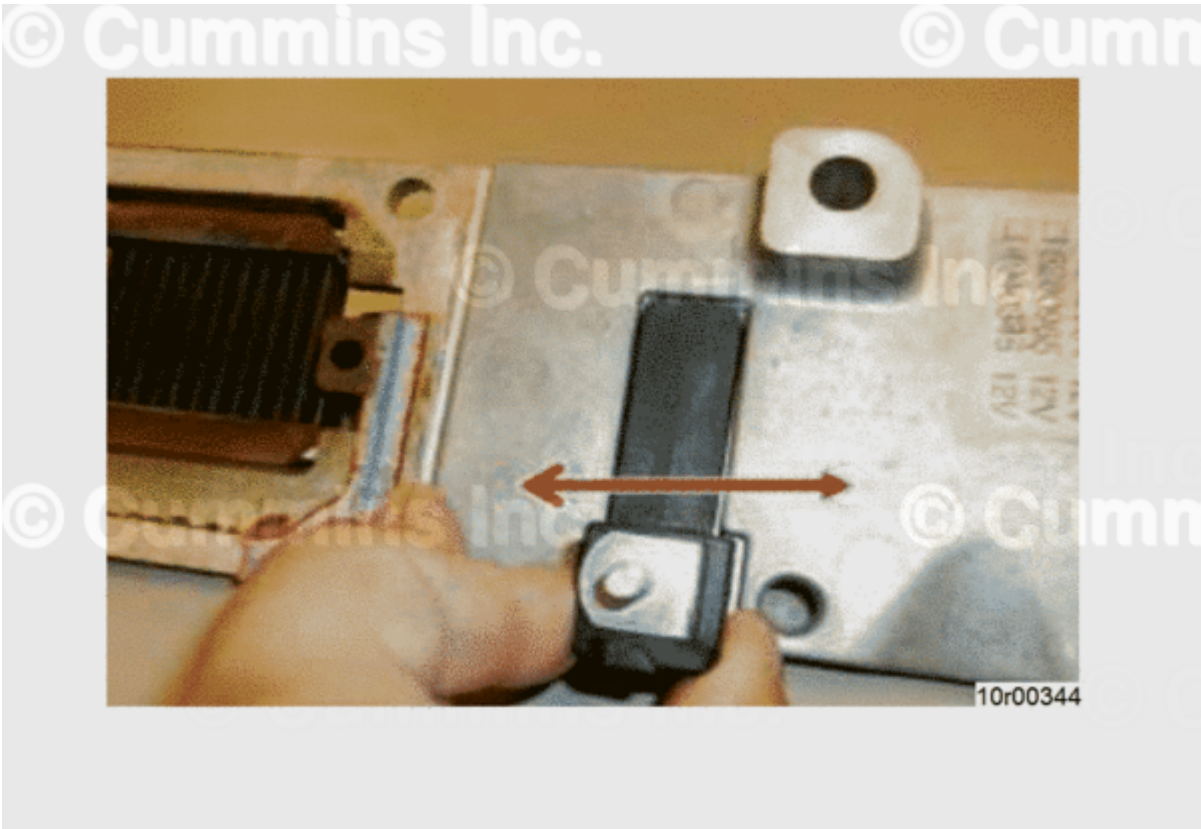
Figure 3, Any Movement of The Terminal Back and Forth As Shown is Unacceptable.
