STAR ONLINE PUBLICATION

Case Number: S211400002

Symptom/Vehicle Issue CEL (Check Engine Lamp) On Shortly After Filling Vehicle

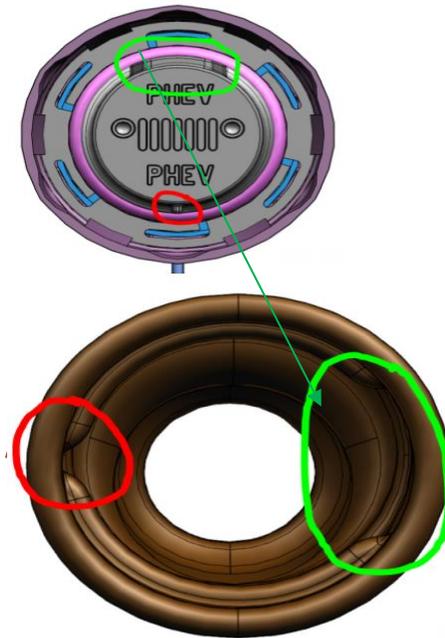
Fig 1

Customer Complaint/Technician Observation: Customer may experience CEL on and or Loose Fuel Filler Cap Warning Light. Technician Observation, DTC's P04EC- EVAP System Large Leak Detected - Fuel Tank Side Stored, P04EE- EVAP System Very Small Leak Detected - Fuel Tank Side.

Discussion: Inspection and verification of the fuel cap to filler neck sealing position. Use the below images Fig 1,2 as a guide to ensure the gas cap tab entry positions are aligned allowing proper sealing to be achieved when securing the cap. Inspect this area prior to service repairs for the above complaint.

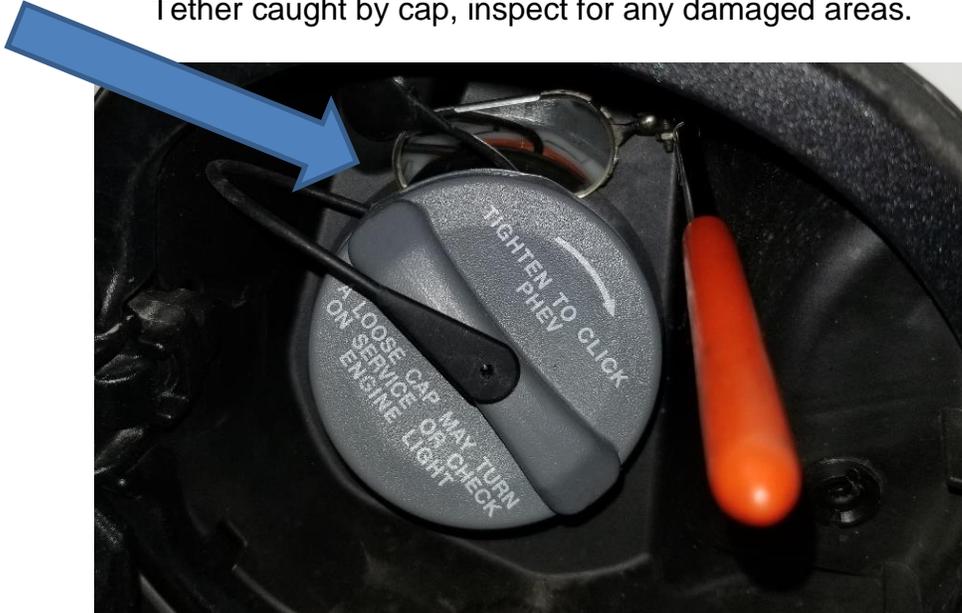
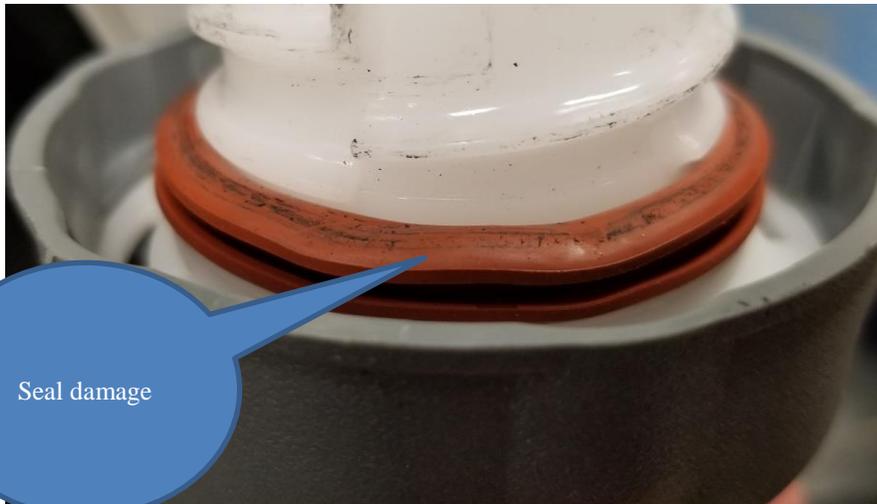
Fig 2

Tether caught by cap, inspect for any damaged areas.
