STAR ONLINE PUBLICATION

Case Number: S1923000014 Rev D

Symptom/Vehicle Issue: Ram Box Lid Fitment And Or Closing Effort Issues

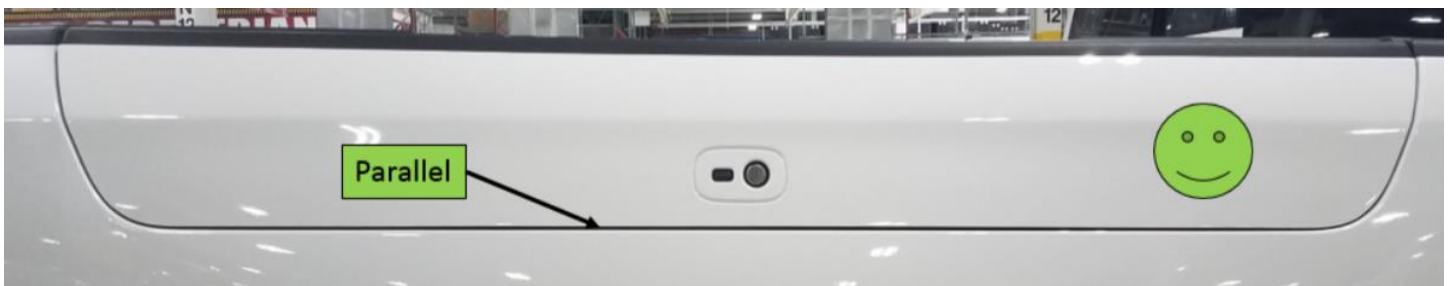
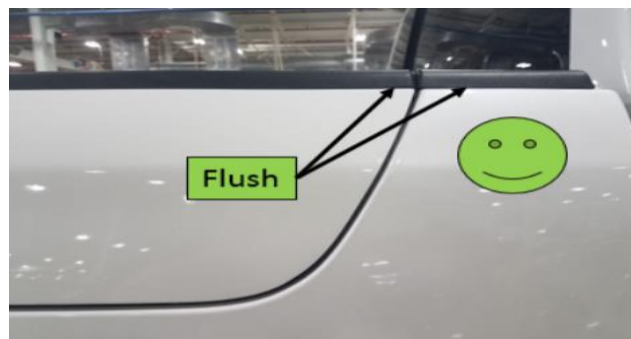
Discussion: Lid fitment issues can be improved with adjustments. Visually inspect and test operate the lids to confirm an issue. The bed to Ram Box gaps should be even. The lid top should be flush to the bedside. If not- follow the steps below to adjust. Acceptable gaps and fitment:

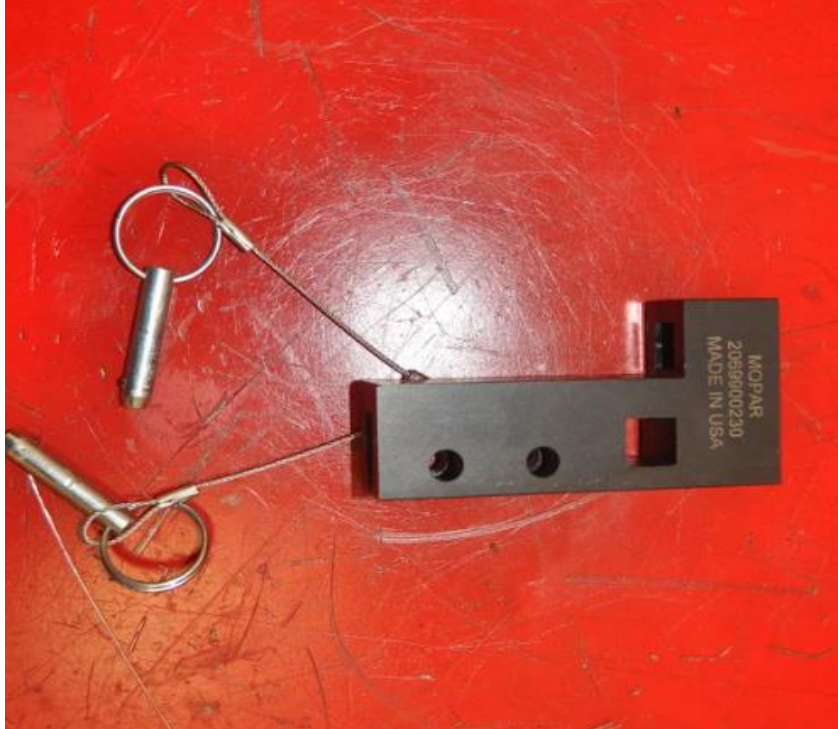
Mopar special tool 2069900230

Tool 2069900230 has multiple ½” drive squares to allow different pry locations to aid in adjusting striker loop using different length ½” drive socket extensions. The pins lock the tool to the striker. Service information is in process of being updated and Mastertech will be discussing this tool’s usage.

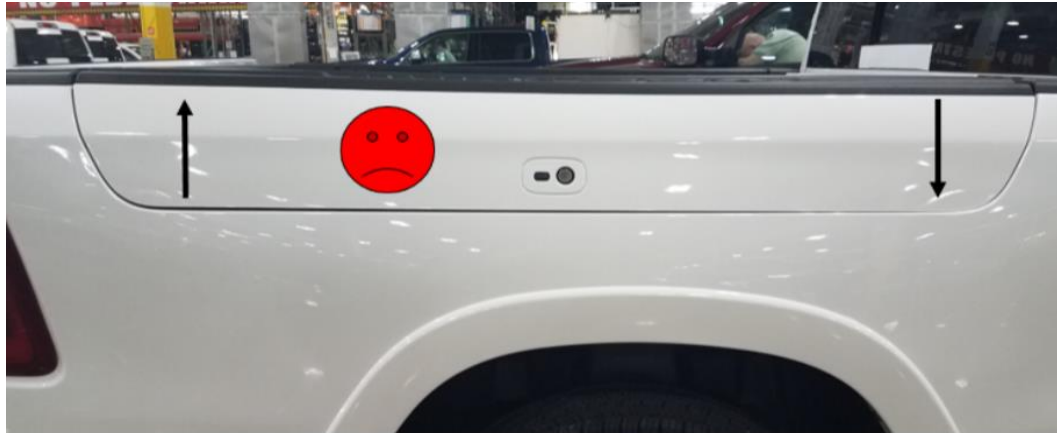
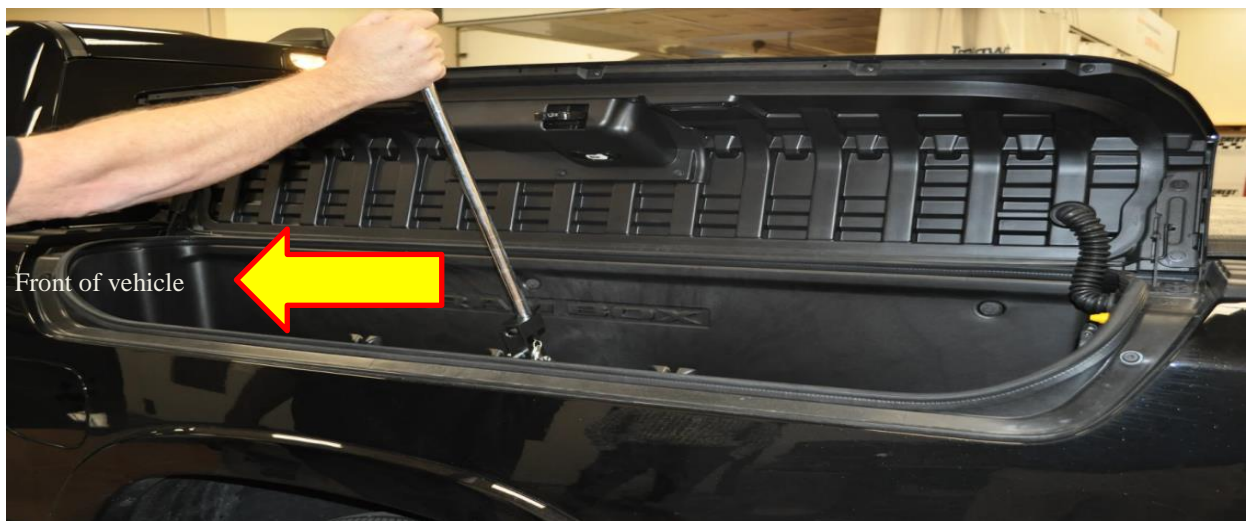
1. Uneven gaps at bottom of lid.

If the gap is higher at the REAR, open the lid and carefully use a MOPAR essential tool 2069900230 to bend the striker forward (toward front of the vehicle).

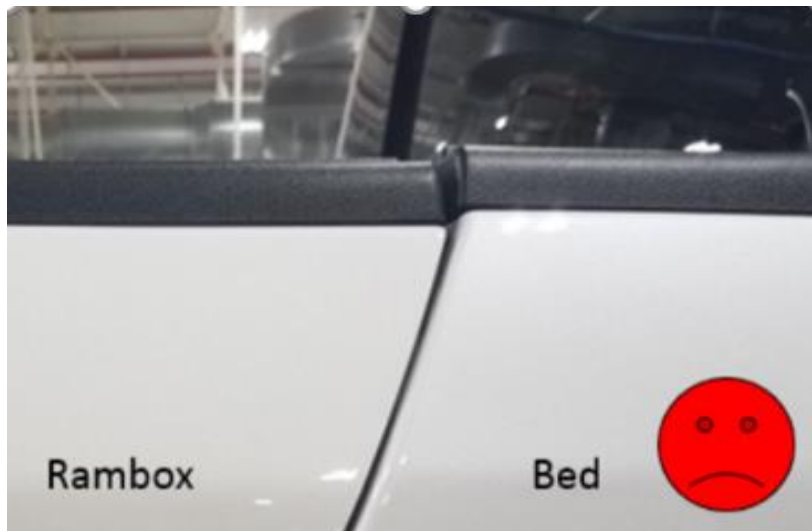
2. Lid not flush. Fix Lid Up/Down Gaps

Under flush condition

After adjusting the lid parallel in step 1, if the lid is under flush to the bed trim and/or closing effort is high, open the lid and use pry tool to bend the striker UPWARDS to raise the lid. Over flush requires a striker move DOWNWARDS to lower the lid.

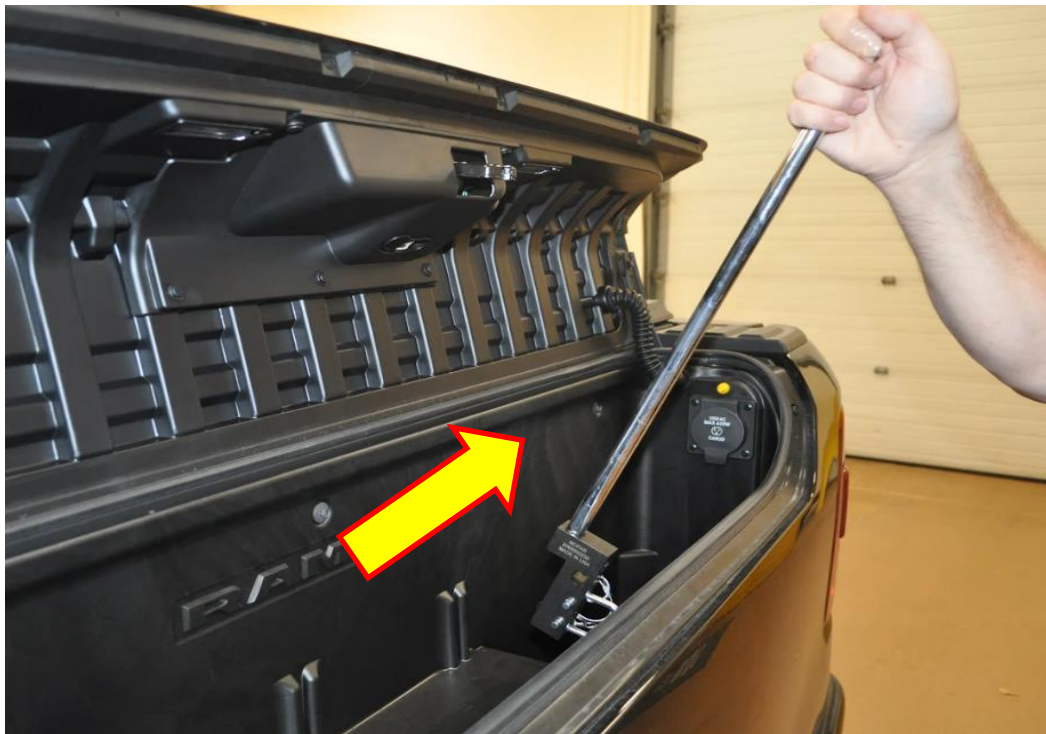
Bending the striker upwards to raise lid.
